## STRUCTURAL INSPECTION

902 Rolling Mill Dr  
Sugar Land, TX 77498

FEBRUARY 7, 2023

REF: CONDITION OF PROPERTY SURVEY

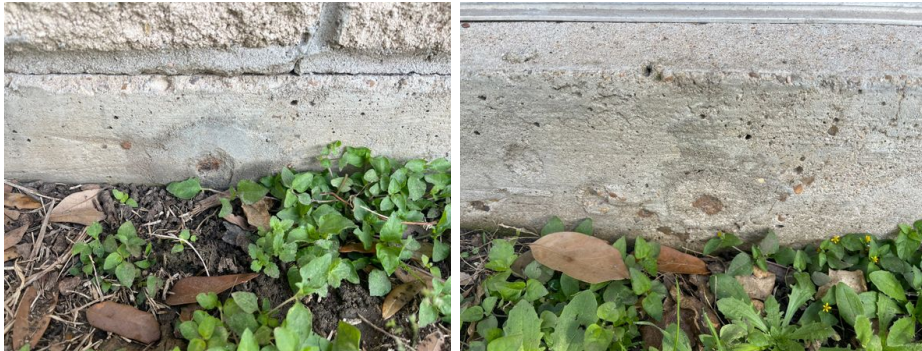
The foundation was a concrete slab on grade, and was reinforced with post tensioned cables.

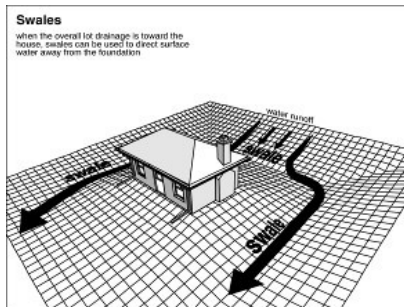
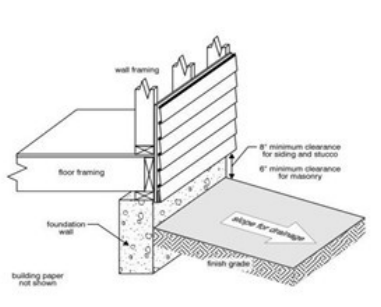
4.6.1 Perimeter Grading/Drainage

The perimeter drainage was observed to be poor at some areas where the lot is not sloped away from the house (6 inch drop in the first 10 feet) and water will pond. Poor drainage conditions near the foundation can contribute to foundation movement. It is recommended that a company specializing in drainage solutions be contacted to provide a recommended solution, along with a cost estimate to provide proper drainage.

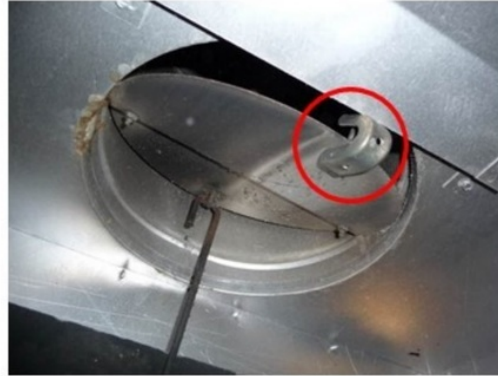
HEI file photo showing c-clamp in metal fireplace

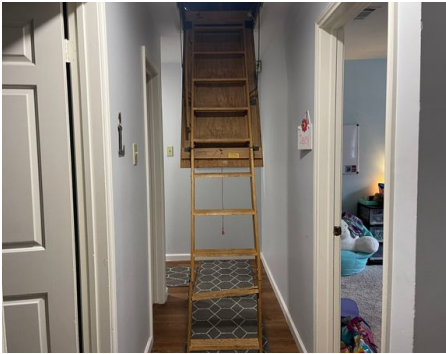
The access ladder into the attic appeared to be the original installation ladder, and the ladder was not labeled to indicate the rated capacity of the ladder. The ladder does not meet current code requirements for ladders into attics. Consideration should be given to replacing the ladder with a ladder that meets current code requirements.

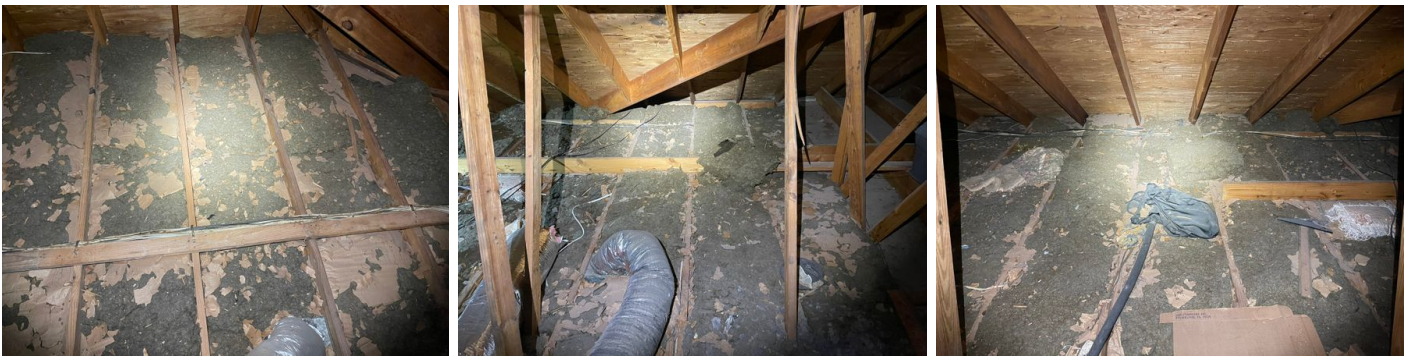
### Insulation: Batt 9"-10"

The insulation in the attic was average by the standard for the age of the house. The insulation appeared to be approximately 9-10" thick, which would be an R30 energy rating. It is pointed out that the insulation requirements according to the latest standard for new houses in this area is an R38 energy rating.

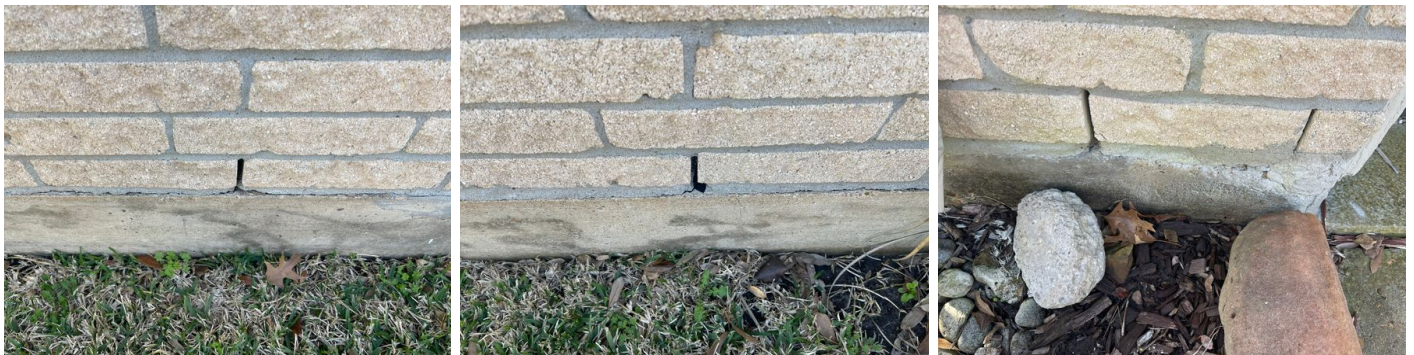
### Brick/Stone Veneer: Weepholes observed

We observed weepholes at the bottom of the exterior wall veneer, which is a good detail to allow moisture a drainage path out of the wall.

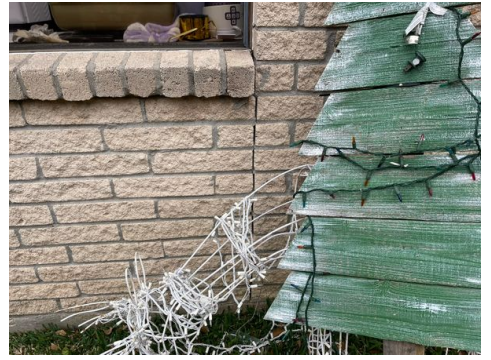
10.1.1 Brick/Stone Veneer

The expansion joints/control joints in the brick veneer need to be sealed to prevent water penetration into the wall cavity/building interior.

**Obtain Cost Estimate**

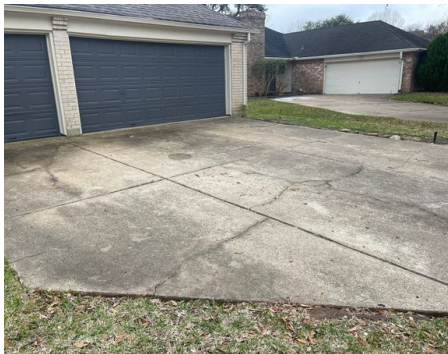
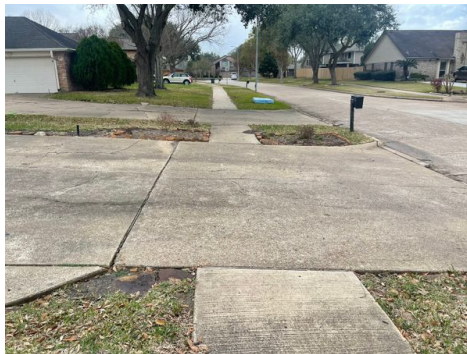
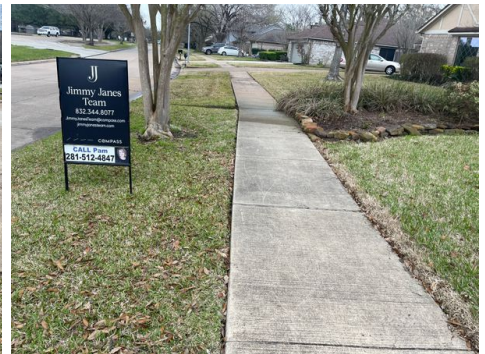
#### Flatwork Concrete/Patios/Walkways: Cracks Driveway

Cracks and some separations were observed in the driveway concrete. In our opinion, the driveway is still in serviceable condition at this time.

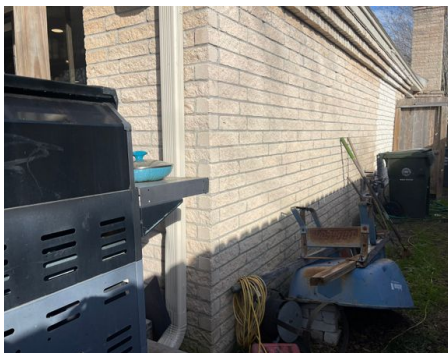
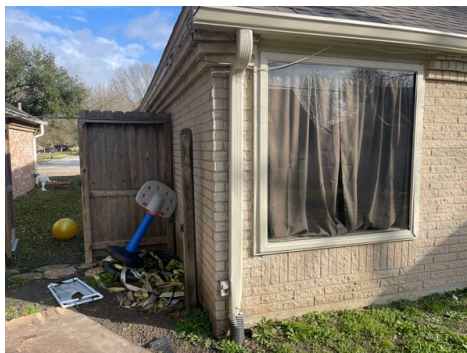
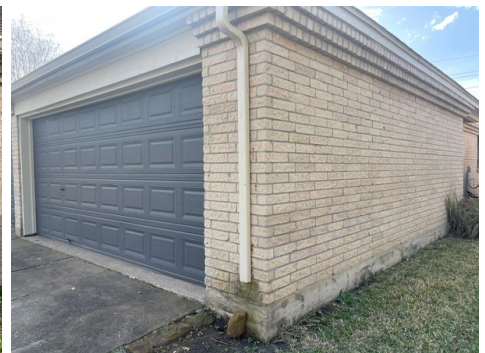
#### Gutters and Downspouts: Gutters and Downspouts - OK with some repairs needed

They gutters and downspouts were generally OK with some repairs needed as noted below.
