## MECHANICAL INSPECTION

11511 Olympia dr  
HOUSTON, TX 77077

# PROPERTY INSPECTION REPORT FORM

June Chapman in C/O Debbie Cooper <i>Name of Client</i>	10/05/2022 9:00 am <i>Date of Inspection</i>
11511 Olympia dr, HOUSTON, TX 77077 <i>Address of Inspected Property</i>	
Luis Mireles <i>Name of Inspector</i>	TREC#22797 <i>TREC License #</i>
<i>Name of Sponsor (if applicable)</i>	<i>TREC License #</i>

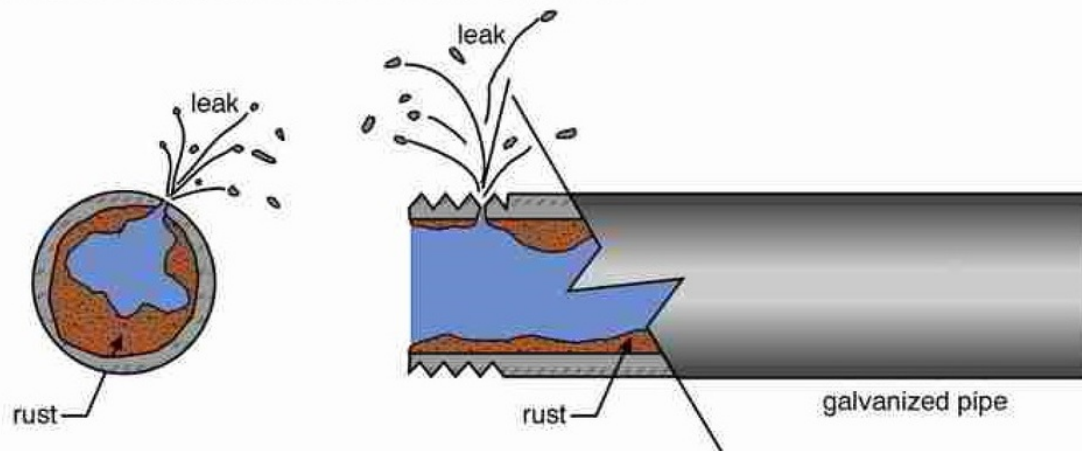
All or portions of the water piping for the property was observed to be the original galvanized piping. It is pointed out that the galvanized piping will deteriorate with time, and will corrode on the inside of the piping, thereby reducing the inside diameter of the pipe, and restricting the flow of the water through the pipe. In addition, the piping will corrode through to the outside of the pipe and will eventually deteriorate to where the pipe will start leaking. It can be anticipated that the galvanized water piping throughout the house will need to be replaced when it is causing reduced water pressure or is corroded enough to start leaking.

rusting of galvanized pipe can greatly reduce water pressure and will eventually cause leaks as rust creates holes in the pipe walls

problems are likely to occur soonest on pipes carrying hot water, horizontal pipes and at threaded (thinner) sections

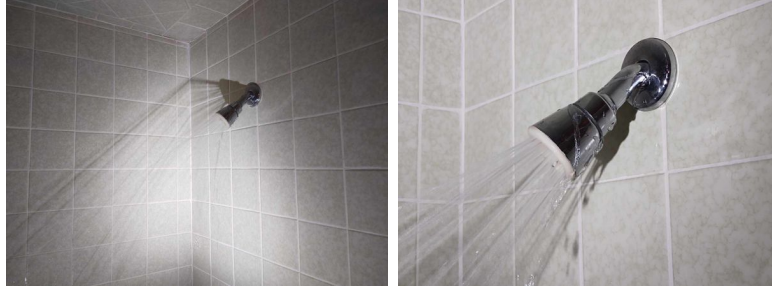
Master bathroom, 2nd Floor Bathroom,

**13: Shower/Tub - Caulk valves**

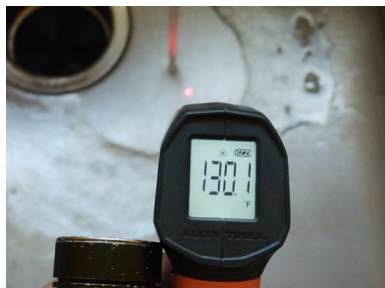
*Water Heater Equipment - limited life:*

Due to the age and/or condition of the equipment, it is our opinion that the equipment has only a limited amount of life remaining. Normal life expectancy for a water heater in the Houston area is approximately 10-12 years.

Recommendation: Contact a qualified professional.

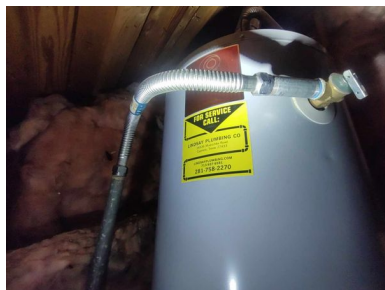
**2: Overflow Pan - Remove Insulation/debris**

Insulation and/or debris was observed in the overflow pan and needs to be removed.

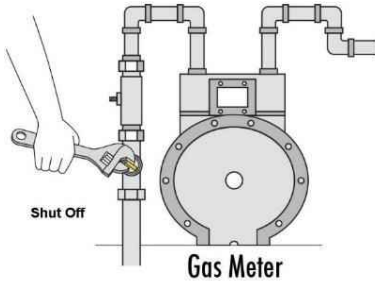
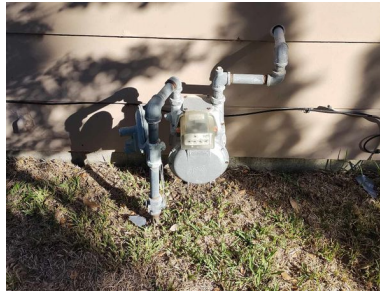
Gas meter,

**1: Gas odor observed**
