STRUCTURAL INSPECTION

11511 Olympia dr
HOUSTON, TX 77077

OCTOBER 5, 2022

REF: CONDITION OF PROPERTY SURVEY

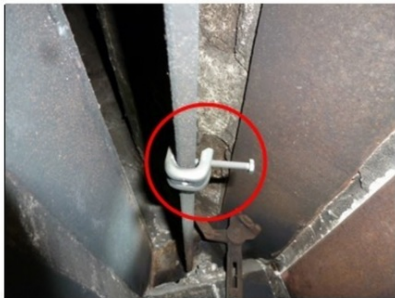
The damper was not equipped with a C-Clamp device to prevent closing the damper completely to allow the hazardous combustion gases a path to escape up the chimney.

HEI file photo showing c-clamp in masonry fireplace

Obtain Cost Estimate

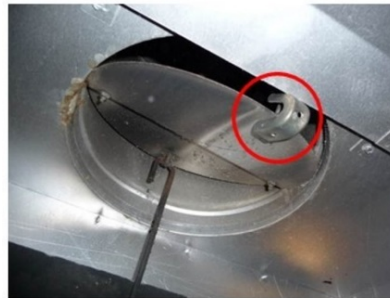
HEI file photo showing c-clamp in metal fireplace

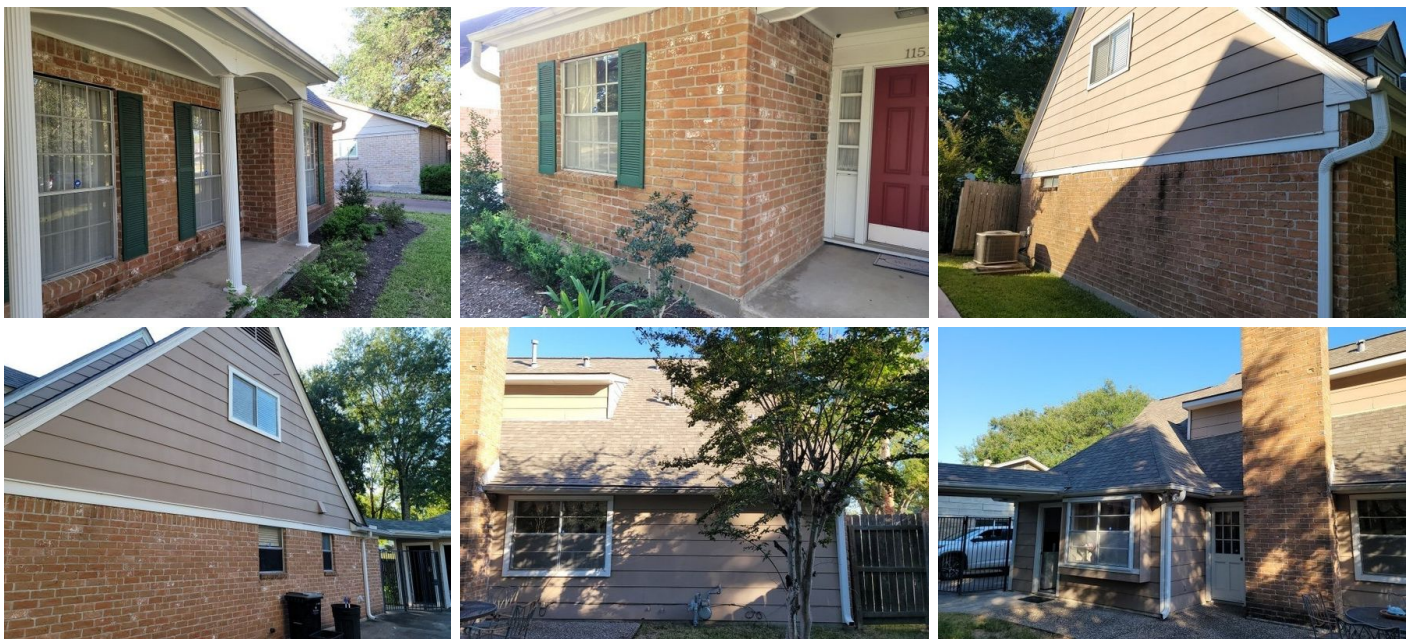
West East

Brick/Stone Veneer: Eroded Brick - Monitor

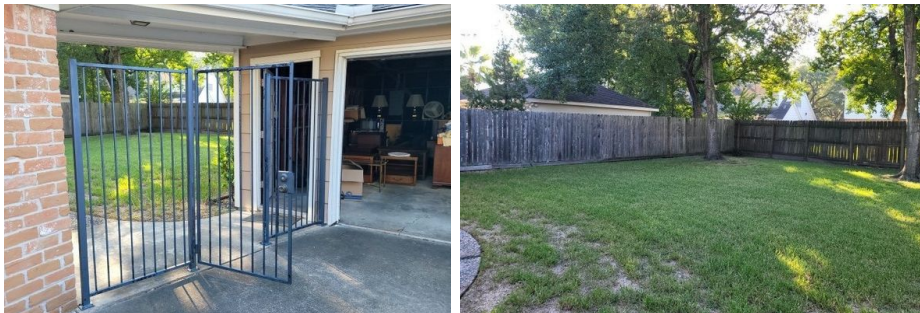
The gates and fences were in generally good condition at the time of the inspection and no repairs were observed to be needed.

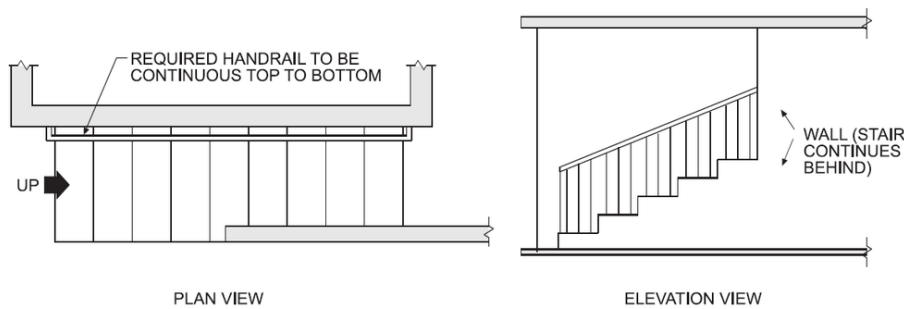
Figure R311.7.8.2
HANDRAILS

The handrails for the stairway were not constructed according to the current building code standards, which is expected given the age of the house. Therefore, the ends of the handrails do not terminate into the wall, which could allow loose clothing or a purse or bag to catch on the open end, causing tripping and/or falling down the stairs.

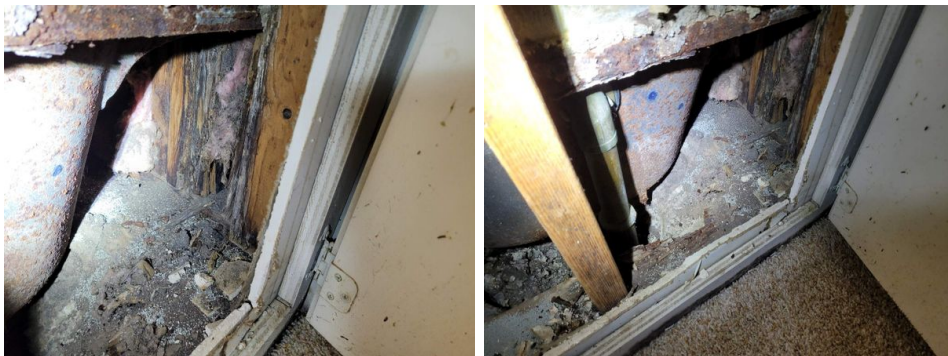
Extensive wood rot was observed and it is recommended that the damaged wood be replaced. It is pointed out that additional damage could be present under the rotted material that will not be visible until the outer rotted materials are removed. Have a service company determine the entire scope of wood rot throughout the house, and provide a cost estimate to replace all rotted wood.

Obtain Cost Estimate
