## Property Inspection Report

11419 Pampass Pass, Houston, TX 77095

Date of Inspection: 2/27/2023 Time: 8:15 AM - 12:15 PM

Inspector: James Sprouse

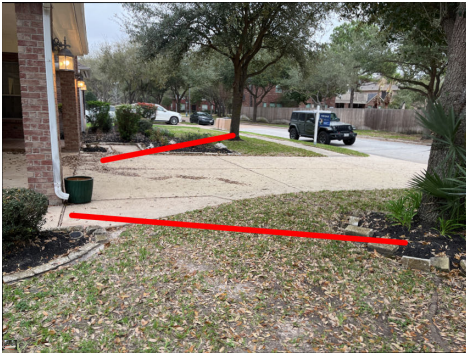
Front: Tree roots adjacent to foundation

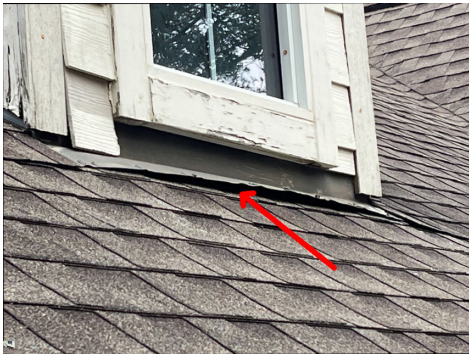
Loose or uplifted flashing was noted on the roof. We recommend having this secured to avoid water intrusion. This was observed on the front.

Front: Uplifted flashing

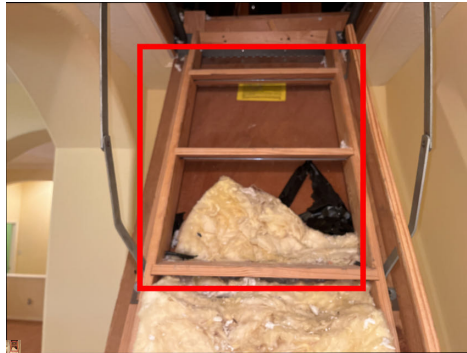
The pull-down stair to the attic was not properly insulated. We recommend adding insulation for improved energy efficiency.

Pull-down stairs lacked sufficient insulation

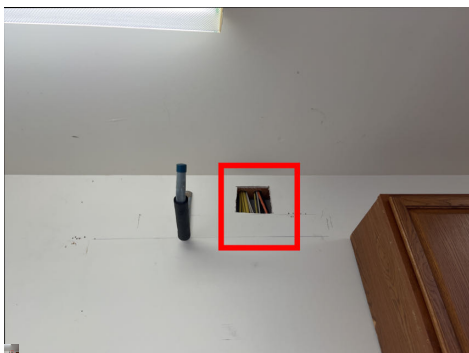
Garage: Hole in fire wall

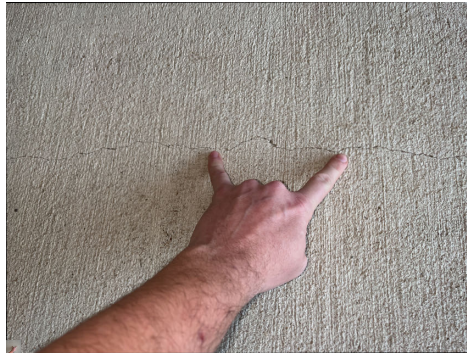
Porch slab: hairline crack

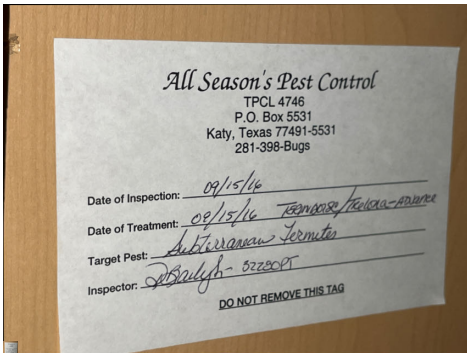
Evidence of previous wood destroying insect treatment was observed in the form of treatment notice sticker, bait stations. We recommend asking the sellers when the house was last treated as warranties might be transferable.

Kitchen sink: Evidence of prior termite treatment

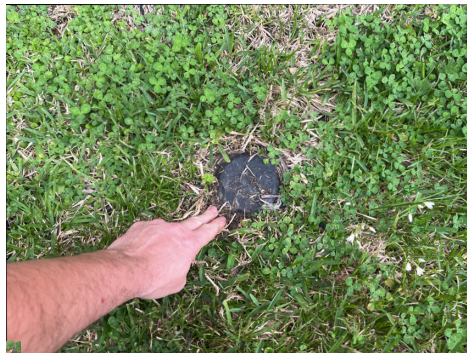
Bait stations: Evidence of previous termite treatment

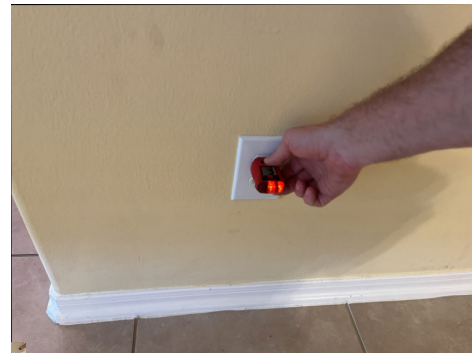
Living room: Outlet not GFCI protected

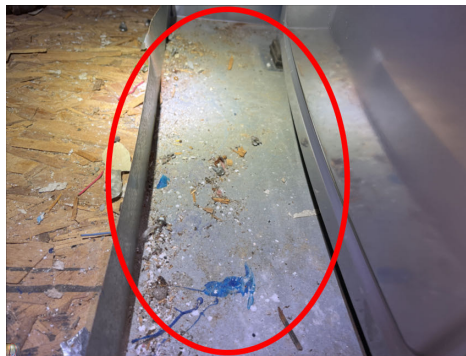
Debris was noted in the evaporating coils safety pan. We recommend all debris be removed to prevent drain lines from clogging.

Debris in safety pan

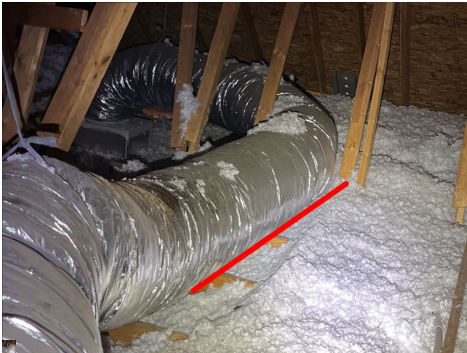
Air ducts were placed on the attic floor. Today's standards do not allow this practice anymore as thermal bridging could create condensation inside the ductwork. We recommend having the strapped and elevated.

Duct on attic floor

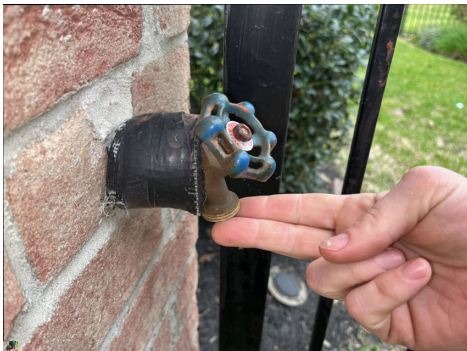
An exterior hose bibb did not have a back flow preventer. Anti-siphon devices keep contaminated water from entering the potable water of the house plumbing. These devices are cheap and can be found in most home improvement stores. We recommend making the upgrade.

Rear right: Back flow preventer recommended

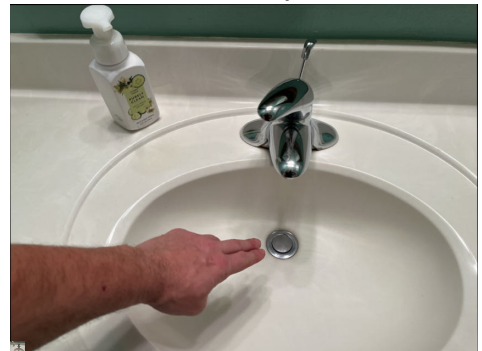
**MAINTENANCE:** A stopper was not functional at a bathroom lavatory/tub. We recommend having stoppers adjusted or repaired to retain water as designed. This was noted in bathroom 1, bathroom 2 both lavatories, bathroom 3 both lavatories, and bathroom 3 tub.

Bathroom 1: Drain stop did not retain water

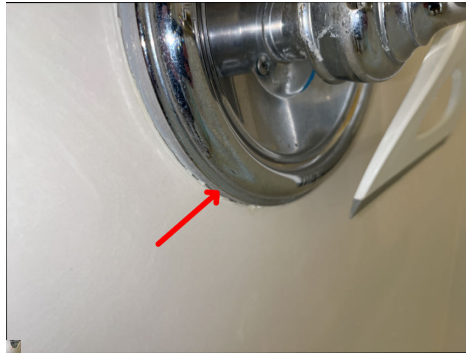
Deteriorated caulking/grout was noted, which may allow damage from moisture intrusion of the wall assembly at a bathroom. We recommend having this recaulked. We observed this in bathroom 2, and 3.

Bathroom 2: Deteriorated caulk

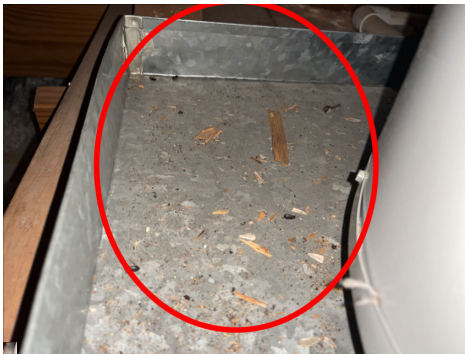
Debris/insulation was noted in the safety pan. We recommend this be cleared to prevent the drain line from clogging.

Debris in safety pan

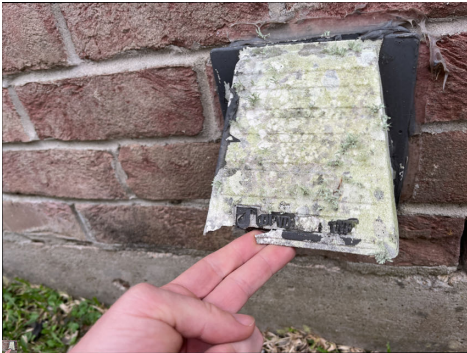
Right: Damaged damper

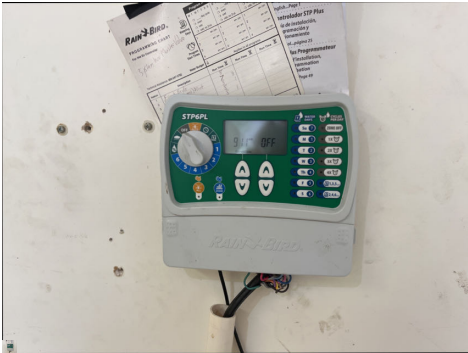
Garage: Controls to sprinkler system

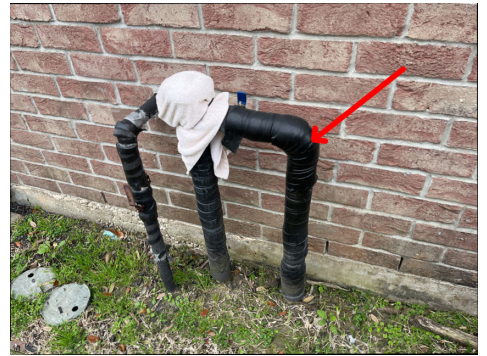
Right: Backflow preventer

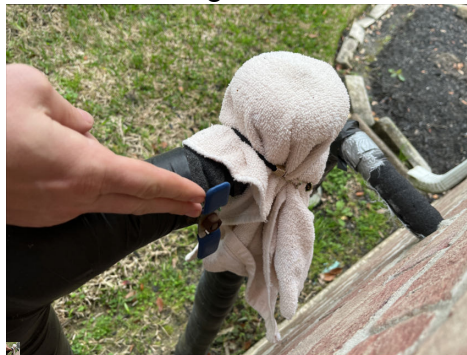
The sprinkler system had been winterized. For liability reason, de-winterizing the sprinkler system went beyond the scope of our inspection. We recommend having this further evaluated by a professional landscaper.

Backflow preventer off/winterized
