Total Home Inspection

Property Inspection Report

2716 S Millbend Dr, Spring, TX 77380
Inspection prepared for: Eliazbeth Shaw
Real Estate Agent: -

Date of Inspection: 1/30/2023 Time: 9:00-11:00AM
Age of Home: 1977 Size: 1276
Weather: 40's intermitten rain
Order ID: 3314

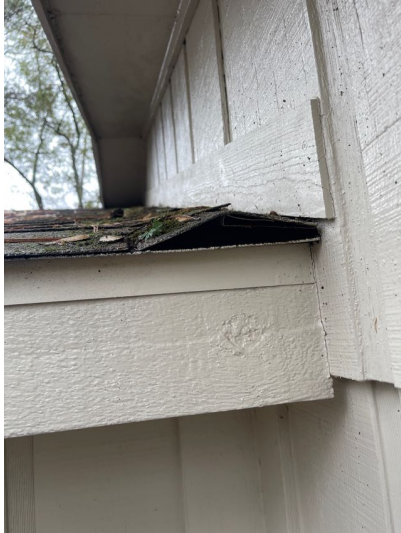
Flashing was lifted at the bottom of the vertical wall on the left side.

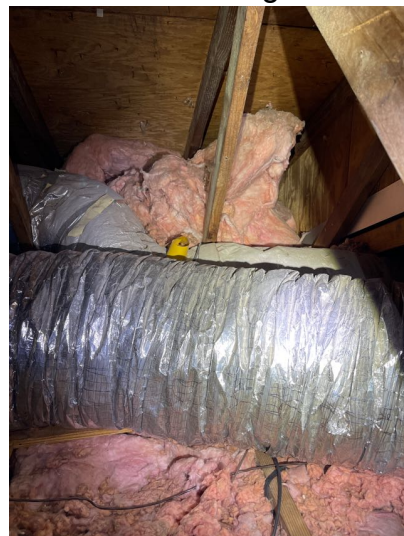
Low level of insulation and in need of improvement for better efficiency. Current efficiency standards are R38, and previously R30.

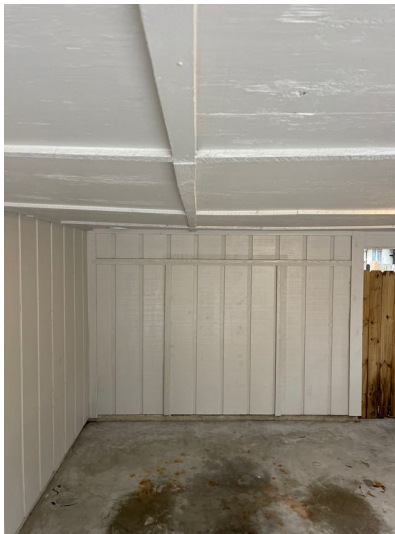
The ceiling in the carport area was sagging.

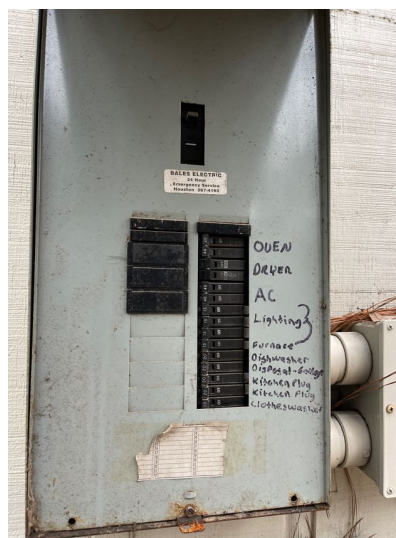
Access to electrical panel was obstructed. Working space in front of the panel should be 30" wide by 36" deep.

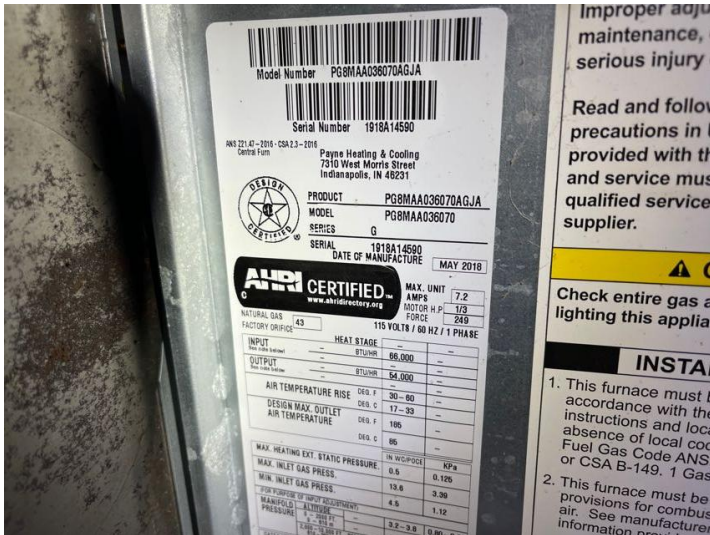
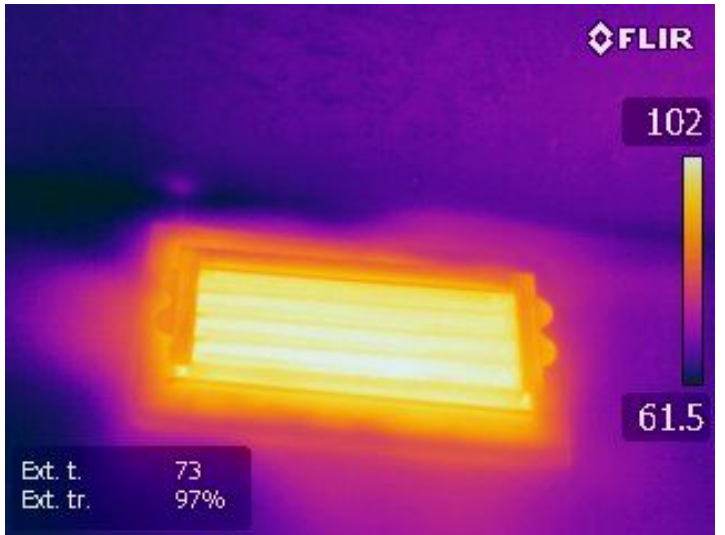
A forced air type, natural gas fired, standard efficiency furnace located in the attic was manufactured by Payne in 2018. Furnace serviced the home with 60k btu's. Furnace was operated, covers were remove and interiors observed. Unit appeared to be functioning as intended.

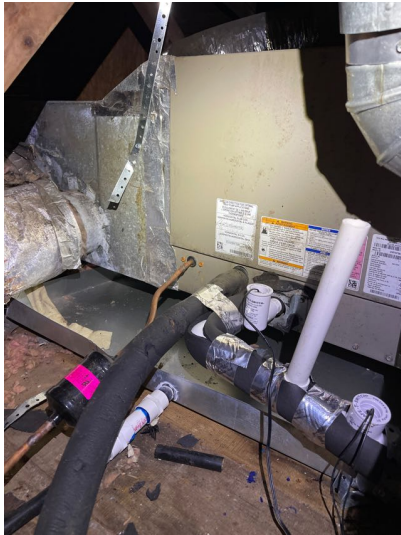
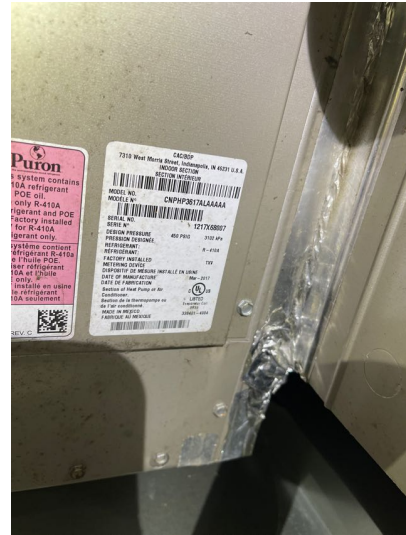
Heating, Ventilation and Air Conditioning Systems Cooling Equipment Evaporator unit manufactured by Carrier in 2017. Unit appeared to be 3 ton.

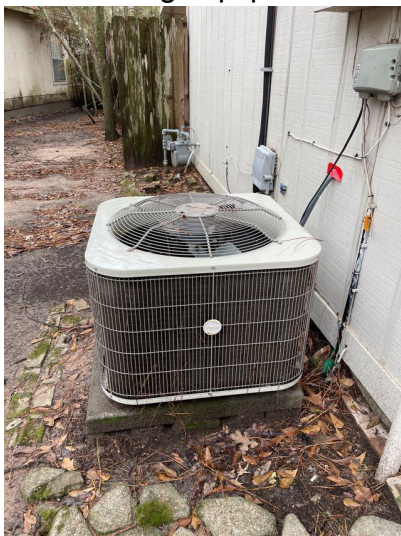
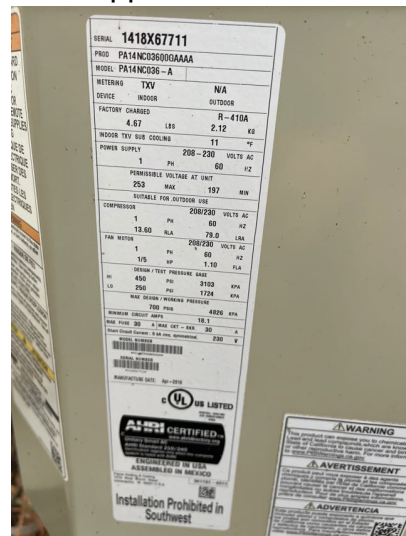
Heating, Ventilation and Air Conditioning Systems Cooling Equipment The Condensing unit manufactured by Payne in 2018. Unit appeared to be 3 ton, 14 SEER, using 410a refrigerant. Per the manufacturer's label, max amps on breaker should be 30. Per the labeling on the electrical panel, AC was connected to a 40 amp breaker.

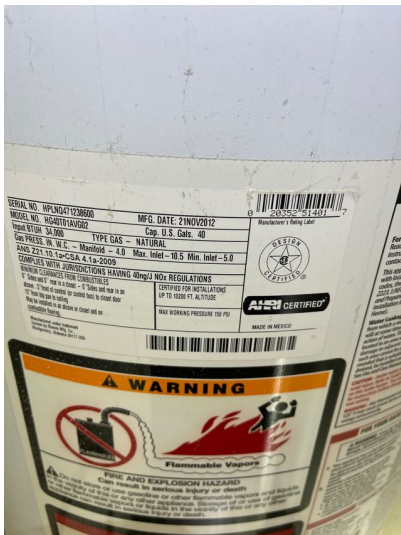
Gas fired water heater was located in the space adjacent to the upper bedroom and should be separated from the living space by a weather stripped self-closing exterior door and combustion air should be available from the exterior or attic.
