PROPERTY INSPECTION REPORT FORM

| RAUL & VELMA RODRIGUEZ <i>Name of Client</i> | 03/13/2023 <i>Date of Inspection</i> |
| 5822 PINELLAS PARK, SPRING, TX 77379 <i>Address of Inspected Property</i> | |
| Stephen Perry <i>Name of Inspector</i> | 7854 <i>TREC License #</i> |

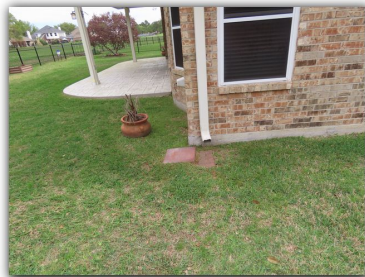
☑ DEFICIENCY-(MINOR COSMETIC DEFICIENCY- "CORNER POP" ON THE OUTSIDE CORNERS OF THE SLAB THAT IS RECOMMENDED TO BE POINTED WITH MORTAR (Deficiency)****

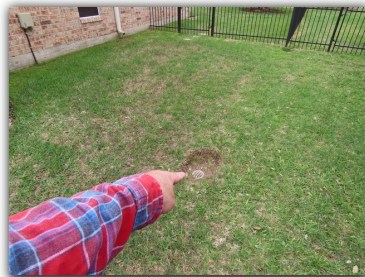
Erosion or ponding at the French drains that are recessed deep below grade; needs large rocks installed to prevent erosion and the drain system from becoming clogged.

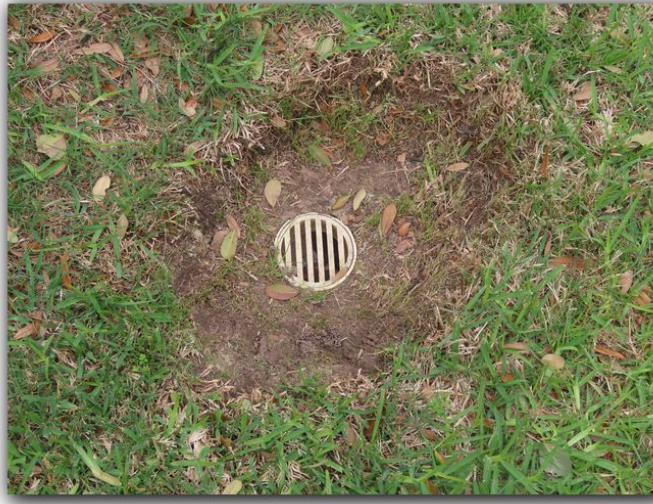
- **THE GUTTER DOWN SPOUTS HAVE FLEX TUBING CONNECTIONS TO THE FRENCH DRAINS BELOW SURFACE THAT ARE NOT RECOMMENDED DUE TO POTENTIAL LEAKS WITH THESE TYPE TUBES. IT IS RECOMMENDED TO HAVE A SOLID PVC TYPE DRAINS THAT TERMINATE TO FRENCH DRAIN BELOW SURFACE **** (Deficiency) ******

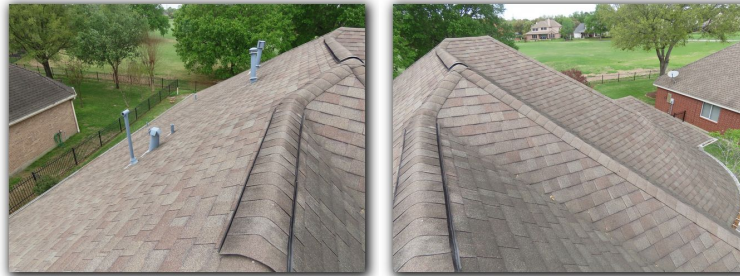
Comments: **The roof appears to be approx. 12 years old and does have deficiencies detailed below and active roof leaks as well. In need of repairs by a roofing expert.**

- **There is hail damage present; recommend overall evaluation and repairs or potential roof replacement by a roofing expert.**(Deficiency)****

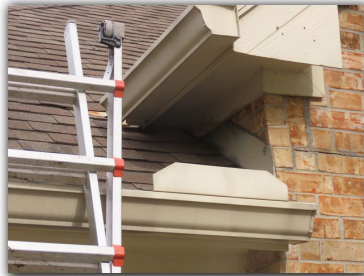
Trim, soffit, fascia boards are in need of repair **** (Deficiency) ** (signs of vermin attempting to gain entry into the home; in need of repair and evaluation by a pest expert)**

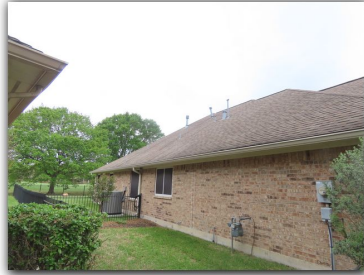
Flashing is lifting, ill configured, or missing; and active roof leaks with water stains/patchwork on the master closet below. In need of repairs by a roofing expert. **** (Deficiency) ****

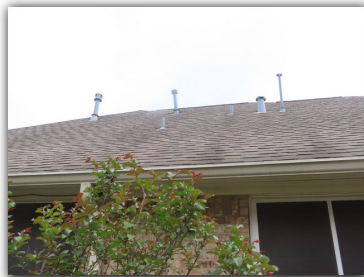
- **THERE IS VENTS AND FLUES WITH RAISED FLASHING THAT NEEDS TO BE PROPERLY SEALED DOWN BY A ROOFING EXPERT.**(Deficiency)****

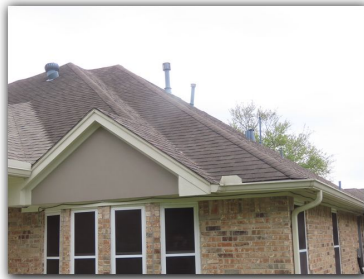
- **THERE IS SEVERAL RAISED SHINGLES IN VARIOUS LOCATIONS THAT NEEDS TO BE REPAIRED AND PROPERLY SEALED DOWN BY A ROOFING EXPERT** **** (Deficiency)****

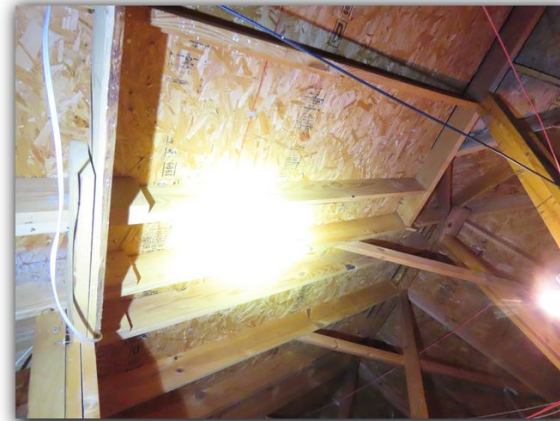
Evidence of moisture penetration **** (Deficiency) ** (above the master closet); in need of repair by a roofing expert)**

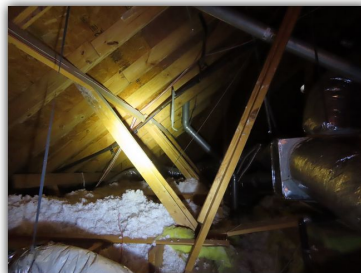
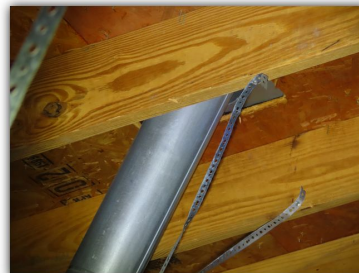
THERE IS SOME RAFTERS WITH SEPARATION FROM THE RIDGE BEAM THAT IS ALSO COMMON WITH STRUCTURAL SETTLEMENT AND IN NEED OF EVALUATION AND REPAIRS BY A FRAMING EXPERT. ** (Deficiency) **

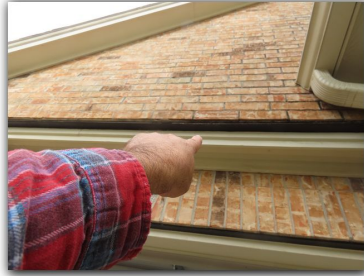
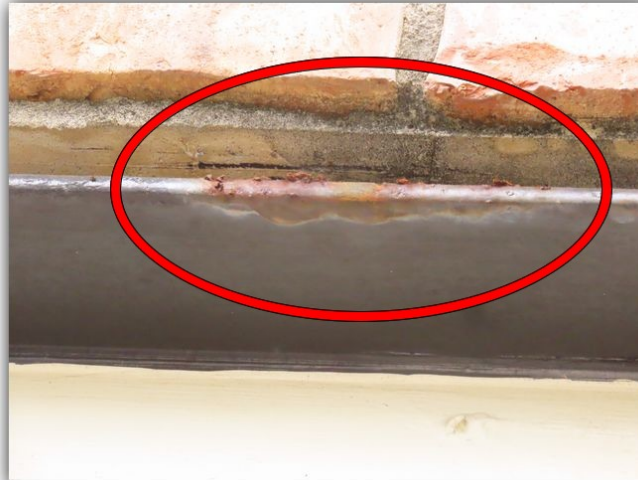
Rusted steel lintels that need repairs and paint **** (Deficiency)****

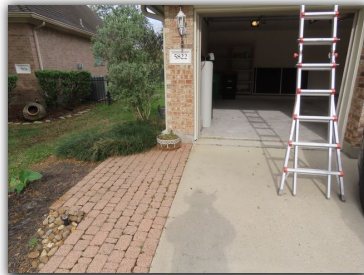
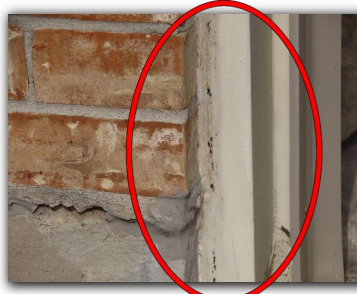
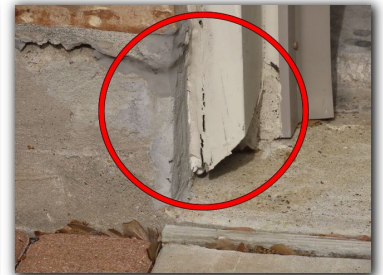
Caulking / sealant is separated or missing in some areas **** (Deficiency)** (Separations in trim and calking at the brick can also be a sign of structural settlement as well)**

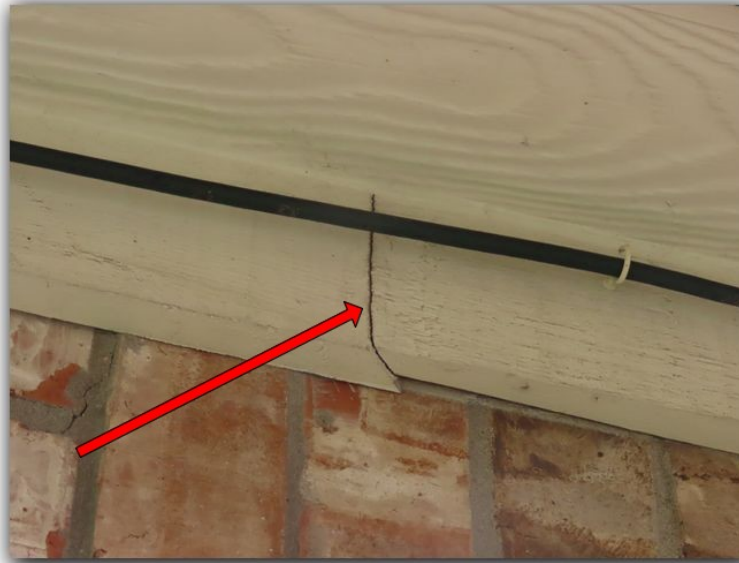
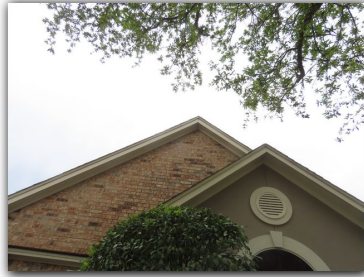
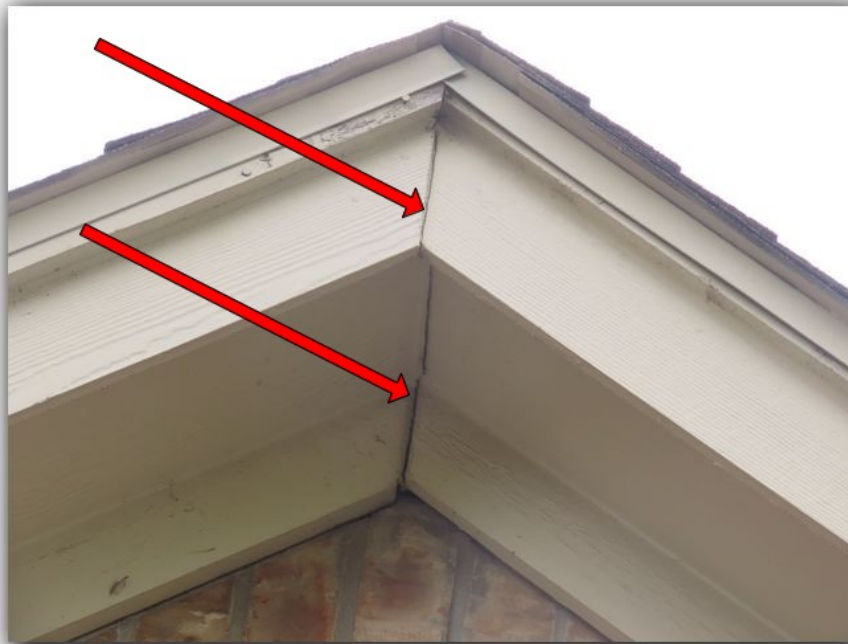
Some cracks at the brick; SIGNS OF STRUCTURAL SETTLEMENT ABOVE

THE GARAGE THAT NEEDS TO BE REPAIRED/POINTED BY A MASONRY REPAIR EXPERT AND ALSO MONITORED FOR ANY FURTHER SIGNS OF STRUCTURAL SETTLEMENT.(Deficiency)****

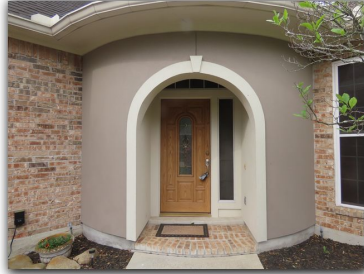
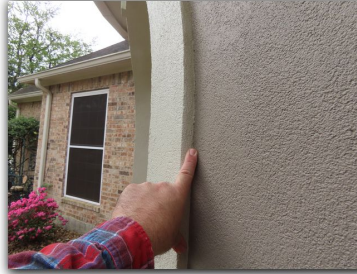
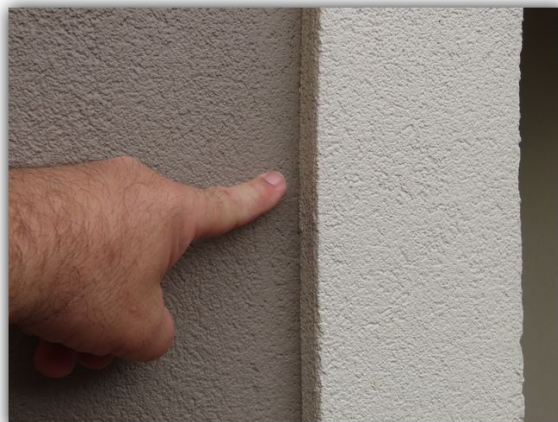
STUCCO IF NOT SEALED PROPERLY DUE TO CRACKS OR OPENINGS AND SEPARATIONS CAN ALLOW MOISTURE TO BECOME TRAPPED INSIDE THE WALL THAT IS SOMETIMES NOT VISIBLE FROM THE INSIDE WALLS OR EXTERIOR WALLS AND CAN CAUSE ROTTED FRAMING AND MOLD INSIDE THE WALLS UNDETECTED FOR A LONG PERIOD OF TIME IF NOT PROPERLY SEALED. ANY AREAS OF STUCCO THAT ARE NOT PROPERLY SEALED OR CRACKS AND SEPARATIONS SHOULD BE PROPERLY REPAIRED AND SEALED. I DO RECOMMEND FURTHER EVALUATION AND REPAIRS BY A STUCCO EXPERT.

There is a lack of caulking in several locations of trim, accent molding and a lack of weep screed/drainage system in some locations that can result in water penetrations with stucco if not properly sealed. In addition, there is other locations shown below that does also need caulking (high performance caulking recommended) in various locations of the stucco

framing/mold/insulation and wall damage.

RECOMMEND FURTHER EVALUATION BY A STUCCO

EXPERT. * (Deficiency) *****

I do recommend an evaluation for "invasive stucco inspection" by a stucco expert that includes probing the walls with a moisture meter to determine if there may be potential high levels of moisture inside the wall in these locations that can remain trapped inside the wall and result in moisture related damage such as rotted

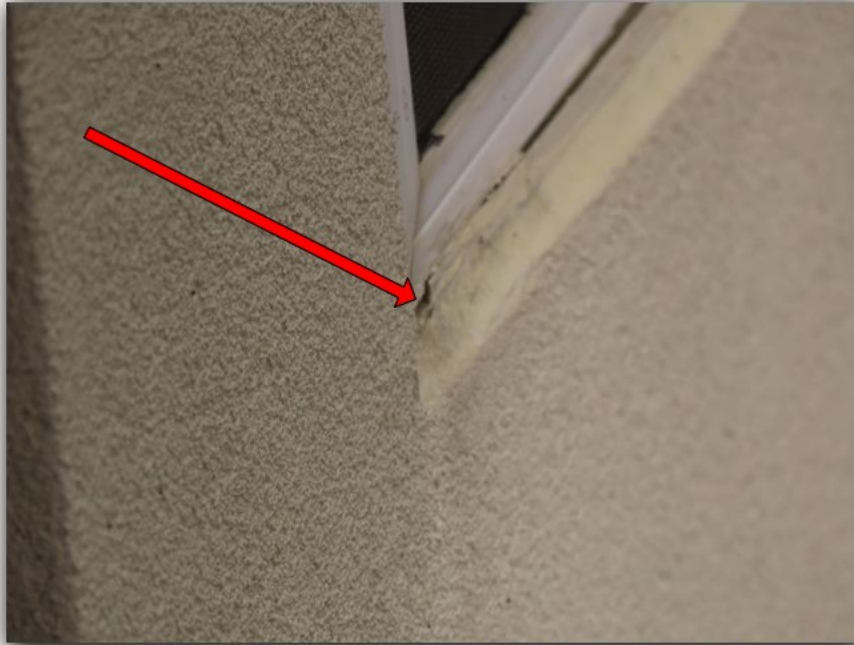
- **The bottom of the stucco wall terminations does not have weep screed or drainage system present; in need of evaluation and repairs by a stucco expert.**

**** (Deficiency) ****

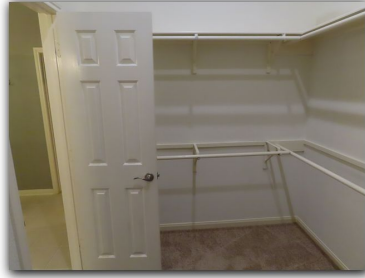
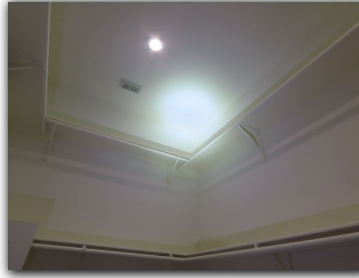
- Ceiling cracks in some areas** (Deficiency)****
- Signs of structural settling**
 - **INDICATING STRUCTURAL SETTLEMENT THAT NEEDS TO BE PATCHED/FINISHED/TEXTURED AND MONITORED FOR ANY FURTHER CRACKING**

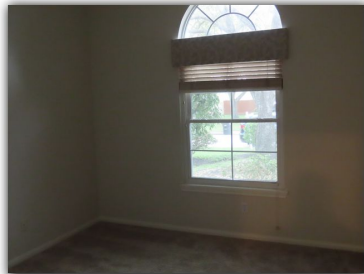
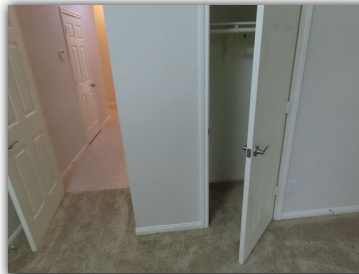
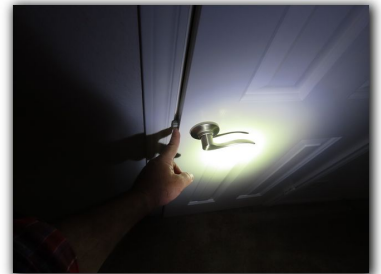
- **Front secondary bedroom closet door is not latching; a sign of structural settlement and in need of repair.** (Deficiency)****

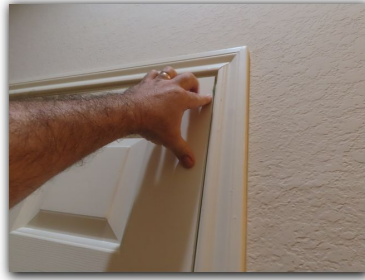
- Garage entry door is rubbing on the frame and can be a sign of structural settlement; in need of evaluation and repair. **** (Deficiency)****

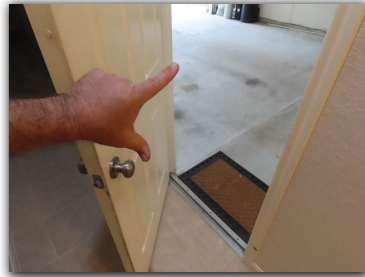
- **THE GARAGE ENTRY DOOR IS NOT SELF CLOSING AS REQUIRED FOR FIRE SAFETY FOR ATTACHED GARAGE ENTRY DOORS.** (Deficiency)****

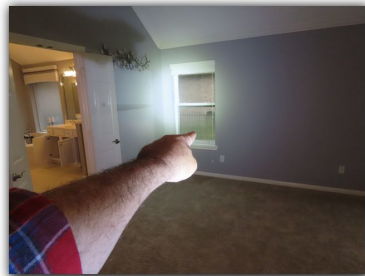
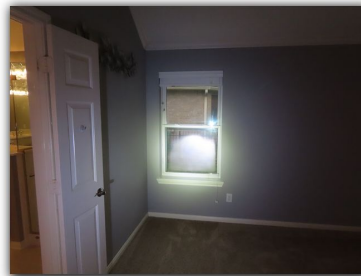
- Some window / door screens are damaged or missing
- Thermal pane window seals have failed, moisture is present **** (Deficiency)**** (SOME WINDOW HAVE A BROKEN SEAL, CAN BE A SIGN OF STRUCTURAL SETTLEMENT AND DOES REQUIRE WINDOW SASH REPLACEMENT AS WELL)

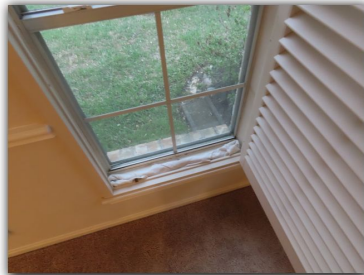
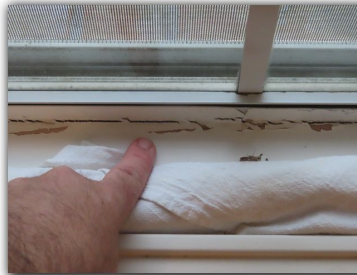
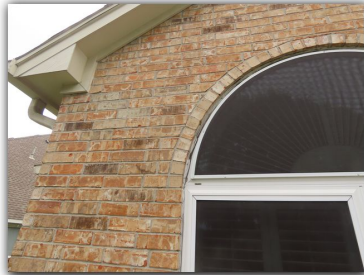
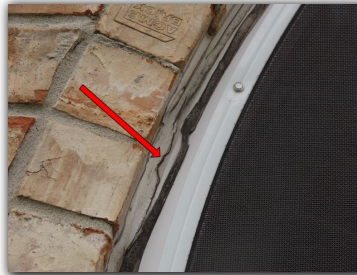
Caulking / plastic , etc. damaged and / or missing****(Deficiency)****

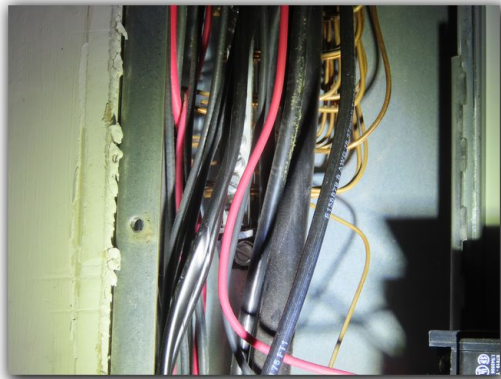
DEFICIENCY- NO GREEN BOND SCREW PRESENT AS IS NOW REQUIRED; RECOMMEND EVALUATION AND REPAIRS BY A LICENSED ELECTRICIAN. (Deficiency)****

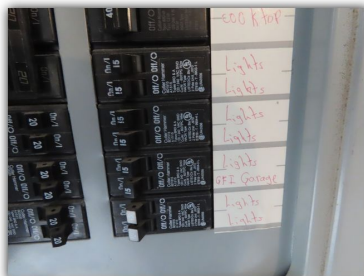
• **THERE IS NO AFCI PROTECTION IN ALL THE REQUIRED LOCATIONS.** AFCI (ARC FAULT CIRCUIT INTERRUPTION) PROTECTION PROVIDES FIRE SAFETY PROTECTION. **NOW REQUIRED FOR NEW CONSTRUCTION** IN BEDROOMS, GAME ROOMS, PARLORS, LIBRARIES, DINING ROOMS, HALLWAYS, CLOSETS, SUN ROOMS AND SIMILAR AREAS. **** (Deficiency)****

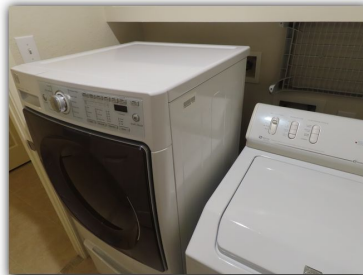
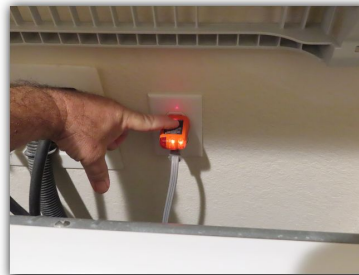
No GFCI/ARC Fault protection at one or more location. This is considered a recognized safety hazard. (Deficiency)****

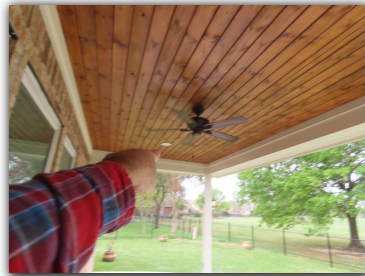
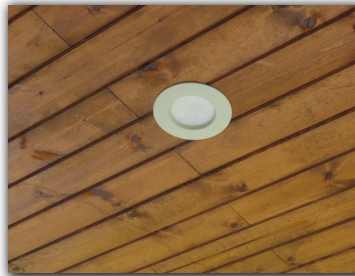
Light fixtures inoperable or in need of repair **** (Deficiency) ** (BACK PORCH RECESSED LIGHTS)**

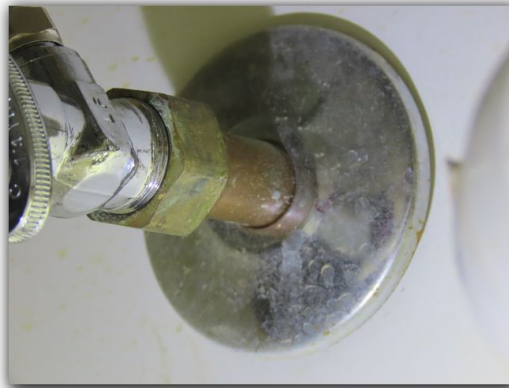
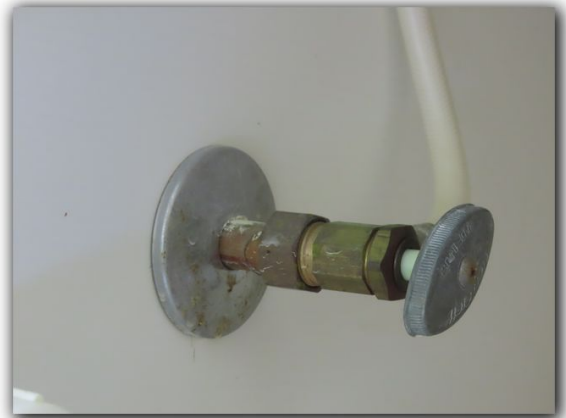
Static water pressure reading: 57
Type of supply piping material: COPPER
Comments:

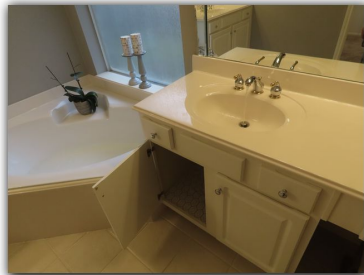
The master right side sink has low water pressure and corrosion at the valves under the sink that needs repairs by a plumber. ** (Deficiency) **

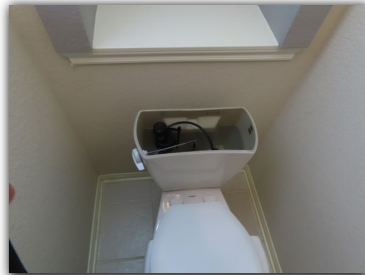
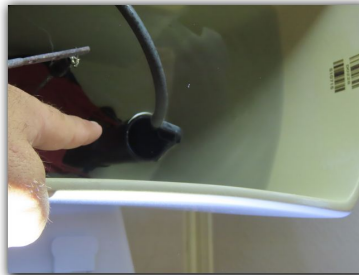
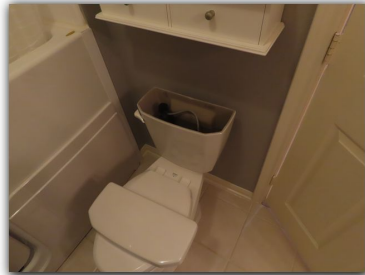
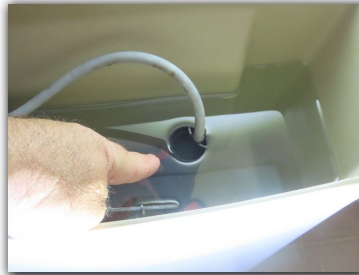
Tank water level is too high **** (Deficiency) ****

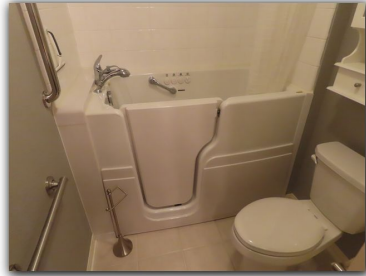
- **The hall spa tub has a slow drain; in need of repairs by a plumber.** (Deficiency)****

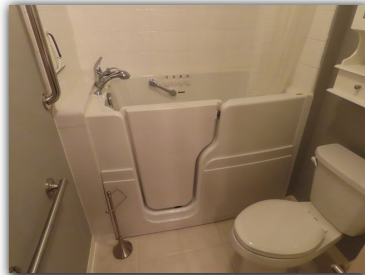
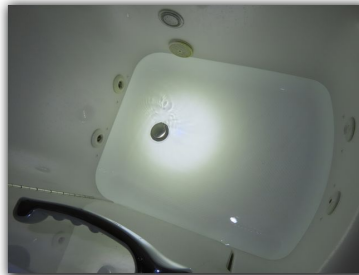
Electrical motor not bonded **** (Deficiency)****

Lack of ground fault circuit interrupter, inaccessible pump(s) or motor(s) **** (Deficiency)****

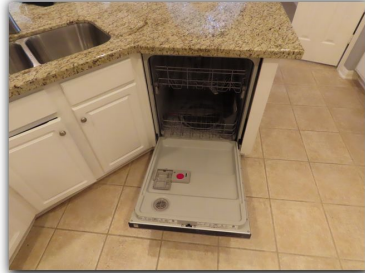
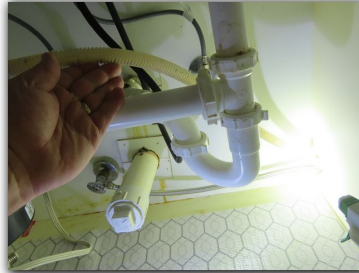
No anti-siphon loop at the drain line **** (Deficiency) ****

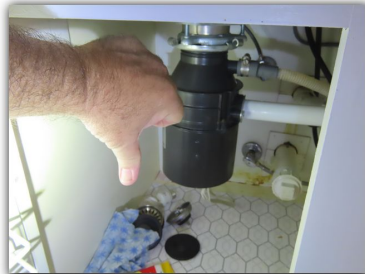
Inoperative Unit **** (Deficiency) **; needs replacement.**

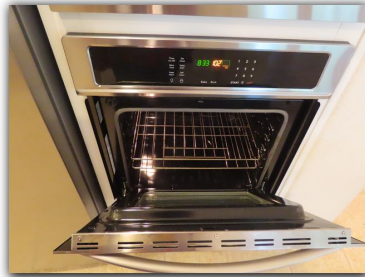
Unit #1: Electric Gas
Tested at 350°F, Variance noted: 5 hot °F (max 25°F)
Unit #2: Electric Gas
Tested at 350°F, Variance noted: _____ °F (max 25°F)

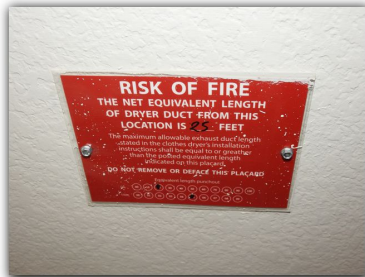
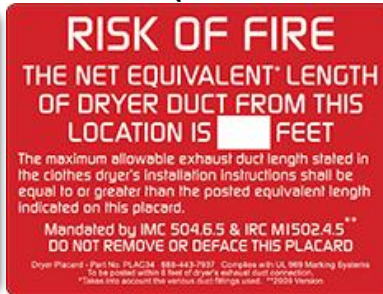
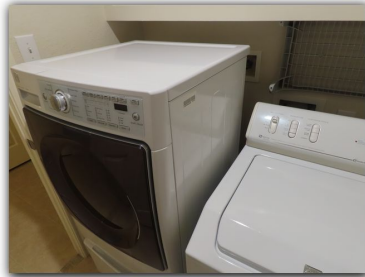
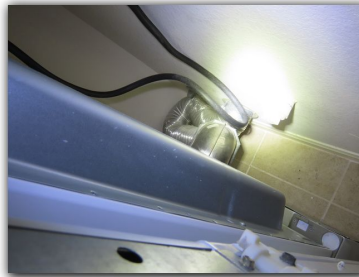
The dryer duct is a long span that extends into the upper wall and attic and terminates to a roof vent. Long span dryer ducts are recommended to have a "booster assist fan" installed that helps prevent lint from being trapped inside the duct and provides improved clothes dryer performance as well.

DEFICIENCY-IT IS NOW REQUIRED FOR NEW CONSTRUCTION TO HAVE A DISPLAYED SIGN IN THE LAUNDRY ROOM THAT SHOWS THE NET EQUIVALENT LENGTH OF DRYER DUCT DISTANCE FROM THE WALL TERMINATION IN THE LAUNDRY ROOM TO THE ROOF TERMINATION/EXTERIOR TERMINATION.

IT IS RECOMMENDED TO HAVE THE CLOTHES DRYER DUCT PROFESSIONALLY CLEANED OUT ANNUALLY FOR IMPROVED CLOTHES DRYER PERFORMANCE AND FIRE SAFETY PROTECTION.
