FIG Services LLC d/b/a FOX INSPECTION GROUP
Property Inspection Report #210607RB-2135 Quenby Street
8616 Daffodil St. Houston, TX 77063
(Office)713.723-3330 (Email) office@foxinspectiongroup.com

Stucco Moisture Inspection Report Prepared For: Erick & Mara Calderon

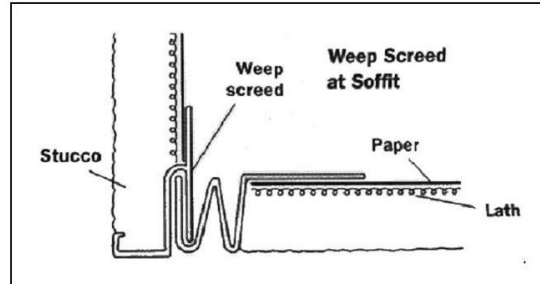
Did not observe weep screed at bottom of the stucco wall, where it intersects with the soffit. The following diagram depicts a “best practice” procedure as defined in the Texas Lathing and Plastering Contractor's Association (TLPCA) Stucco Resource Guide. This detail provide a means for moisture to exit from behind the stucco if the wall assembly leaks (we seldom see a weep screed at these locations on most stucco homes / buildings). Due to moisture / soft substrate observed in these areas (see page 6 & 8 above), installation of a weep screed is recommended.

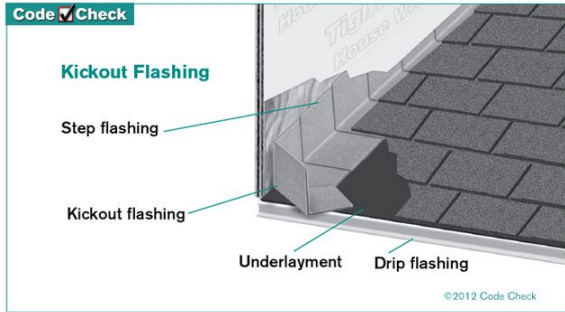
Did not observe "kick out" flashing where a roof / balcony terminates along a vertical wall. This flashing encourages rain water running down roof / balcony to be diverted / "kicked out" away from wall and reduce chance of water penetration behind wall.
