Inspection Report

PROPERTY INSPECTION REPORT

16211 Townes Rd, Friendswood, TX 77546

Tony Ngo - TREC License # 22826 8/6/2020

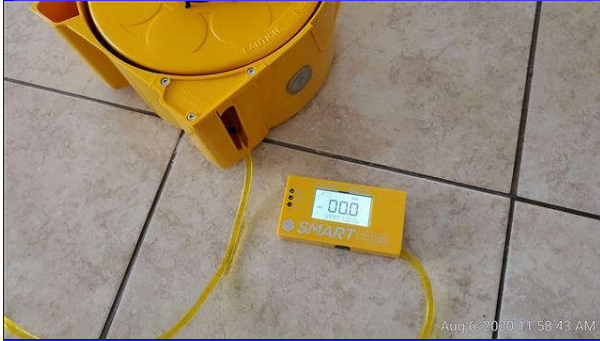
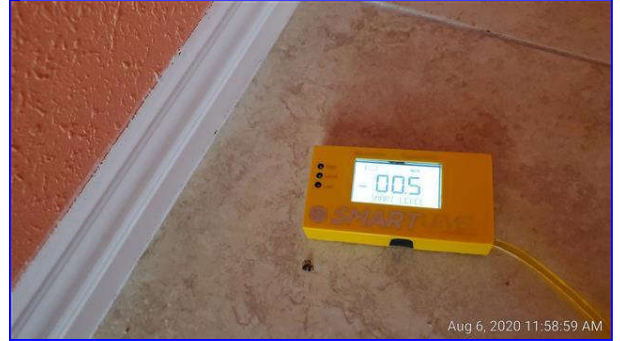
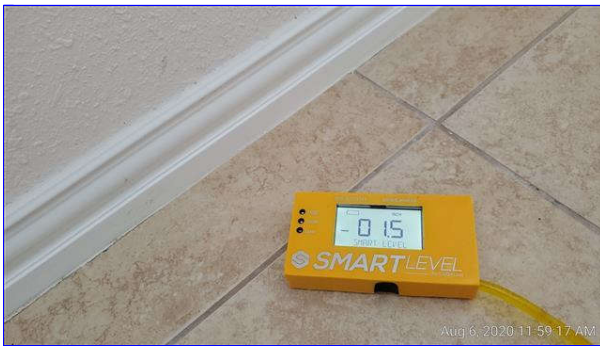
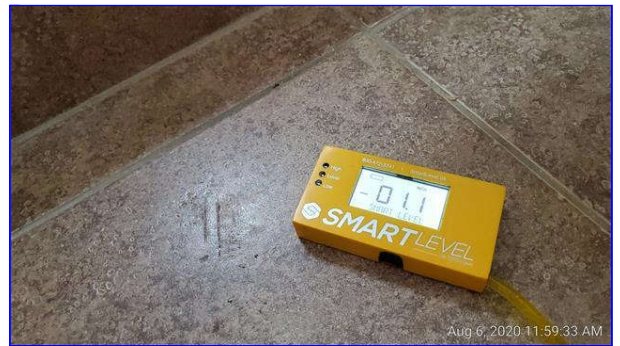
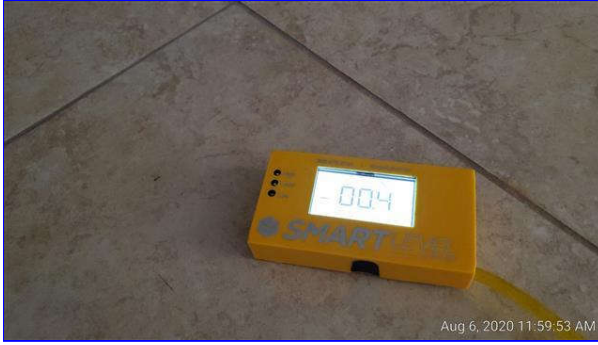
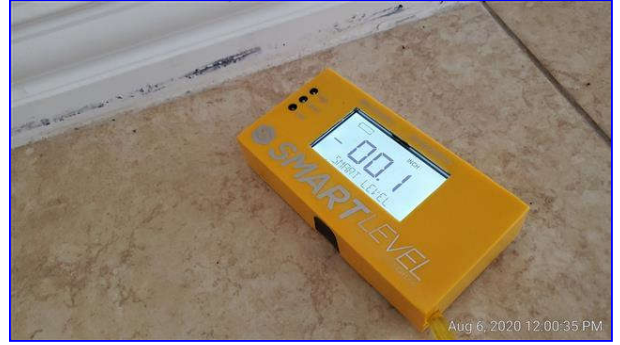
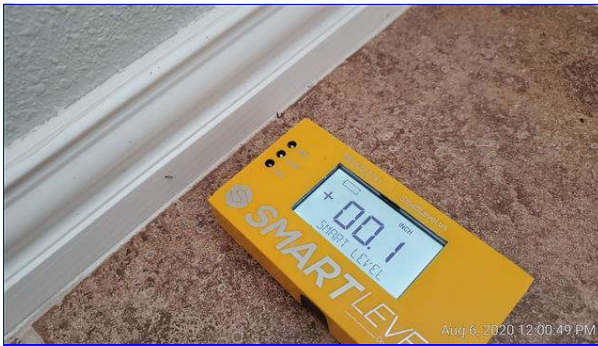
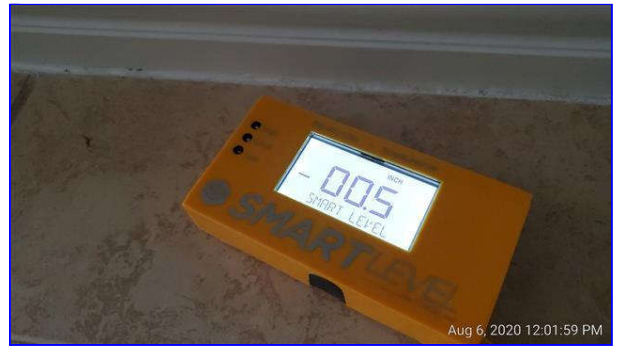
- The foundation level measurements indicated a variance of approximately +/- 1.5" inch]. Concrete Slab foundations most often reveal some unevenness due to workmanship at the time of construction. Therefore, these measurements do not necessarily represent the actual degree of deflection from differential movement of the foundation. Although deviations/slopes in the foundation can assist the inspector in evaluating the foundation performance as to the direction and degree of possible movement, these deviations/slopes is not, by themselves, a measurement of foundation movement. Based on the floor measurements taken, it is my opinion the slab was reasonably level at time of the inspection.

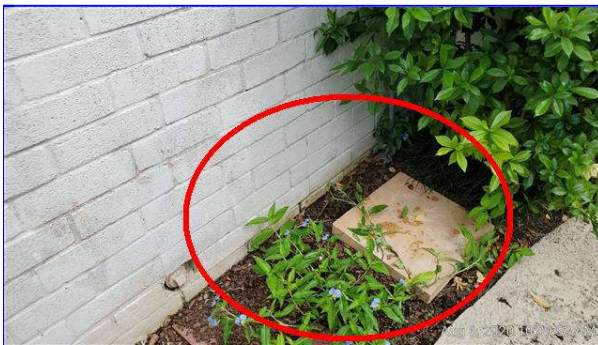
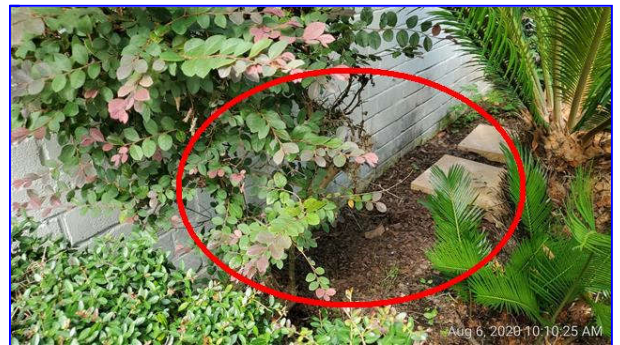
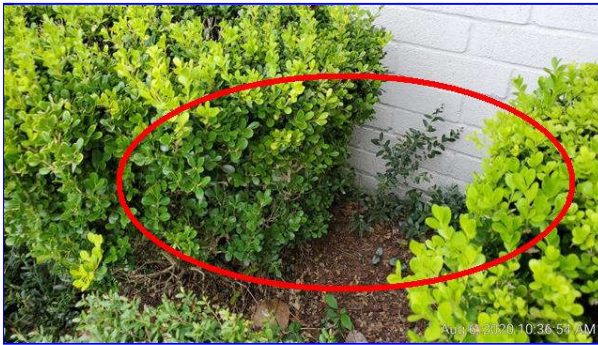
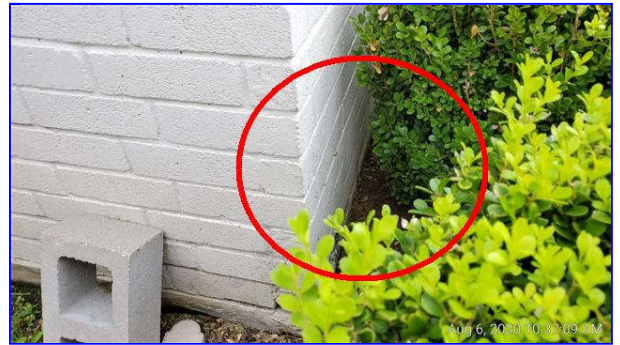
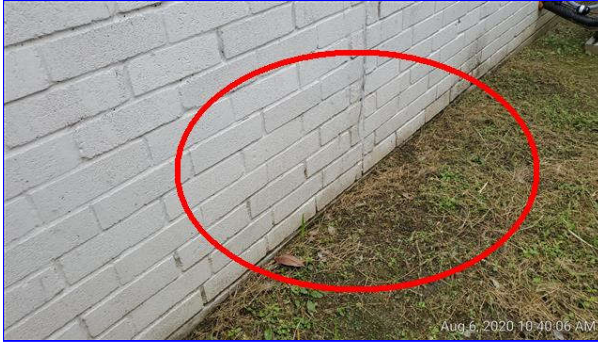
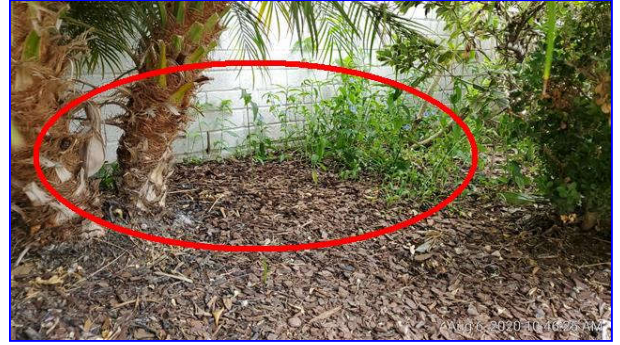
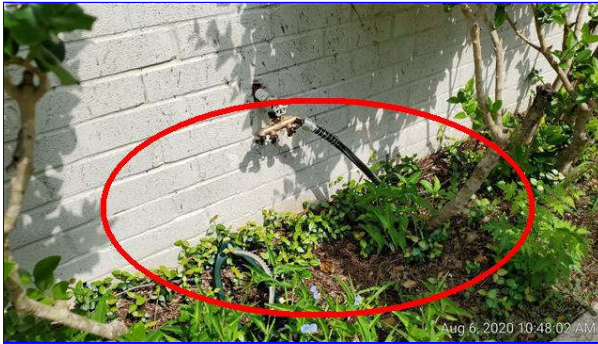
- High soil levels/flower/planting beds were observed at the foundation walls in various locations. This prevented visual inspection of the foundation. A minimum of four inches of foundation wall should be exposed under the brick veneer and a minimum of six inches of foundation wall should be exposed under the wood surfaces. High soil levels are conducive to wood destroying insect infestation, and possible water penetration into the home. When repaired, the grade should slope downward away from the home directing runoff away from the foundation. Improvements should be undertaken by professional landscaper.

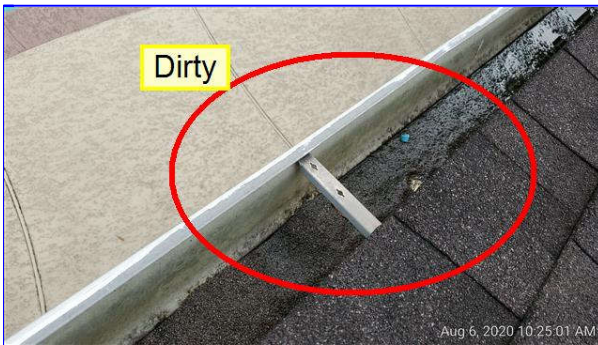
B. Item 11(Picture)

- The gutters and down spouts was observed to be in need of cleaning. Gutters and downspouts should be further examined for possible defects after cleaning for proper drainage.

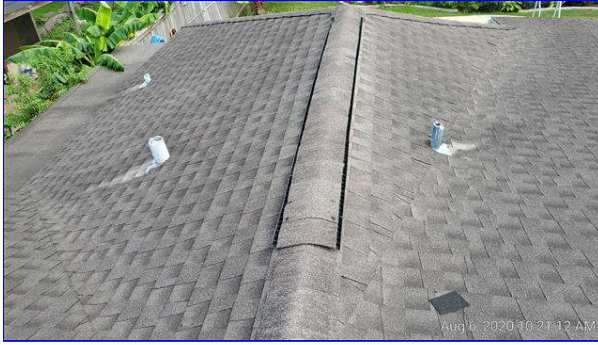
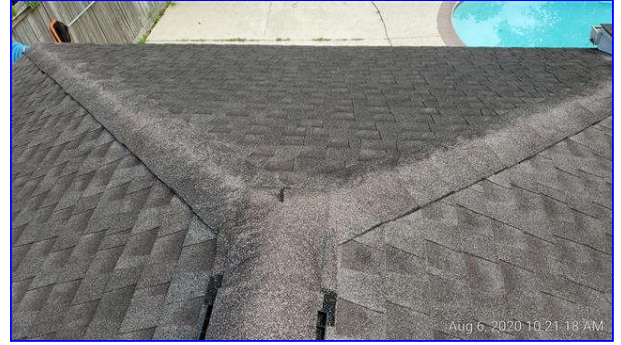
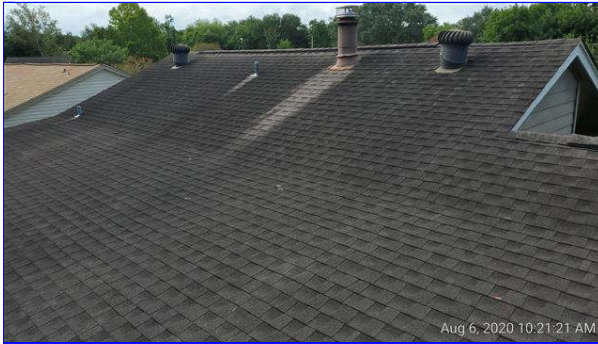
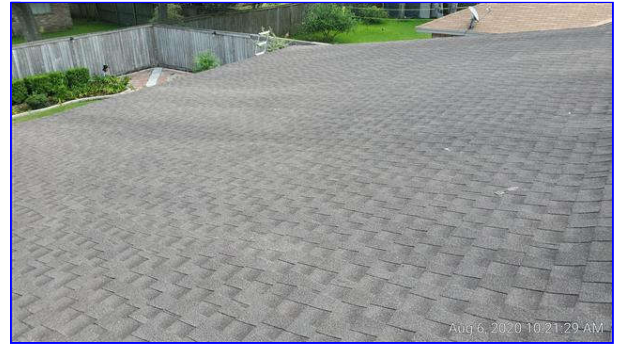
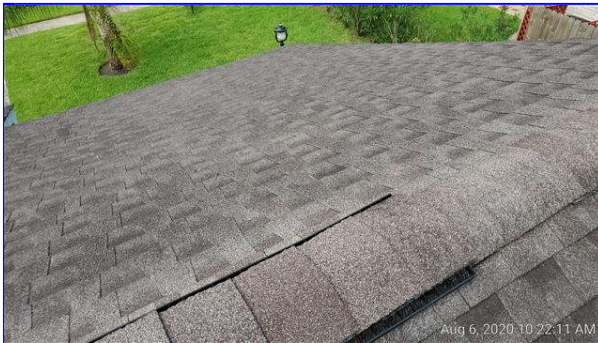
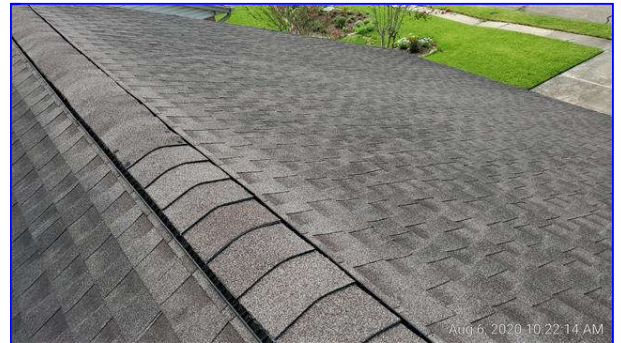
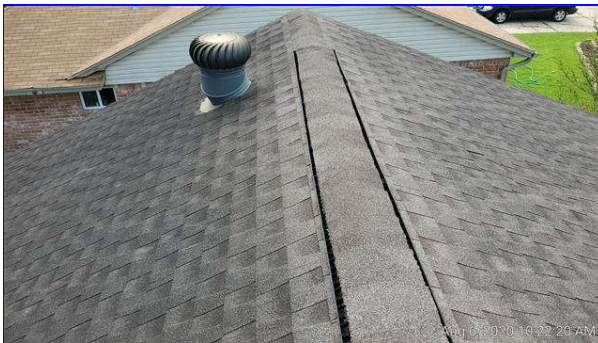
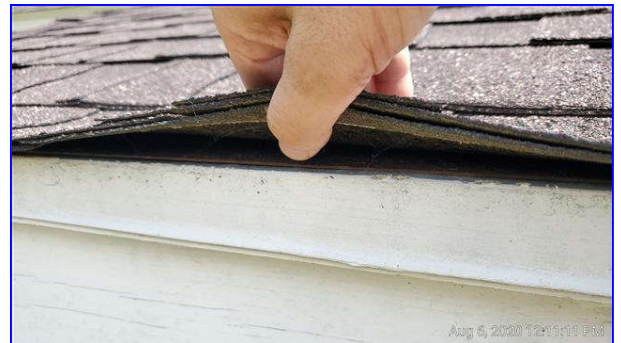
- The roof covering was observed to be in fair condition. Minor repairs are needed. A qualified roofer should be consulted to further evaluate these conditions and provide an estimated cost of repairs.
- **Buyers Advisory Notice - Inspector Limitations Regarding Roof Systems** : Roof systems consist of many components, some of which are not accessible under the best of conditions. The

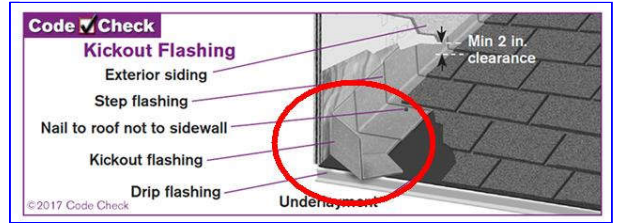
C. Item 15(Picture) Kick Out Flashing

- Kick out flashings were observed to be missing. Kick out flashings should be installed to help direct the water away from the home. Bent counter flashing is not a substitute for proper kickout flashings. A qualified, verified roofing contractor should be consulted regarding repairs.

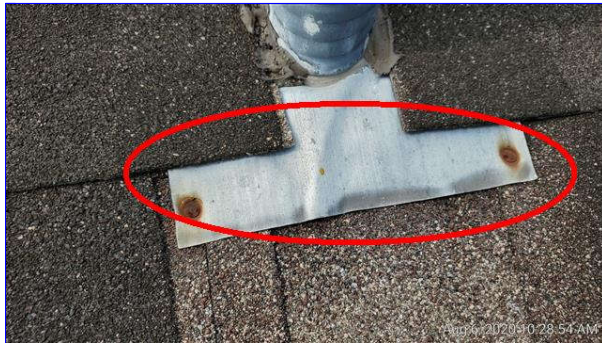
C. Item 16(Picture)

- Exposed nail heads at the roof surface should be sealed to prevent water intrusion.

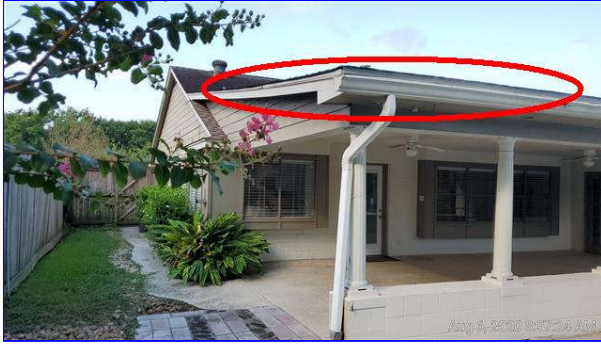
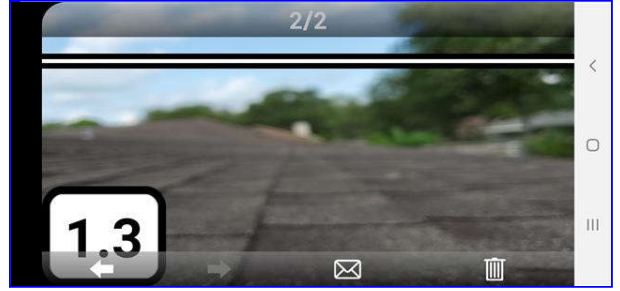
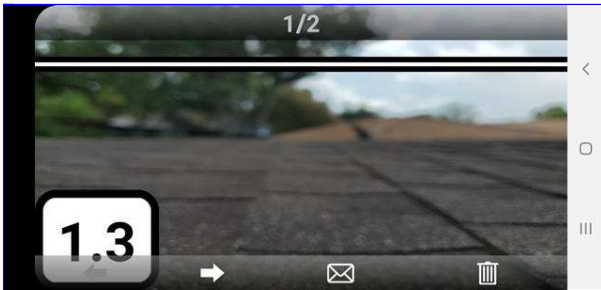
- The roofing material at the rear of the home is not intended for this low slope application. While this condition does not pose a serious short term concern, it may be affect the reliability and longevity of this section of roof.

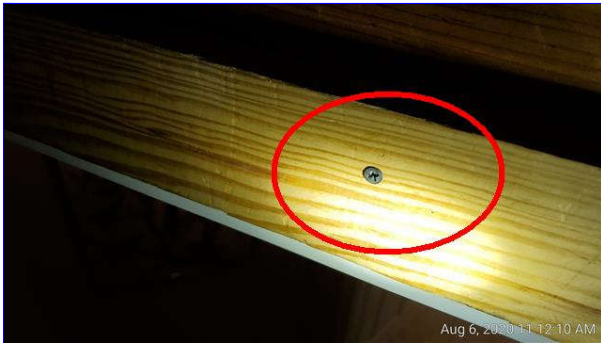
D. Item 9(Picture)

- The pull down stairs were observed to have the following defect: installed with incorrect hardware, per manufacturer instructions. Injury could result if not repaired. Attic access ladders should be installed with 16d or larger nails or bolts per manufacturer's instructions for safety reasons.

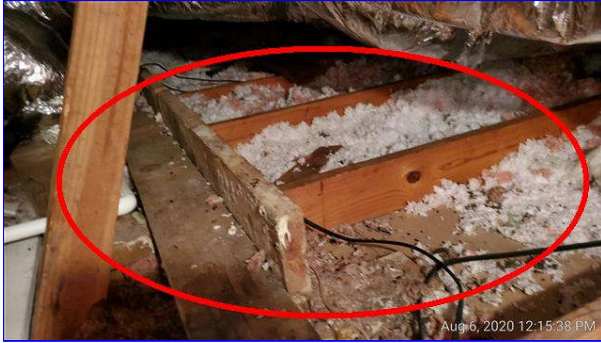
D. Item 19(Picture)

- Ceiling joists were observed to be damaged or deteriorated. The inspector recommends that the structural supports be further evaluated and repaired as needed by a certified, licensed foundation specialist.

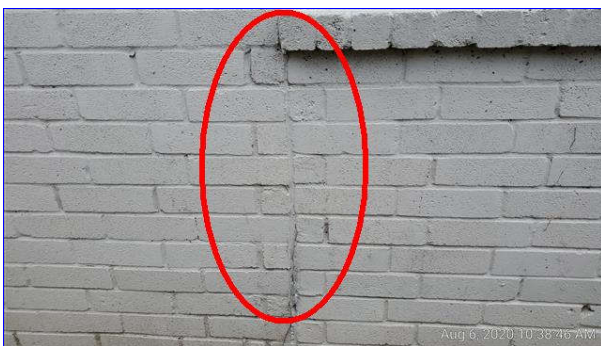
E. Item 1(Picture)

- BUYERS ADVISORY NOTICE: Freshly painted or repaired interior/exterior wall coverings may conceal defects that would otherwise be observed. The inspector recommends that the interior/exterior walls be monitored over time for defects concealed at the time of the inspection.
- Brick repairs were observed. The reason for these repairs is unknown. Some repairs maybe potentially related to foundation movement or repairs from foundation movement. There is no way for the inspector to determine the exact cause for these repairs.

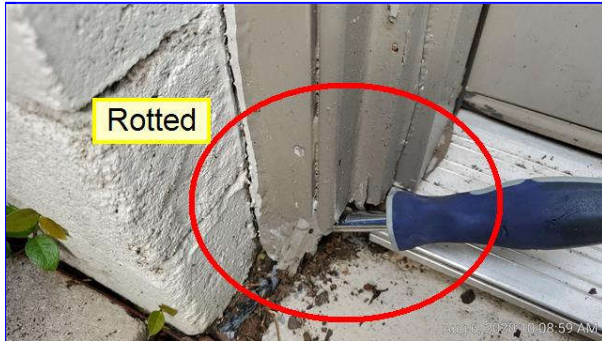
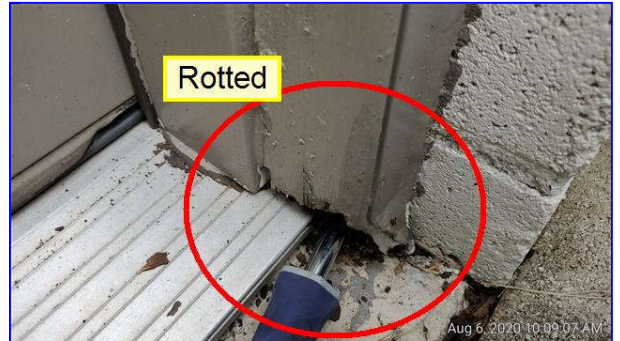
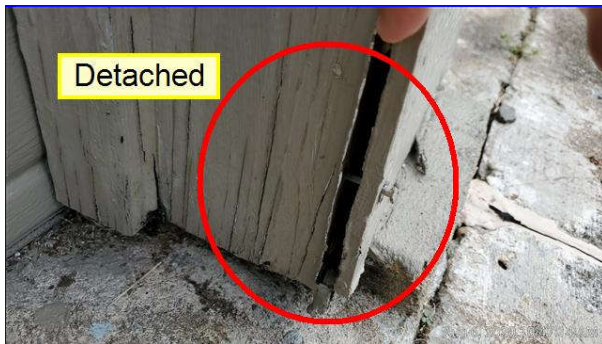
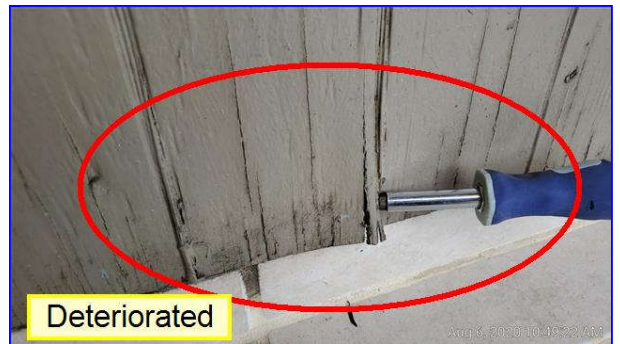
- The siding and trim, in various locations, were observed to have the following defects: damaged, detached, in poor condition and needs improvement. This condition could lead to moisture intrusion into the home. While it could not be verified, there may be concealed damage to the underlying structure. A qualified exterior contractor should be consulted regarding repairs.

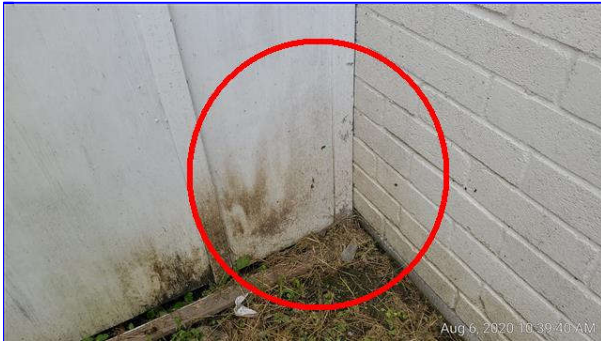
E. Item 13(Picture)

- Wood was observed to be in contact with structure. This is considered a condition conducive for wood destroying insects. Recommend clearing the contact between the structure and the wood.

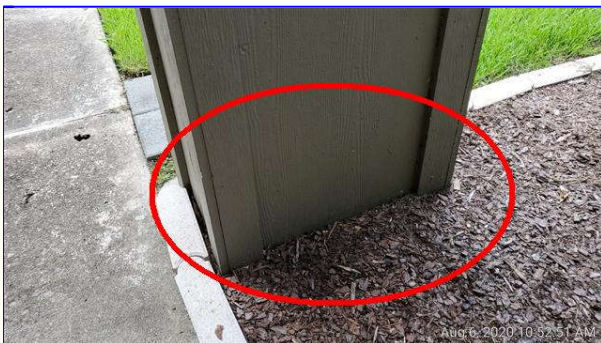
E. Item 14(Picture)

- Wood was observed to be contact with ground in and/or around the structure. It is recommended that these areas be observed for wood destroying insect; (i.e. termites). When possible, remove any wood to ground contact.

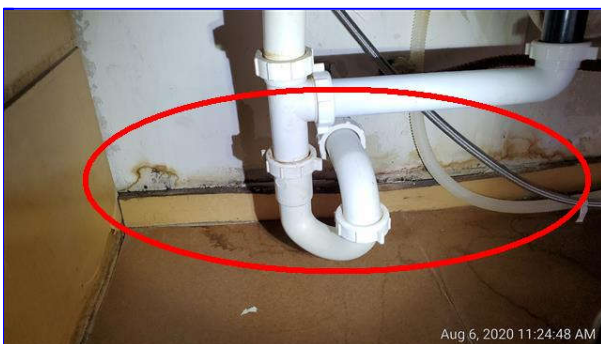
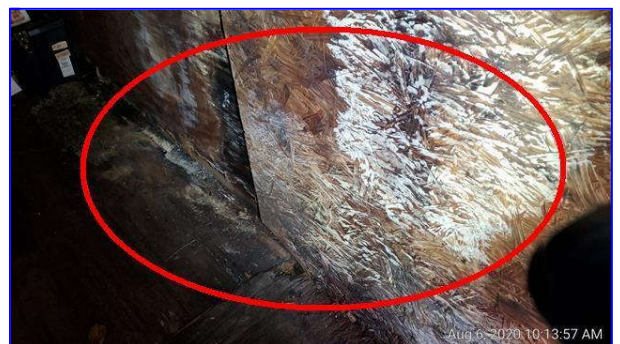
- An organic biological substance was/were observed to be present on walls, ceiling or other surfaces. We did not inspect, test or determine if this growth is or is not a health hazard. The underlying cause is moisture or dampness. I recommend you contact a licensed mold inspector for investigation or correction if needed. This is a potential safety hazard and should be investigated further.

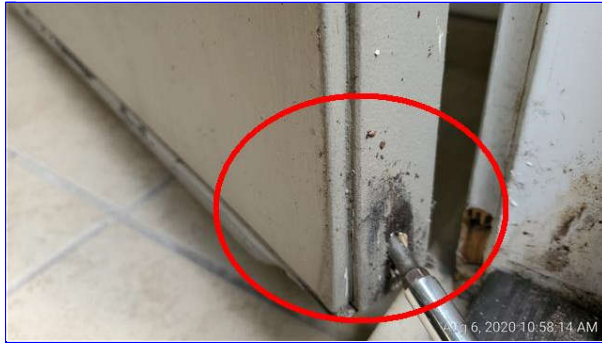
G. Item 1(Picture)

- The exterior door at the side entrance was observed to have the following defect: damaged. A repair or replacement is needed.

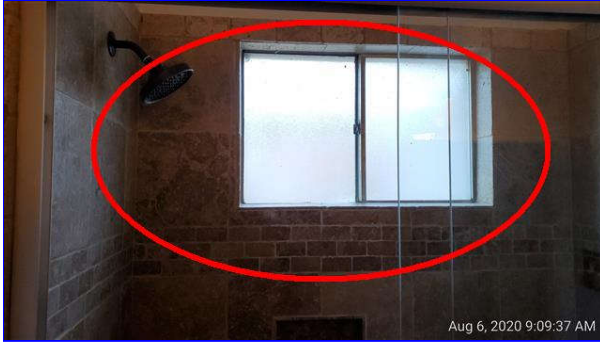
H. Item 1(Picture)

- Safety glass is needed at the shower. Proper glazing should be installed to prevent potential safety hazards.

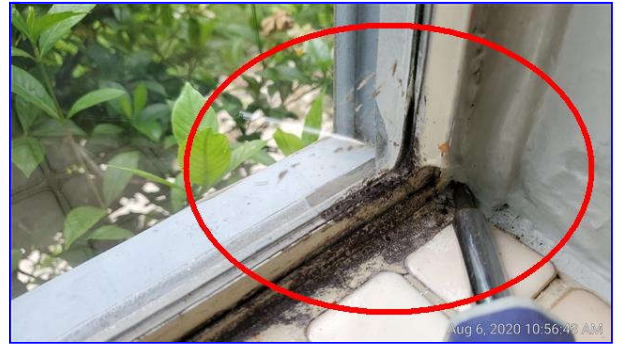
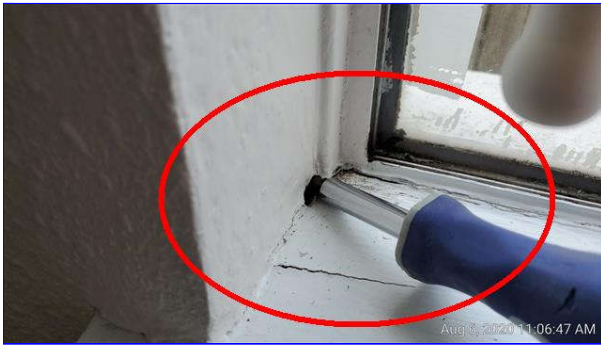
- Several windows in various locations were observed to have the following defect: evidence of leaks. The windows should be repaired as needed.

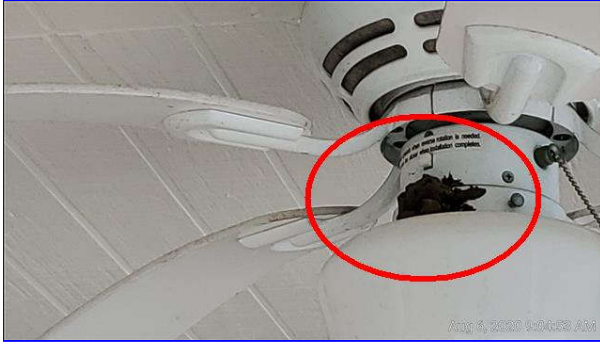
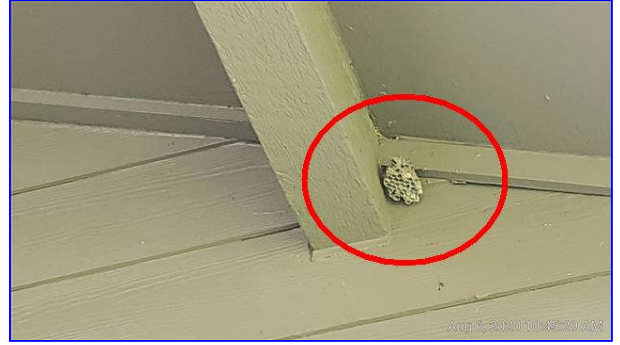
- Excessive number of a wasp like insect was observed in various locations of the home. A qualified, verified, licensed pest control specialist should be consulted regarding this condition and possible treatment.

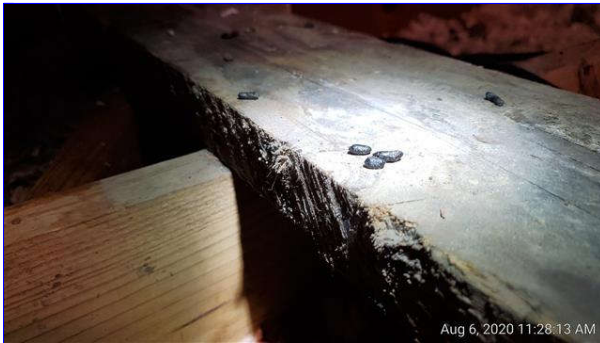
L. Item 21(Picture)

- There is evidence of possible vermin activity in the attic. A pest control specialist should be consulted regarding this condition.

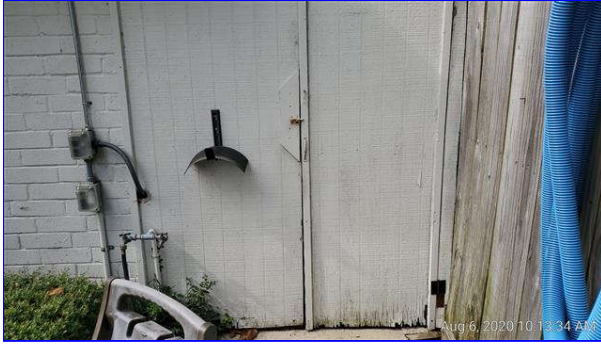
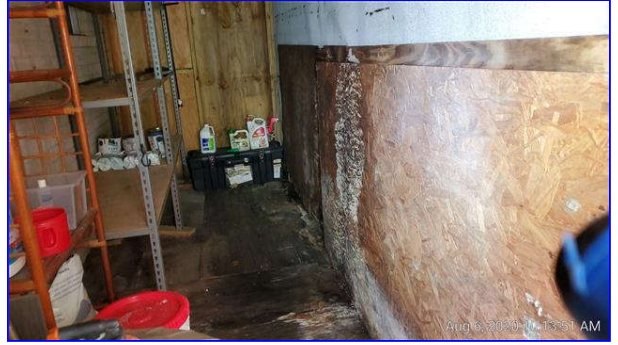
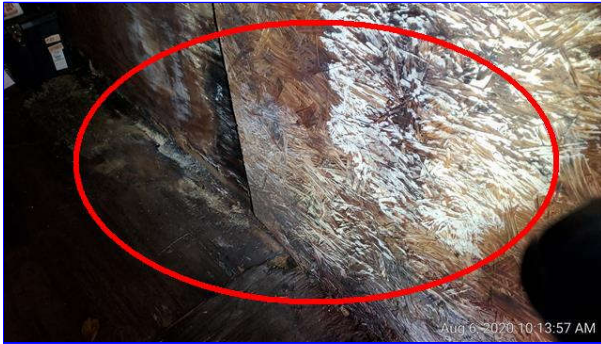
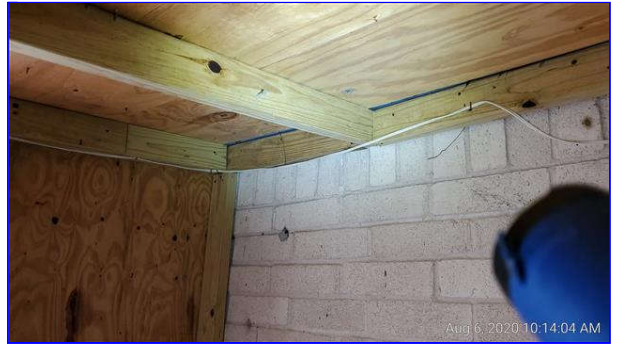
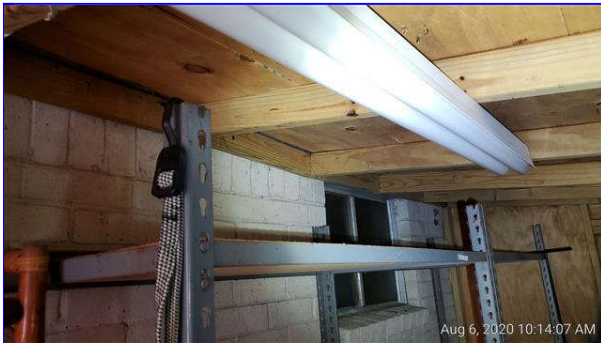
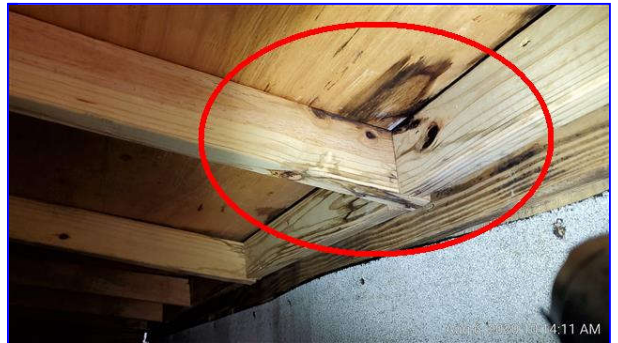
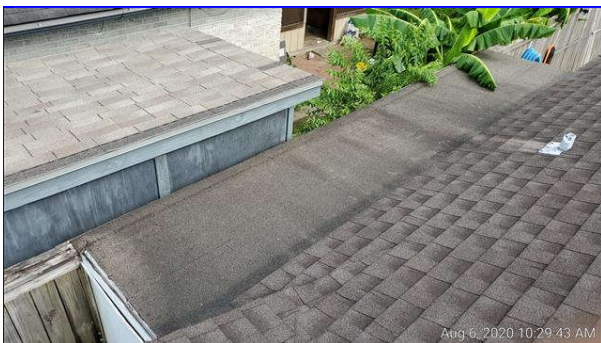
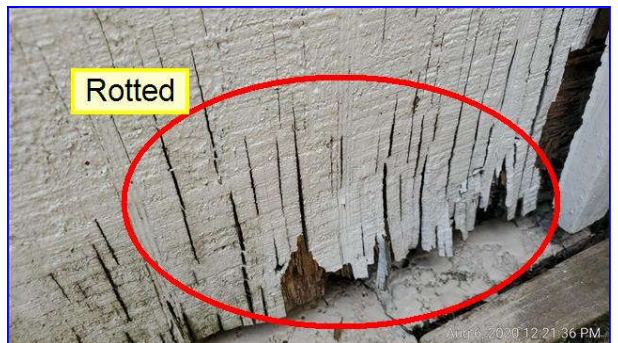
- The enclosed pool equipment/storage room was observed to have been installed in a substandard manner or DIY project. Some components are in poor condition. Further deterioration can occur if not repaired. A fall or injury could occur if not corrected. This is a safety hazard condition. A qualified exterior contractor should be consulted regarding repairs.

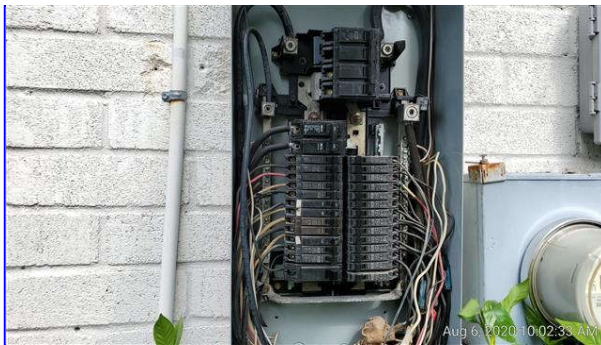
A. Item 5(Picture)

- Proper clearance for the electrical enclosure is needed. The included diagram illustrates the proper clearances needed.
- The heavy foliage at and around the main electrical panel should be trimmed back. This is a safety hazard condition.

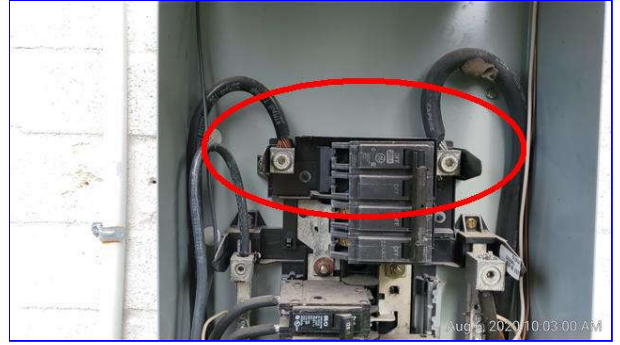
A. Item 14(Picture)

- Missing bushings to protect wiring were observed at the main panel enclosure. Bushings should be installed to prevent damage to the wiring.

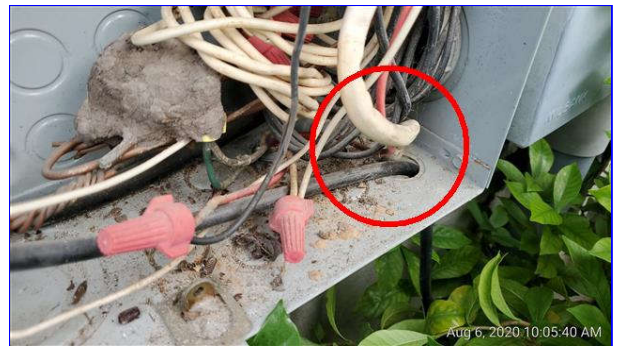
A. Item 16(Picture)

- Excessive openings were observed at the electrical panel. This condition is a safety hazard. These openings should be sealed or adjustments made to close them.

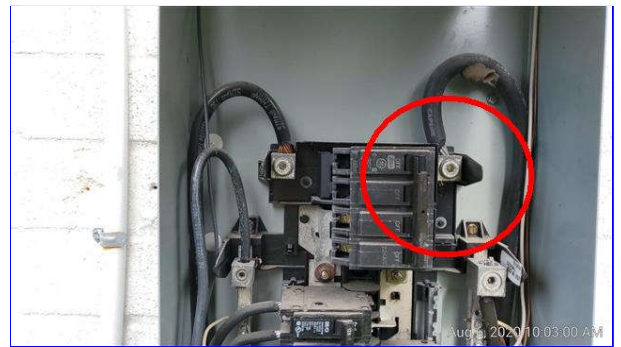
A. Item 20(Picture)

- Circuit breakers in main panel are of a different brand than panel manufacturer. The manufacturer requires that in order for the panel to be safe, only their brand is allowed to be used inside the panel. Even though these circuit breakers are all "UL approved," they are not approved to be used in panels of different manufacturers unless so indicated on the panel label.

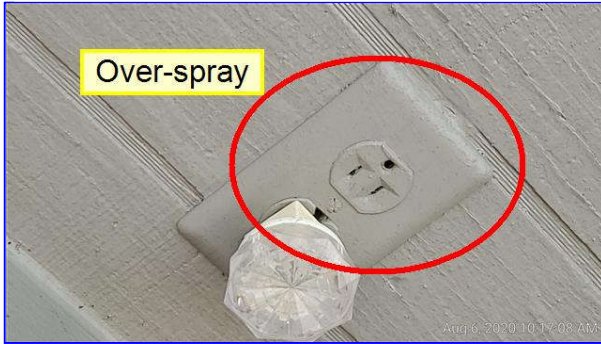
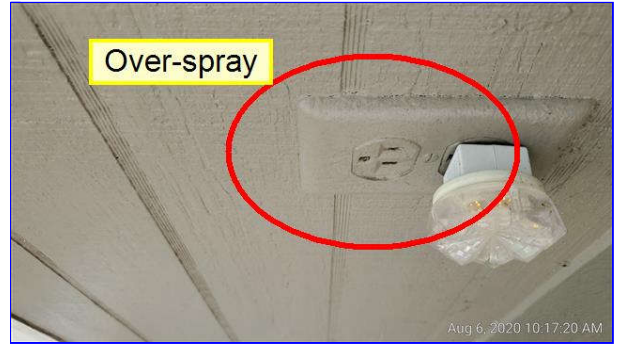
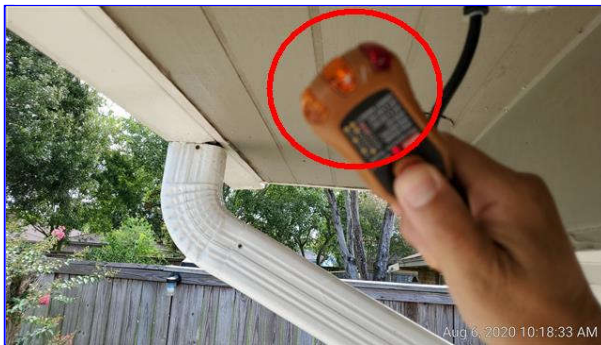
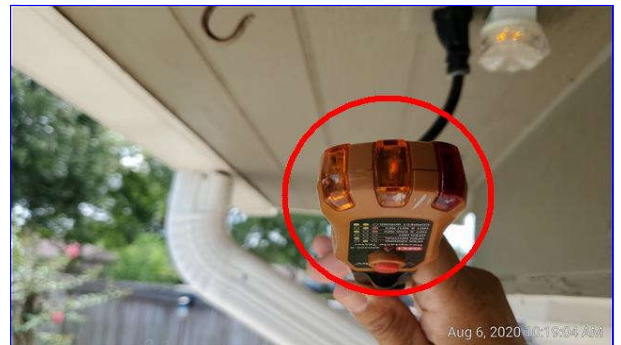
- Several receptacles at the rear porch were observed to have the following defect: not GFCI, over-spray and show to have an open ground when tested. Repairs should be performed by a qualified, verified, licensed electrician.

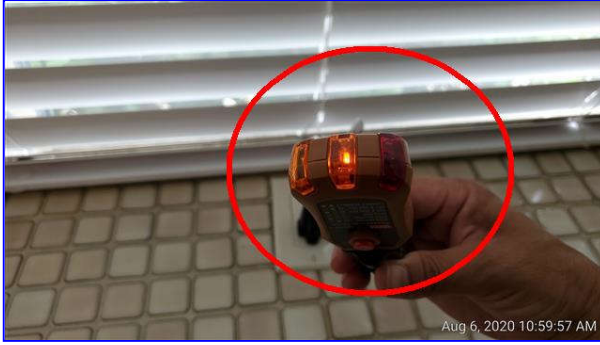
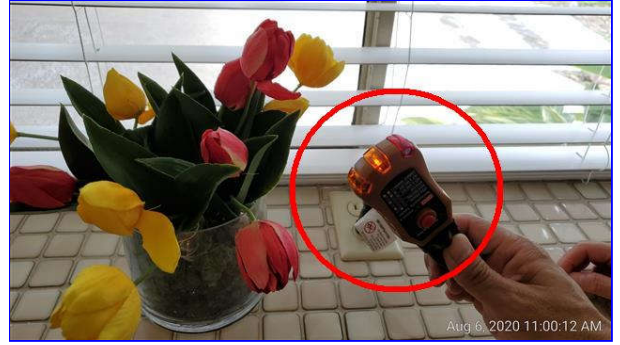
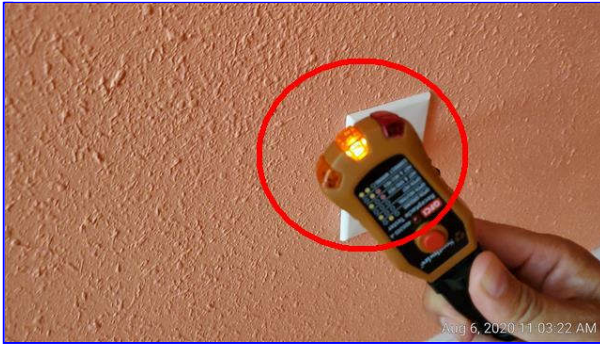
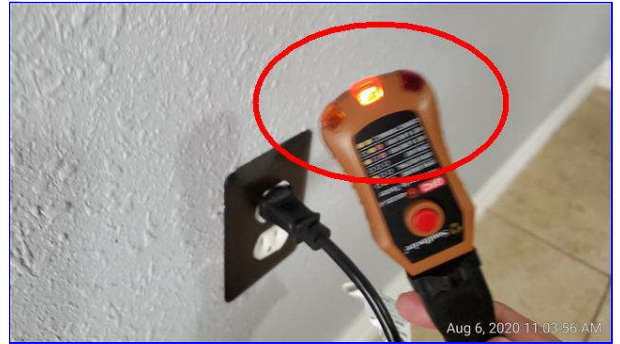
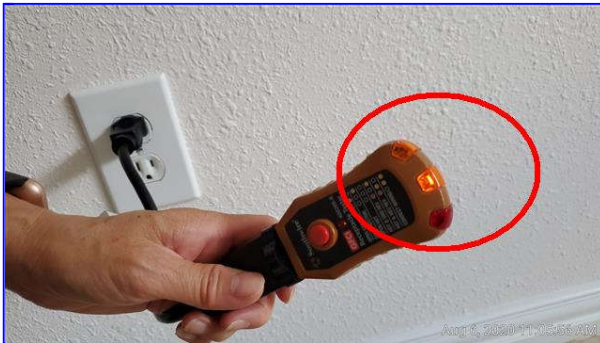
- Multiple receptacles in various locations were observed to have the following defect: show to have an open ground when tested. Repairs should be performed by a qualified, verified, licensed electrician.

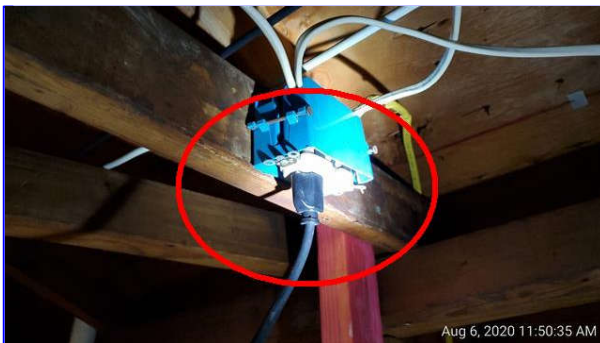
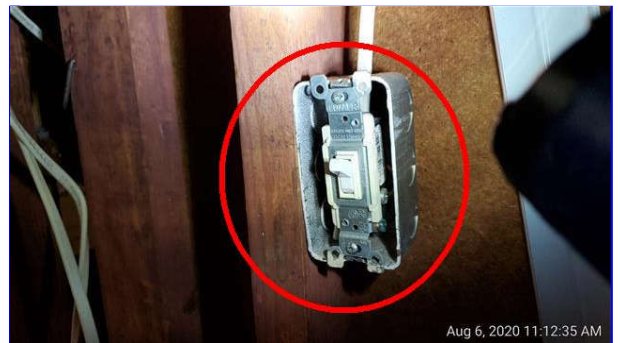
- Several receptacle/switch in the attic were observed to have the following defect: have missing cover plates. Repairs should be performed by a qualified, verified, licensed electrician.

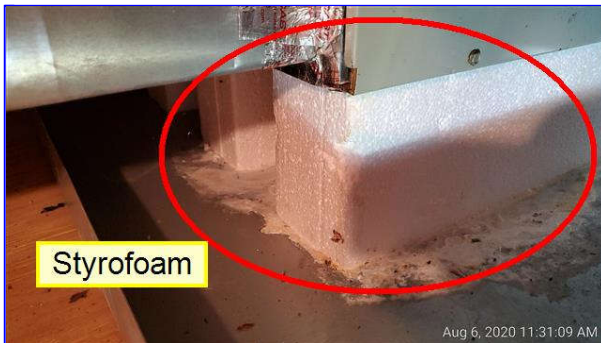
B. Item 5(Picture)

- The HVAC equipment in the attic was observed to be sitting on improper material. Styrofoam may not provide adequate support and may affect equipment performance.

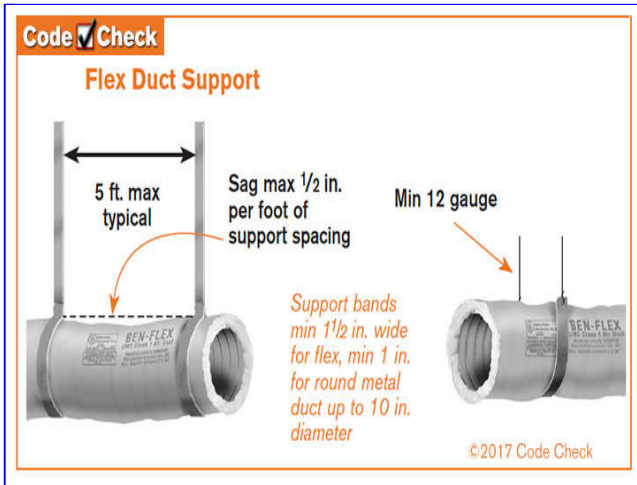
C. Item 3(Picture) Duct Support

- **Buyers Advisory Notice:** Inspecting the interior condition of the HVAC supply and return ducts would require vent removal and/or dismantling the equipment plenums and is beyond the scope of this inspection.
- HVAC flexible ducting should be hung and not left laying on the insulation and framing members. Ducts can sweat when in contact with other materials and or structural members. This can lead to organic microbial growth if not adjusted.

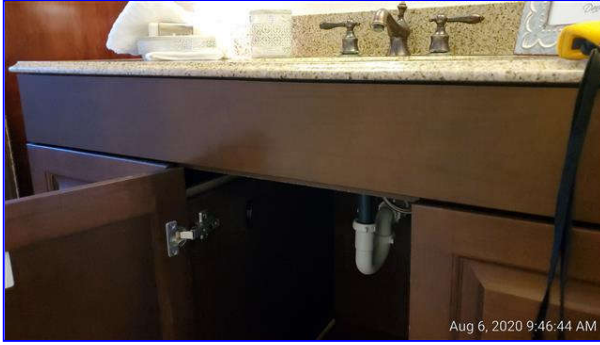
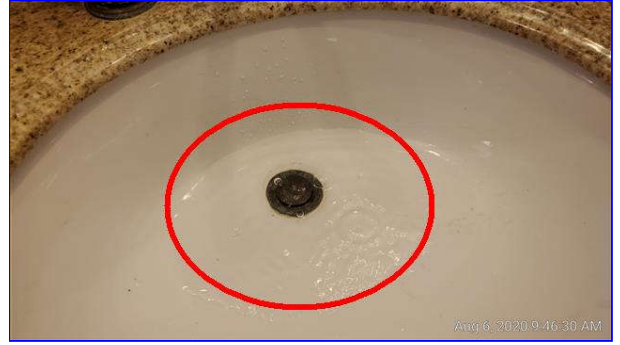
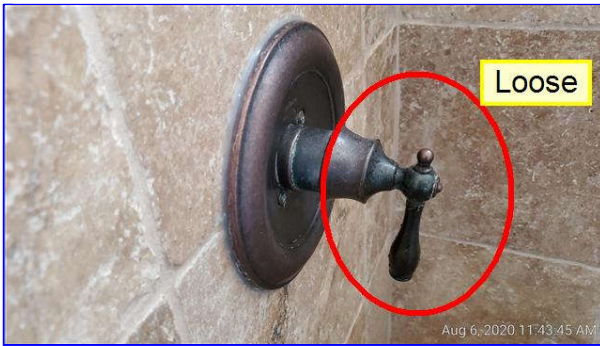
- No visible leaks were observed.
- The drain stop at the sink was observed to have the following defect: holding water when not engaged.
- The faucet at the shower was observed to have the following defect: loose valve handle.

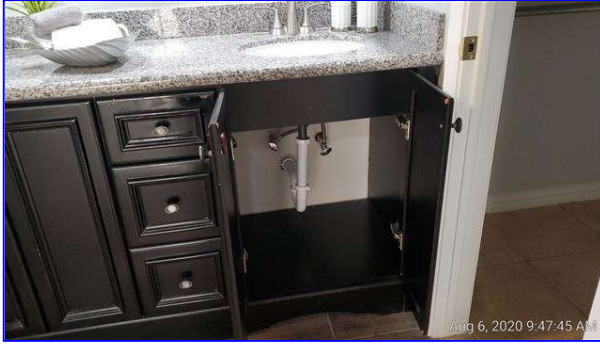
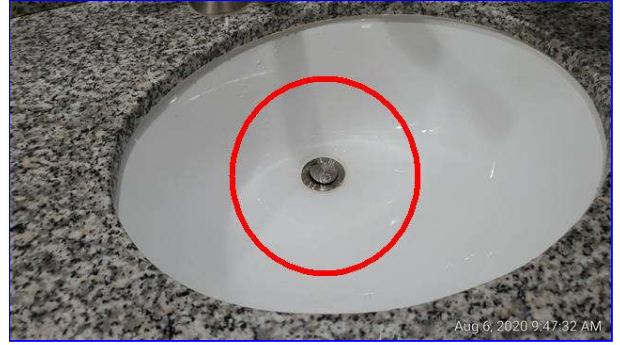
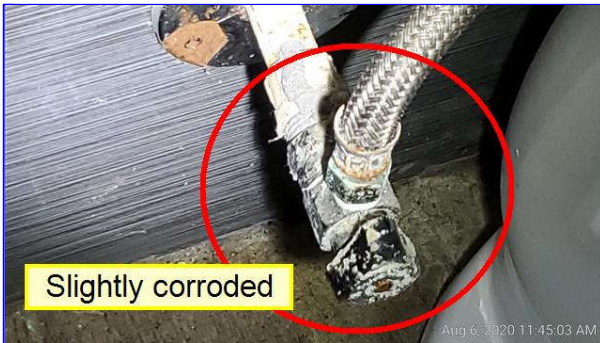
- The drain stop at the sink was observed to have the following defect: holding water when not engaged.
- The fixture connection was observed to be slightly corroded. While not leaking at the time of inspection this condition should be monitored and qualified, verified, licensed plumber should be consulted regarding repair, if needed.

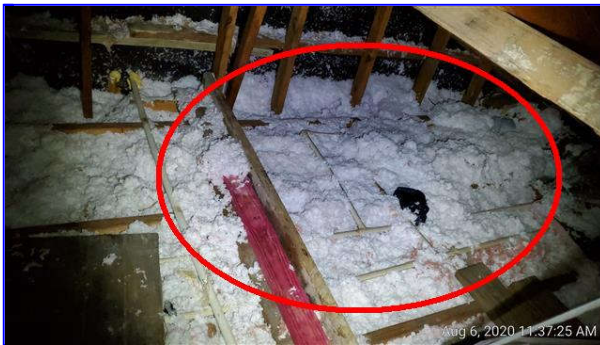
A. Item 14(Picture)

- Water supply lines in the attic were observed to lack adequate insulation. Lack of insulation or inadequate insulation at water supply lines in the attic should be corrected to prevent water damage.

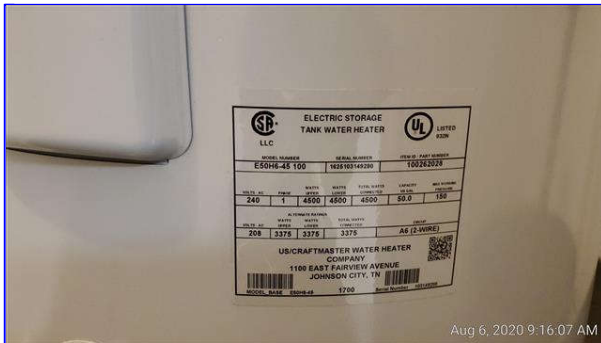
C. Item 6(Picture)

- Drain pan does not extend to exterior as required. Recommend repair to meet current standards.

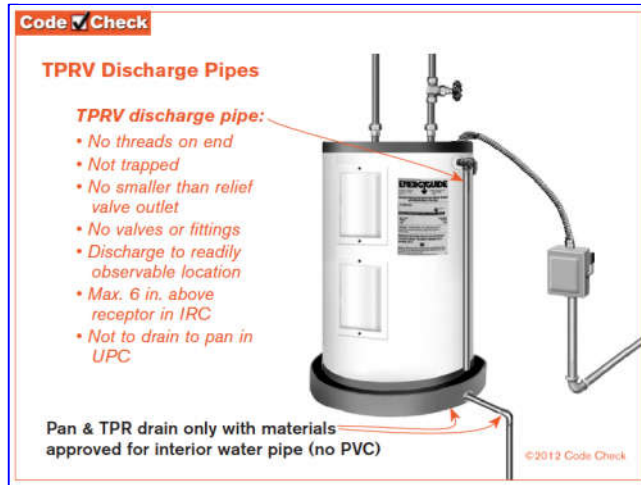
C. Item 9(Picture) TPR Discharge

- TPR discharge requirements are for the occupant safety and should be installed so as to drain by flow of gravity, not terminate more than 6 inches (152 mm) above the floor or waste receptor, discharge to a floor drain, to an indirect waste receptor, or to the outdoors, piped independently of other equipment drains, water heater pans, or relief valve discharge piping to the point of discharge, discharge to a floor drain, to an indirect waste receptor, or to the outdoors, not have valves anywhere, not have tee fittings, not have a threaded connection at the end of the pipe so as to avoid capping, not be trapped, since standing water may become contaminated and backflow into the potable water, not be directly connected to the drainage system to prevent backflow of potentially contaminating the potable water and discharge pipe should be no smaller than 3/4-inch at any point.

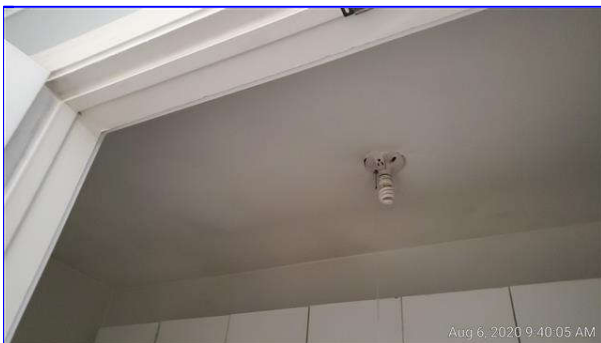
F. Item 1(Picture)

- The laundry area does not have an exhaust fan. Laundry room without an operable window are required to have an exhaust fan vented to the exterior.

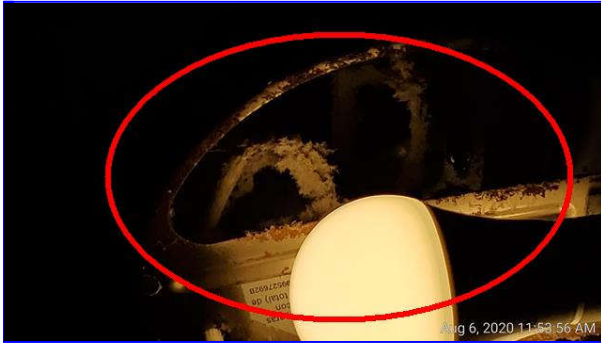
F. Item 2(Picture)

- The mechanical fan in the master bathroom was observed to be excessively dirty. Cleaning is recommended for proper function.

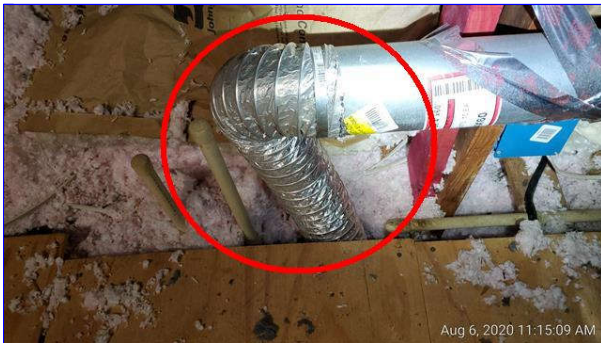
H. Item 1(Picture)

- The dryer vent piping was observed to be the following defect(s): made of flexible vent duct at it passing trough the wall.
