FOUNDATION INSPECTION

14418 Ardwell Dr
Sugar Land, TX 77498

MARCH 13, 2023

REF: CONDITION OF PROPERTY SURVEY

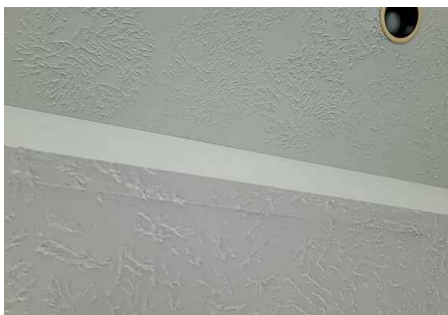
Game Room

The sheetrock tape was observed to be wrinkled at some locations during the inspection including at the above locations.

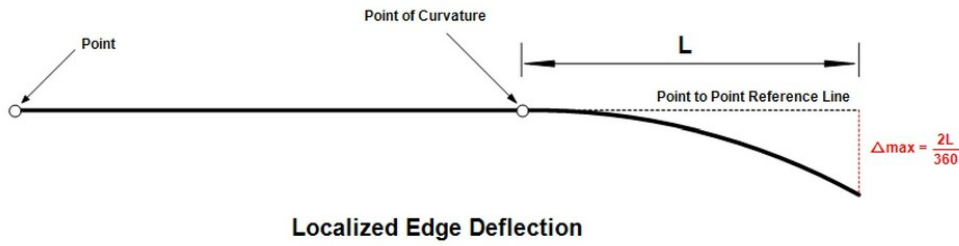
From the master closet, to the dining room ($L = 48$ feet), the maximum allowable deflection is 1.6 inches. We measured a deflection of 1.15 inches at the time of inspection across this span, which is less than the maximum allowable deflection, and is acceptable. This observation can be observed along the red line in the sketch below.

Additionally, according to the ASCE Guidelines, the evaluation of localized localized edge-condition deflections shall be evaluated as a cantilevered member (allowable deflection = one inch deflection in a 15-foot horizontal distance ($2L/\Delta = 360$ per the building code)).

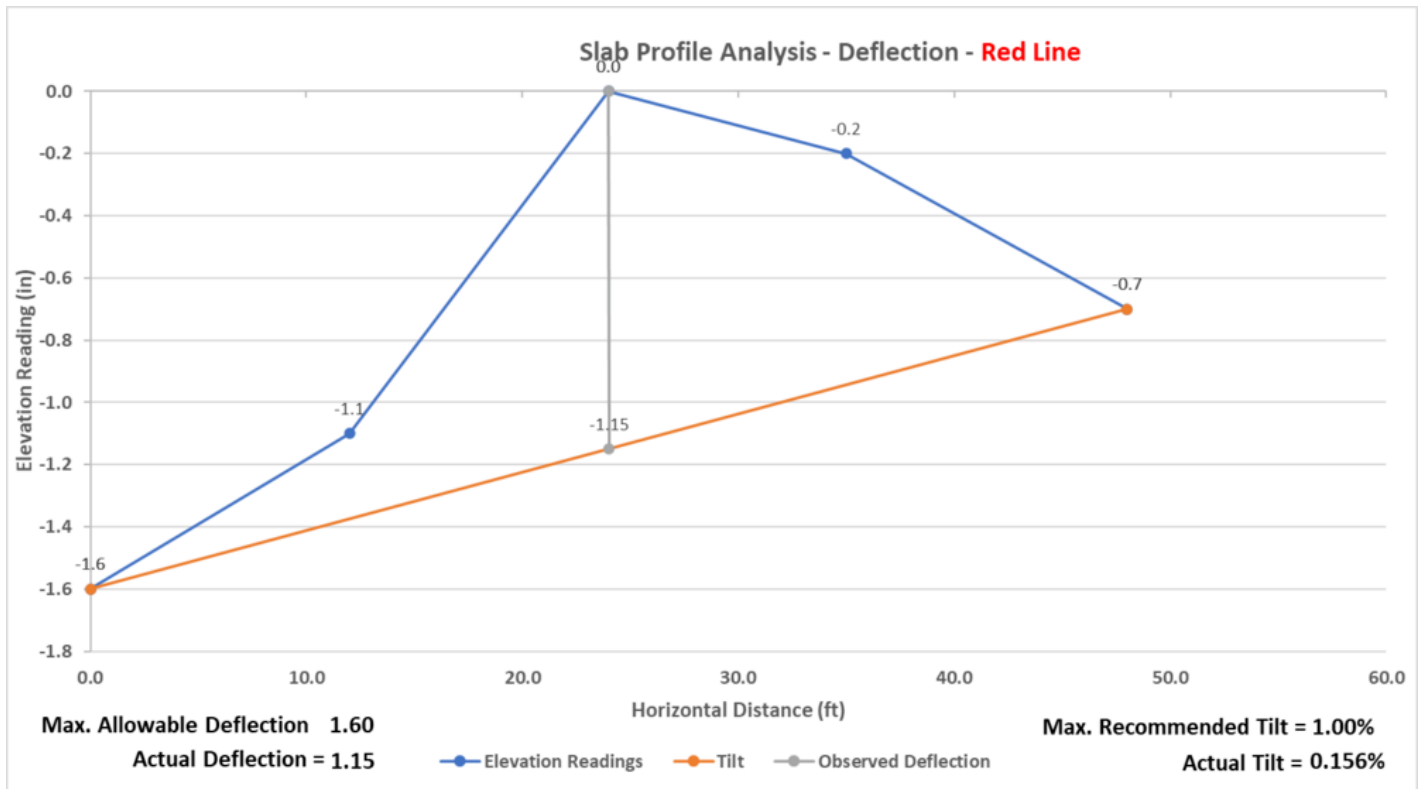
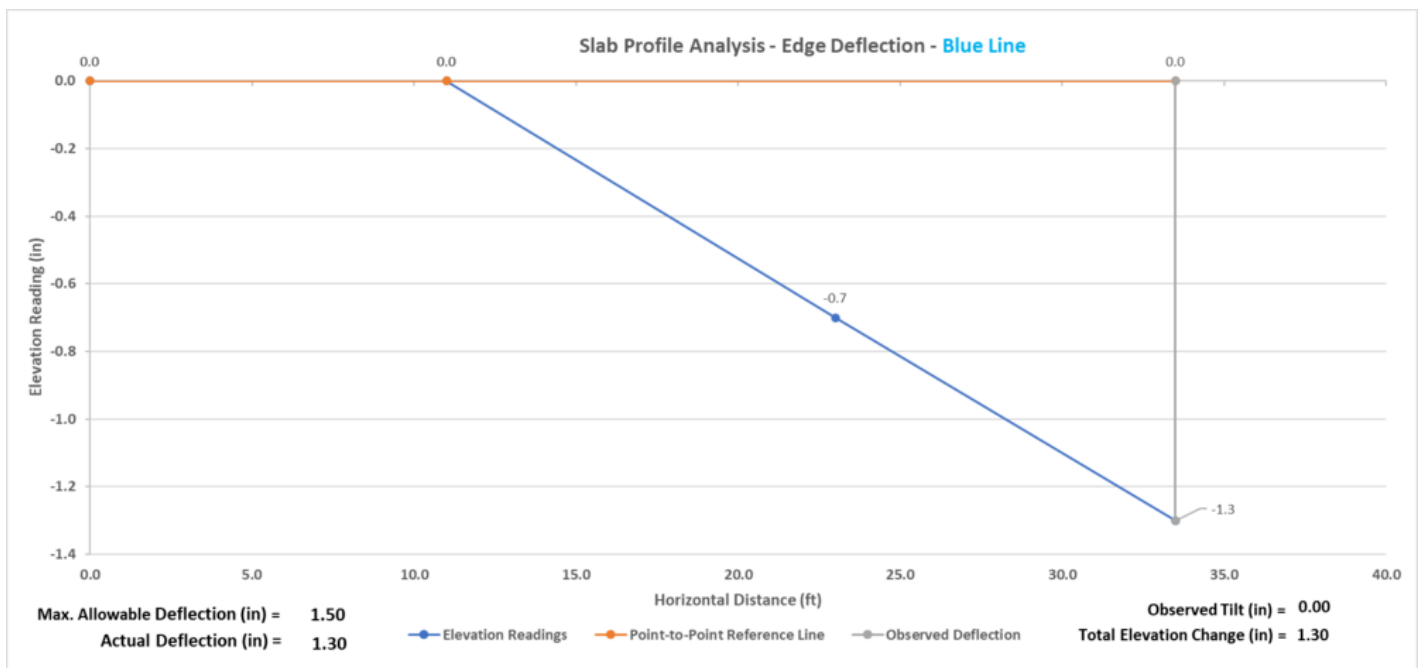
Elevations Readings 14418 Ardwell Drive

The floors were checked with an electronic level, and were observed to be sloping towards the west side of the house. The difference in elevation between the high point and low point was 1.6 inches. The high point was located at the entry, and the low point was located at the primary closet. The unlevelness takes place over a horizontal distance of approximately 30 feet.

From the point of curvature located at the entryway, to the north wall of the family room ($L' = 22.5$ feet), the maximum allowable deflection is 1.5 inches. We measured a deflection of 1.3 inches at the time of inspection across this span, which is less than the maximum allowable deflection, and is acceptable. This observation can be observed along the **blue line** in the sketch below.
