Inspection Report

Property Address:
1710 Westmere Ct
Houston TX 77077

PROPERTY INSPECTION REPORT

By: Sean Kennedy #22935 and Warren Sturges #24574 4/19/
2021
(Name and License Number of Inspector) (Date)

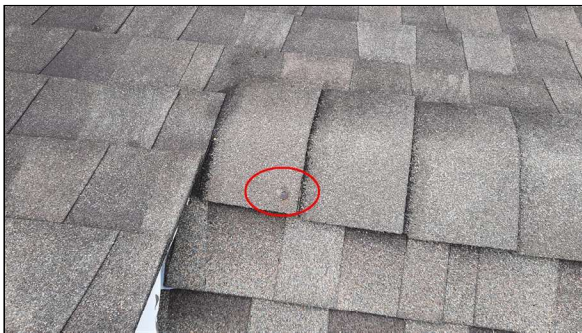
- Exposed nail heads at the ridges should be sealed to prevent water intrusion.

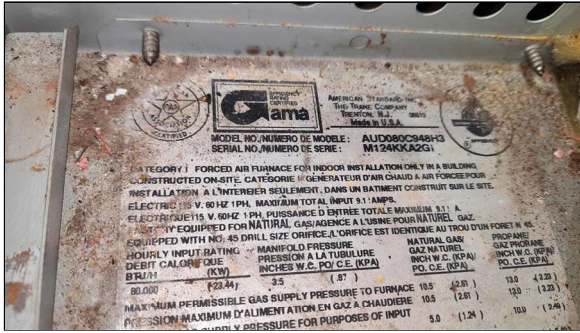
The Heating Unit Photos

- The furnace was operable at the time of inspection. Conditions needing repair were not observed.

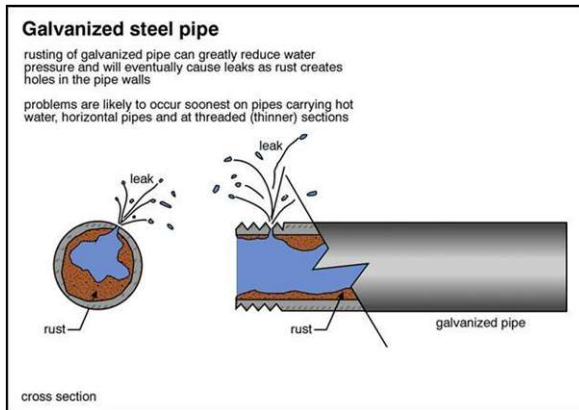
Galvanized Pipe ILLUS

- Steel galvanized supply plumbing was observed. Steel galvanized pipe was commonly used as water supply plumbing until the mid 1980's. Over time, two defects occur with steel water piping. Corrosion accumulates inside the pipe restricting or even stopping water flow to fixtures. Secondly, corrosion penetrates the wall of the pipe causing leaks. This often results in water damage to the home. Most of the supply plumbing is located in walls, between ceilings and floors or under insulation. This makes the piping inaccessible to the inspector. The Client should also be aware some insurance companies will not cover water damage that has resulted from leakage due to faulty steel piping. As time passes, repairs will be needed.

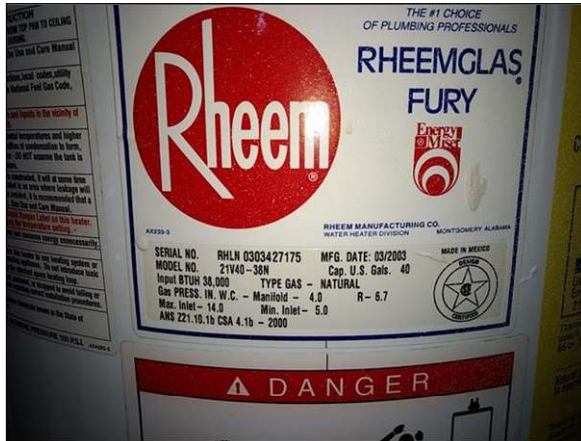
- The water heater appears to be leaking at TPR valve connection. A more thorough inspection by a qualified contractor is needed. A qualified licensed plumber should repair or correct as needed.

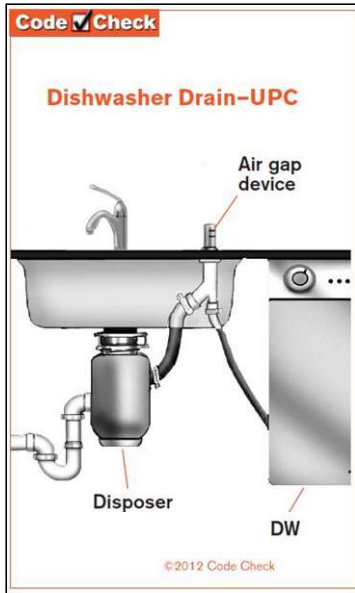
DW Air Gap Illus

- The dishwasher is not equipped with an air gap valve or a high loop to prevent contaminated water from the sink backing into the dishwasher.
