FIG Services LLC d/b/a FOX INSPECTION GROUP
 Property Inspection Report #220119JB-23 Misty Grove Circle
 8616 Daffodil St. Houston, TX 77063
 (Office)713.723-3330 (Email) office@foxinspectiongroup.com

PROPERTY INSPECTION REPORT

Concerning: 23 Misty Grove Circle, The Woodlands, TX 77380
(Address of Inspected Property)

By: Josh Burk, TREC PI: 22850 01/19/2022
(Name and License Number of Inspector) (Date)

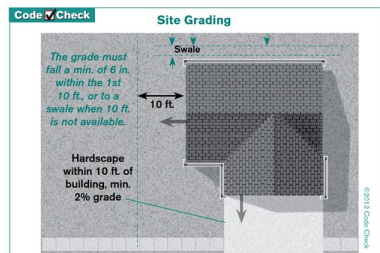
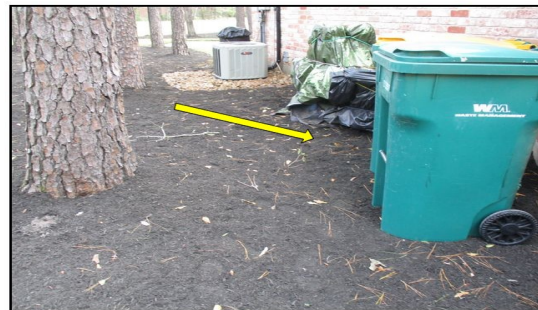
Soil grade and drainage patterns around some areas of the house do not appear to properly direct water away from the foundation to aid in controlling runoff water and could cause differential movement of the foundation or water penetration during heavy rains.

Soil level too high, in contact with siding and/or at/above brick weep holes at one or more locations around the house/garage. Promotes wood rot and is considered a conducive condition to termite activity.

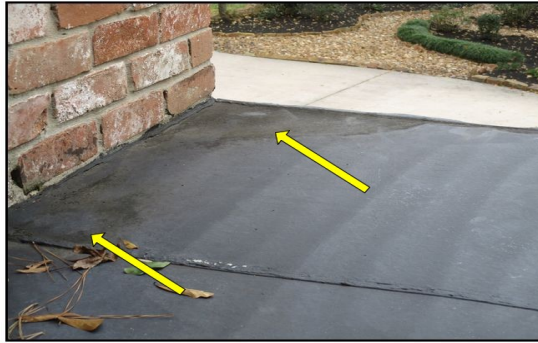
Standing water and/or stains from previous standing water observed on the flat roof. This condition is conducive to water penetration. Recommend roofer be consulted regarding the ability to correct drainage on the roof to prevent/reduce standing water; Above portica shea.

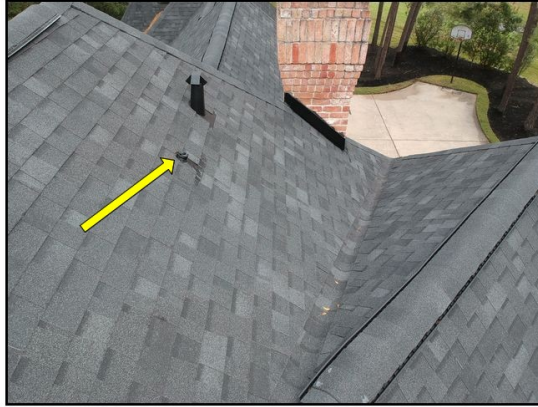
Improperly vented; vents shall terminate not less than 6" above the roof, and not less than 12" from any vertical surface of the building, Ref IRC 3102.

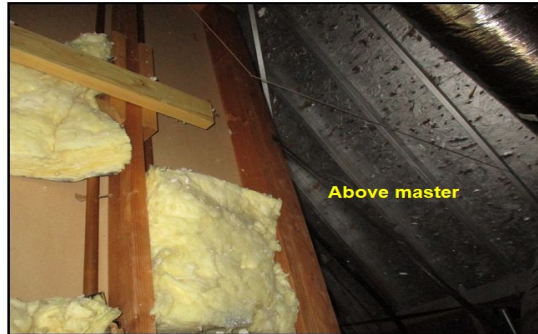
Vertical sections of insulation observed to be missing / displaced on interior walls in attic.

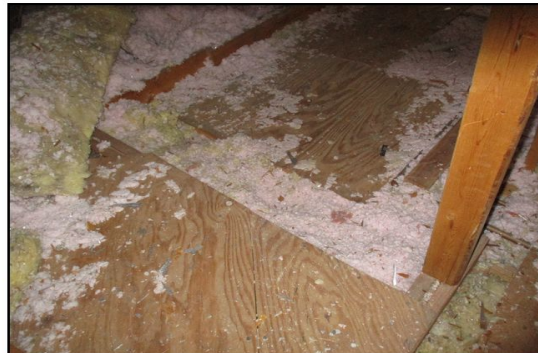
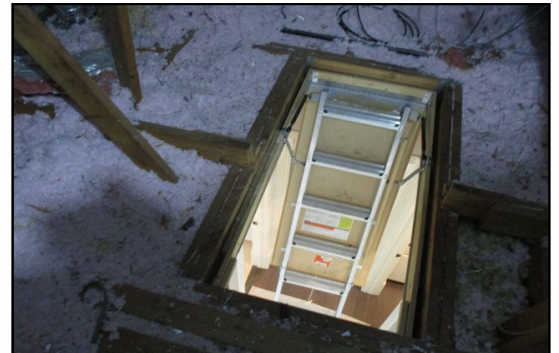
Inadequate attic walkway to mechanical equipment in the attic. Code [IRC 1305.1.3] requires a minimum of 24 inches wide solid floor to equipment for servicing. An area of deficient attic decking is immediately around the pull-down attic stairway and along walkway in attic.

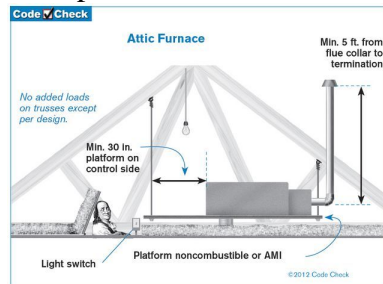
Inadequate attic walkway and/or platform to mechanical equipment in the attic. Code violation, [IRC M1305.1.3] requires 30-inch head clearance and a minimum 24 inch wide SOLID (no gaps or obstructions), floor to equipment for servicing and a 30 inch deep solid platform in front of the equipment.

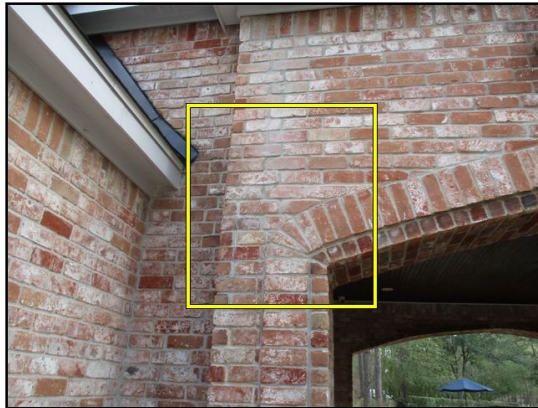
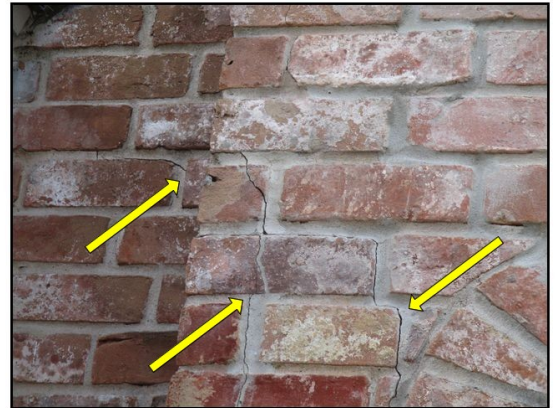
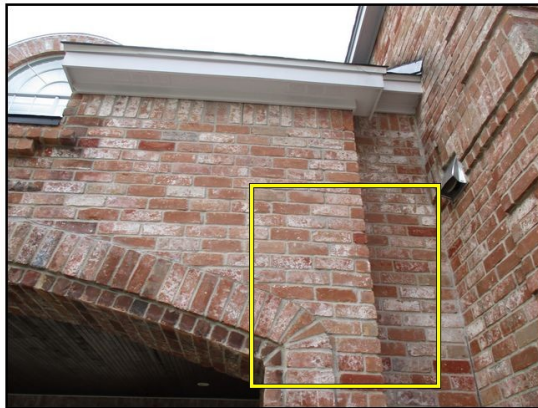
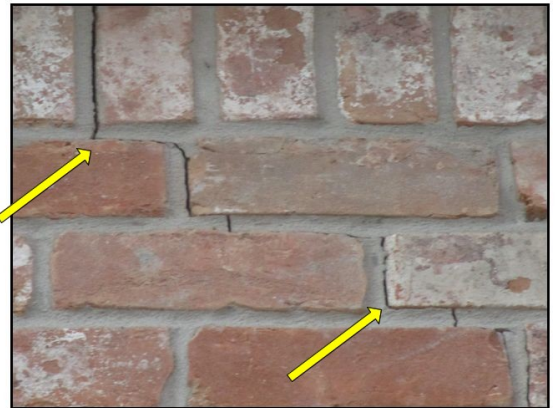
Cracks and or repairs in the brick arch were observed. Loose bricks are hazardous.

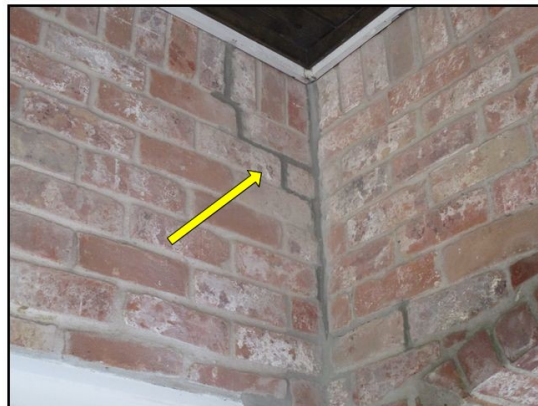
Cracks in brick / stone veneer and/or repairs, one or more locations, Recommend buyer take photographs of cracks, their location, and width [ruler across the crack] with a high-resolution camera that has a date stamp for future reference.

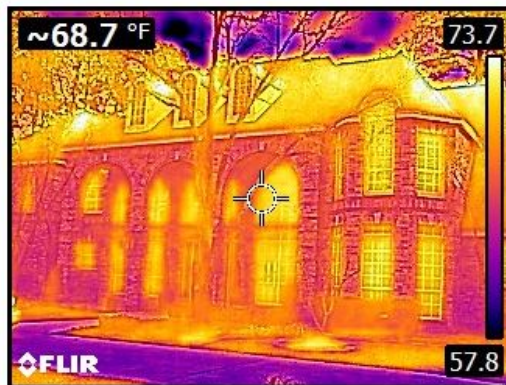
No significant thermal anomalies observed at the time of inspection.

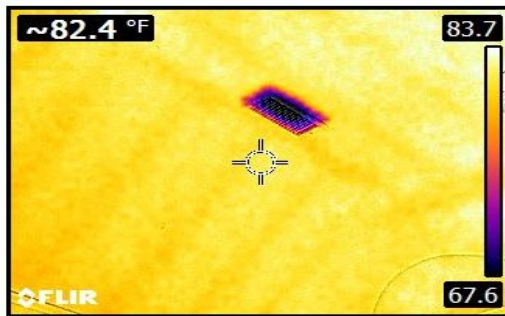
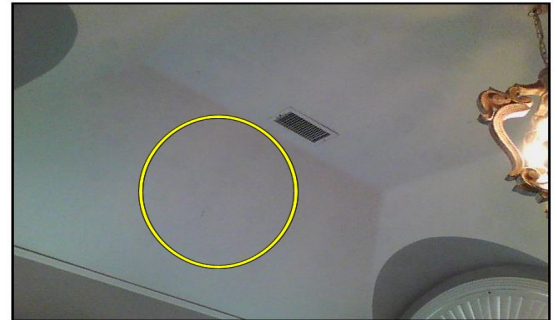
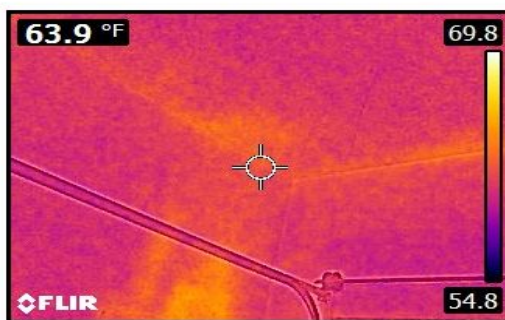
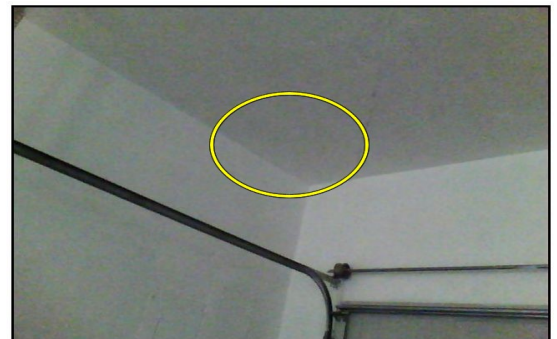
Possible water stains, damage or repairs observed, infrared camera indicated that stains are not active (wet) at the time of inspection; Guest suite and garage.

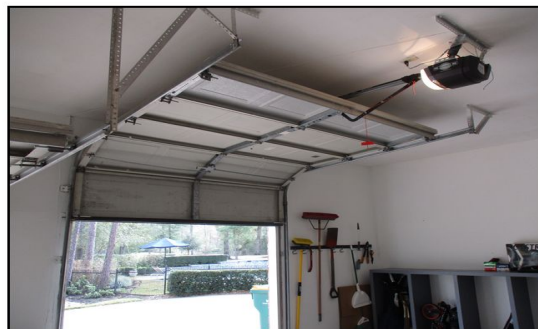
Single bay door has an extra panel that does not fully open and raised tracks.

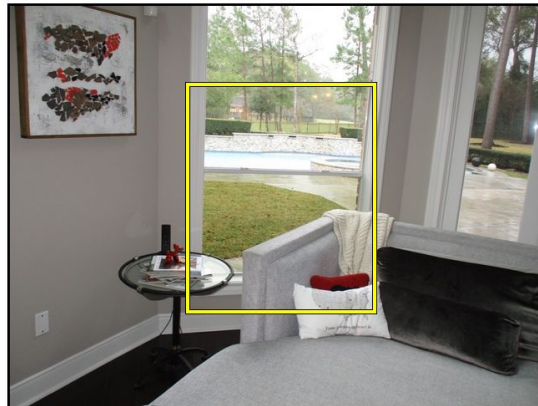
One or more windows will not stay open or will not open fully; **Family room.**

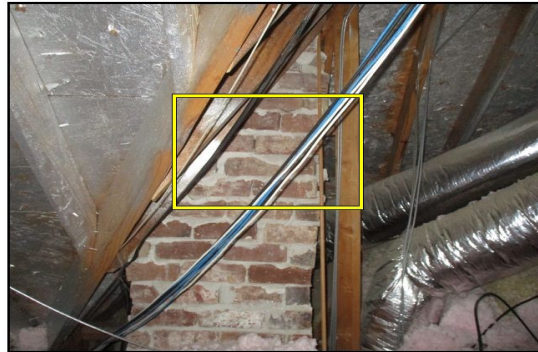
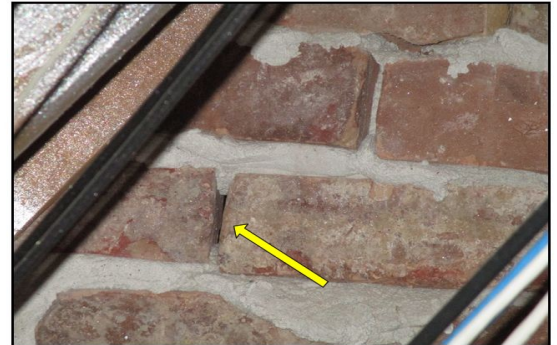
Voids in the mortar between bricks of the chimney were observed in the attic. Voids need to sealed/tuck pointed with mortar to reduce fire hazard.

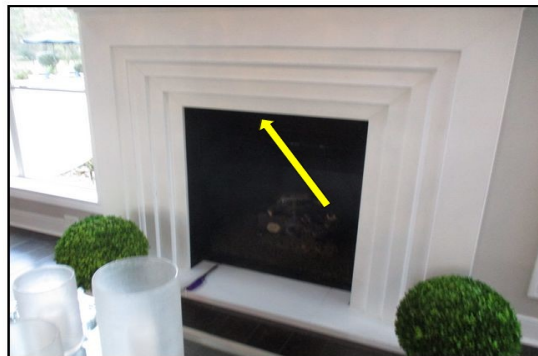
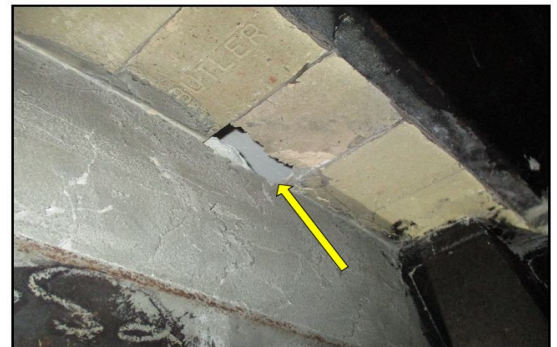
Hearth not sealed properly around the perimeter of damper and/or on the interior backside of the lintel, missing/ cracked brick - potential fire hazard.

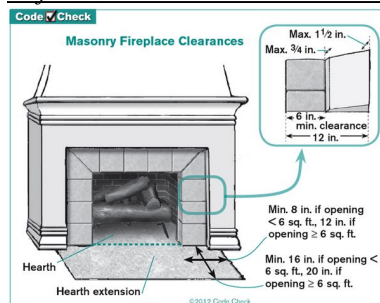
Inadequate sized non-combustible hearth extension at sides of the fireplace. Where the fireplace opening is more than 6 square feet the hearth extension shall extend 20 inches in front and at least 12 inches beyond each side of the opening. Per IRC 1003.10.

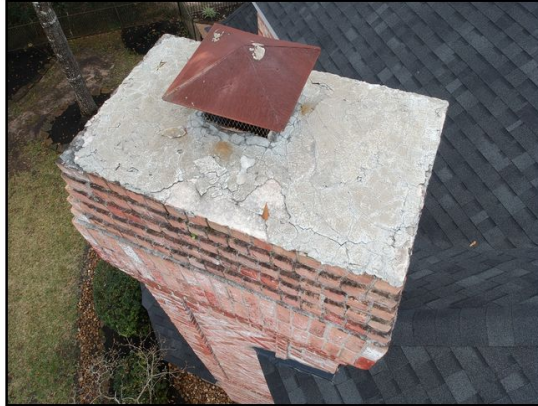
Masonry coping cracked or in need of improvements on top of the chimney.

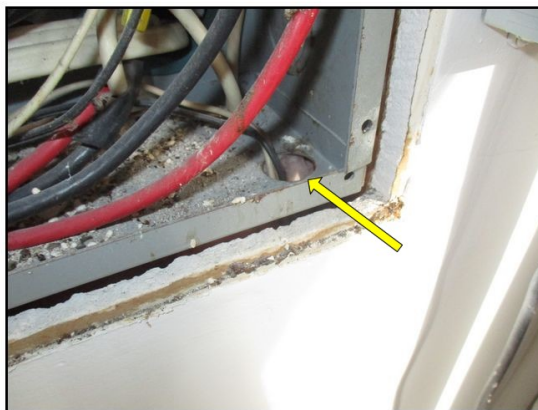
Protective bushing not present around the electrical wire as it passes through a metal box.

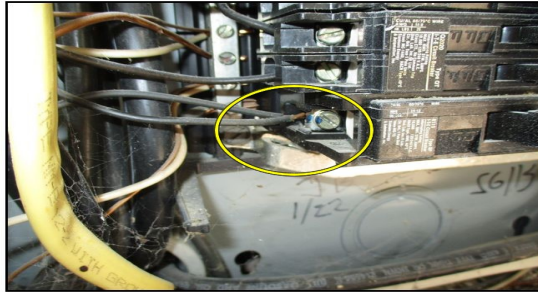
Double lugged breaker(s), [two wires improperly on 1 breaker] observed.

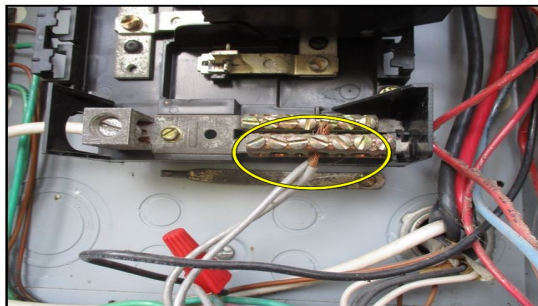
Observed two or more neutral conductors under one screw lug on neutral bus. Current industry standards and NEC permit one neutral conductor per screw lug.

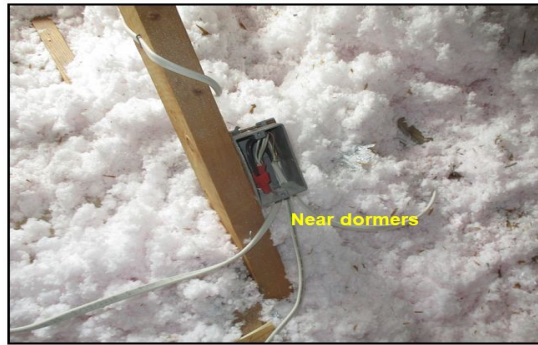
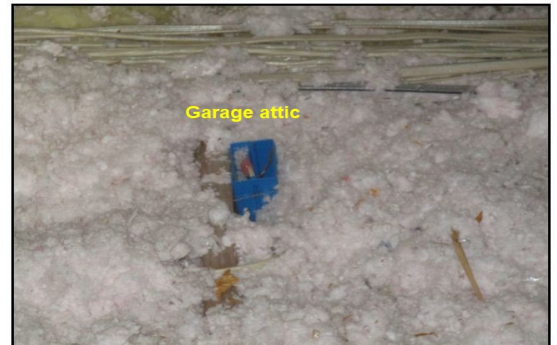
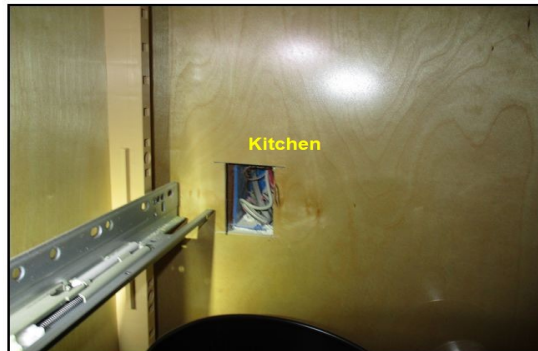
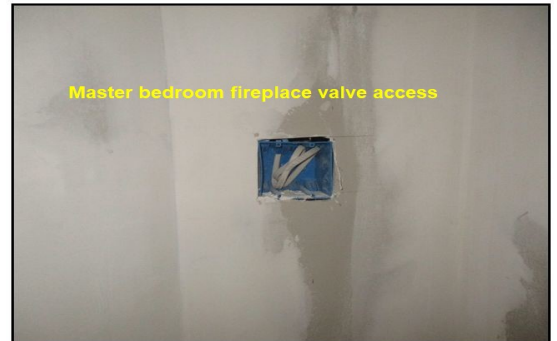
Wire connections are not enclosed in proper electrical junction box(s) or electrical junction box(s) do not have covers in place, including but not limited to the following locations; attics, kitchen cabinet right of oven and master bedroom left of fireplace.

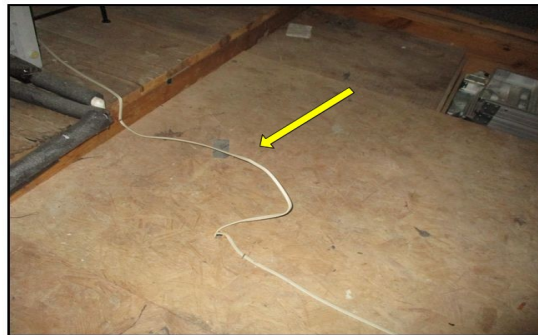
Electrical wiring run/routed along attic floor and is not secured. This condition encourages damage to the wiring and trip hazards from personnel accessing the attic; garage attic.

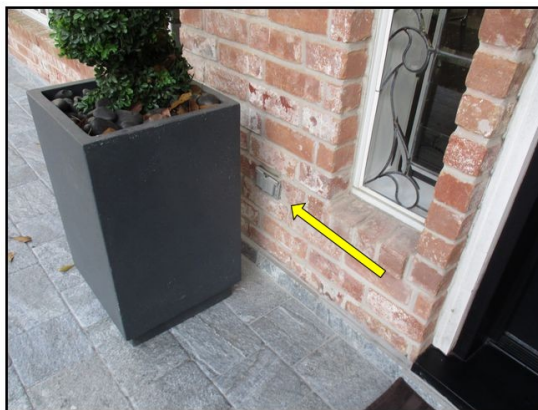
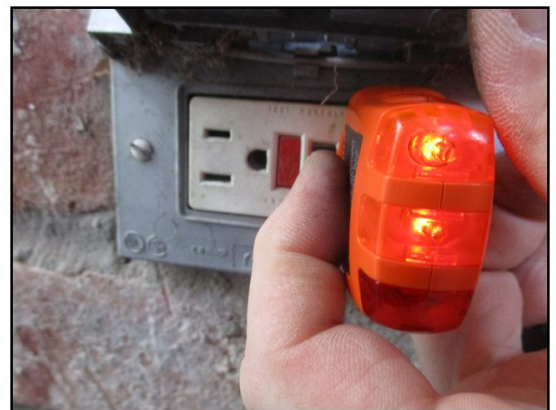
GFCI outlet does not operate properly when tested with simulated short; Front porch.

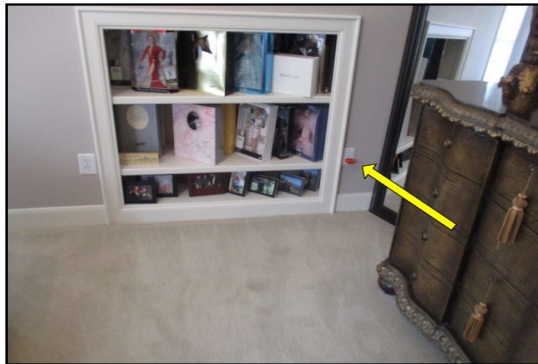
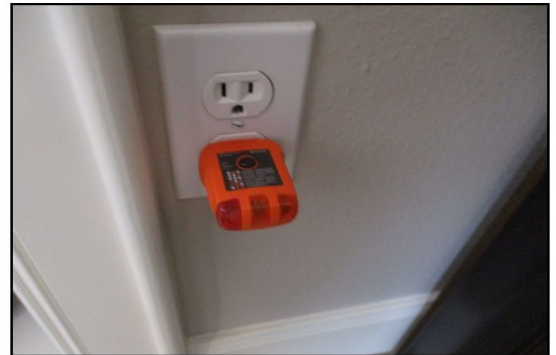
No power to outlet(s); Guest suite East wall.

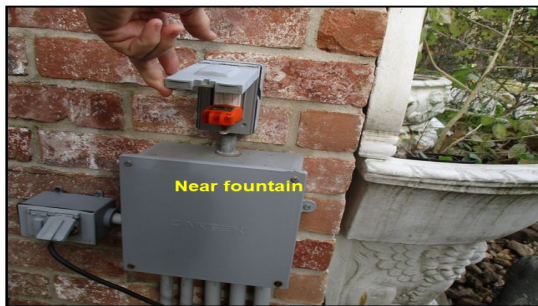
No power to outlet(s), possibly switched controlled. Recommend consulting seller regarding this matter.

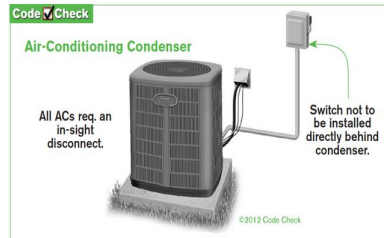
Code requires minimum clearance to electrical service panels/ equipment disconnects to be 36" in front of and 30" from side to side.

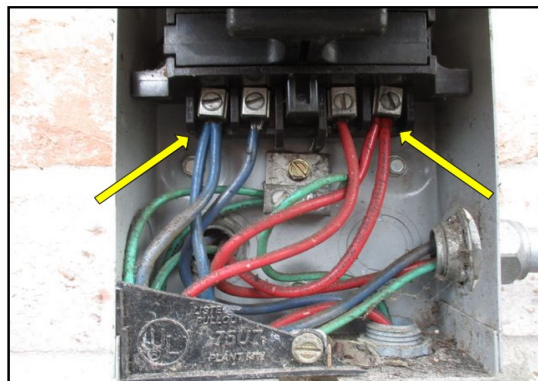
Double lugged [two wires improperly on 1 lug] observed; Guest suite condenser.

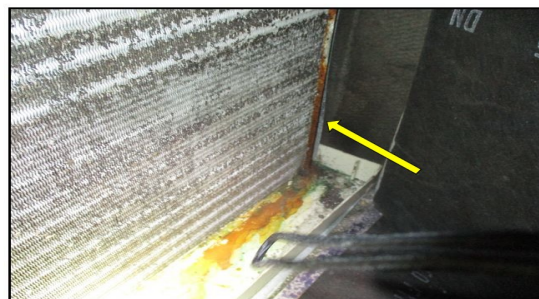
The coils are dirty and in need of cleaning. Dirty coils reduce airflow through the system and create high head pressures at the compressor, thereby unduly stressing and reducing the life span of system components.

The bottom/ sides of the casing has rust pitting, evidence of limited serviceable life.

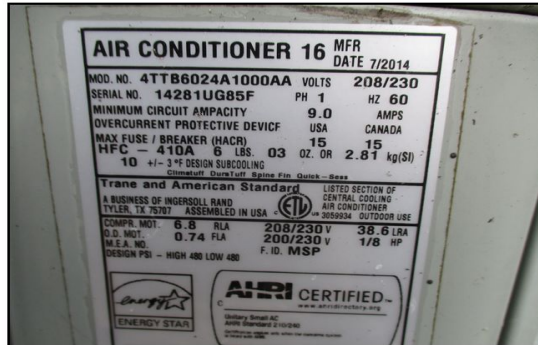
CONDENSER UNIT: GUEST SUITE 2014 TRANE 2 TON/ 15 AMP

Recommend qualified/licensed HVAC technician service/repair/replace as needed. Not cooling well.

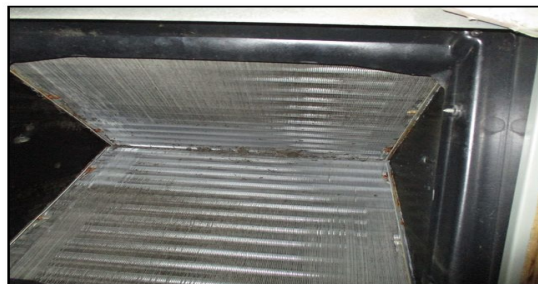
The coils are dirty and in need of cleaning. Dirty coils reduce airflow through the system and create high head pressures at the compressor, thereby unduly stressing and reducing the life span of system components.

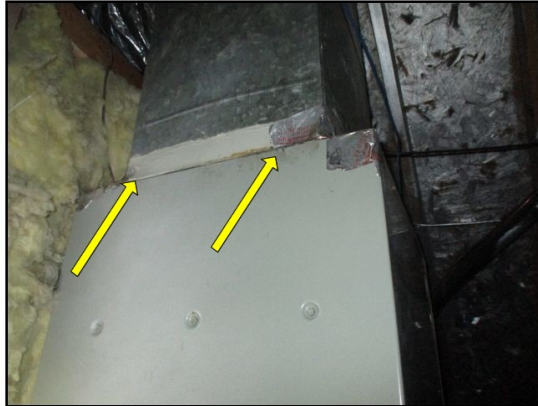
The return air chase is not properly sealed. This condition results in a very significant reduction in cooling capacity and substantially increased operating costs; **guest suite**

Some/ excessive air loss around transition/coil/heater/plenum; **Guest suite.**

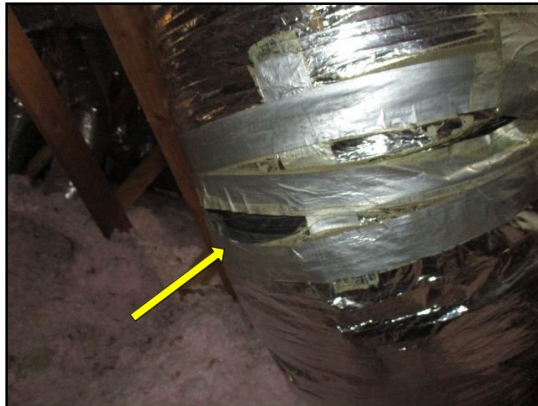
Observed multiple areas of damaged/ loose outer vapor seal on the flex duct in the attic.

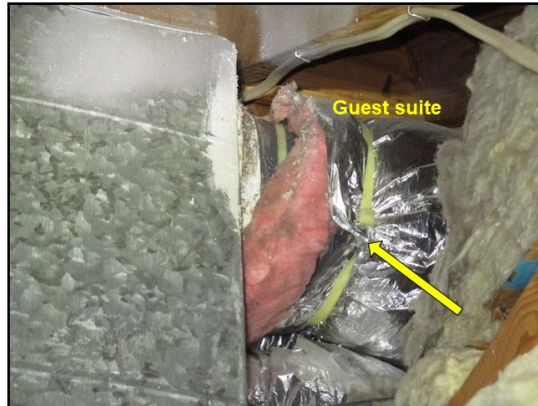
Observed one or more areas in the attic where flex duct mechanical connection zip ties are not snug fit/are loose as required by current industry standards. It appears the proper use of a zip tie cinching tool was sporadic. Loose mechanical connections increase the chance of duct separation in the future, recommend repair.

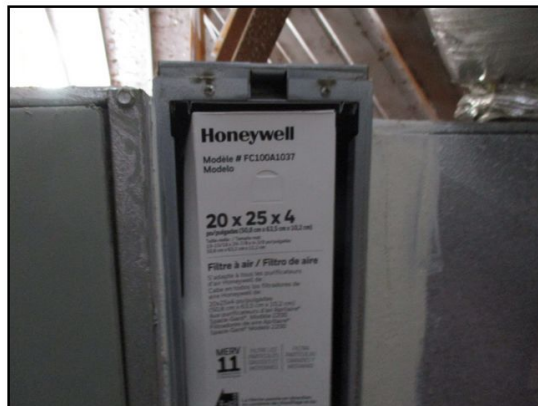
Media air filter(s) located in the attic that requires changing/cleaning every 6 months, recommend checking guide for proper maintenance information.

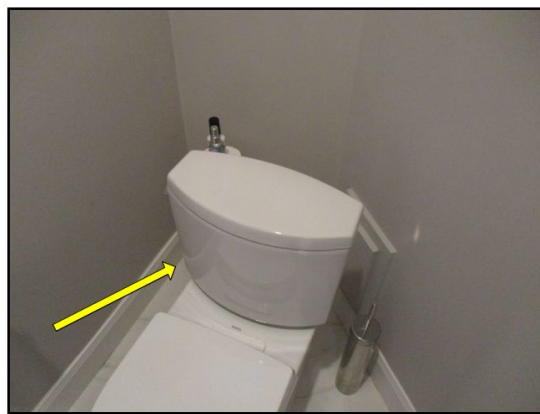
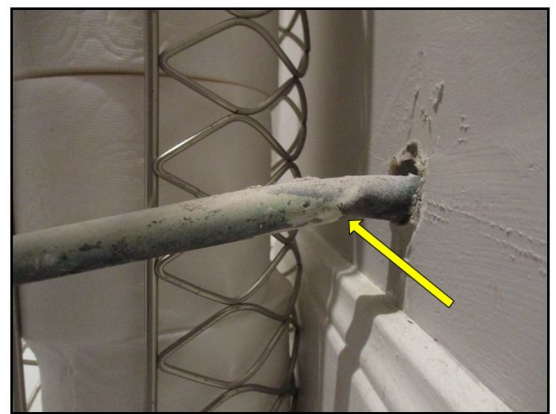
The copper supply pipe is bent/ kinked behind master commode.

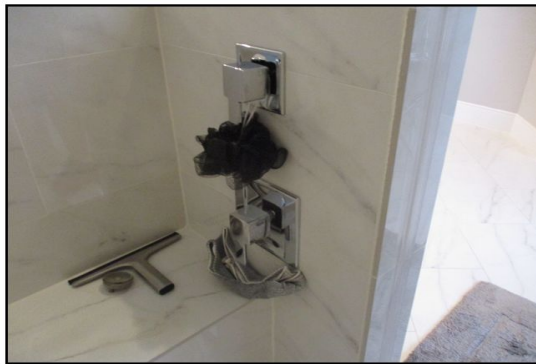
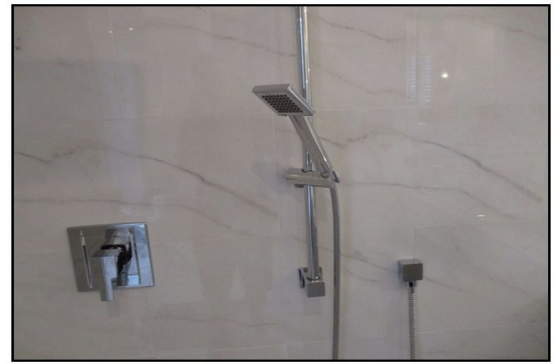
No water from master shower spray wand and or wall shower head. Recommend further evaluation/ repair by a qualified plumber.

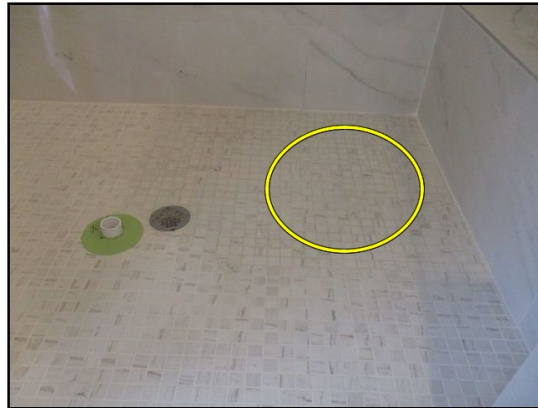
Master shower floor holds water, does not tilt towards center drain.

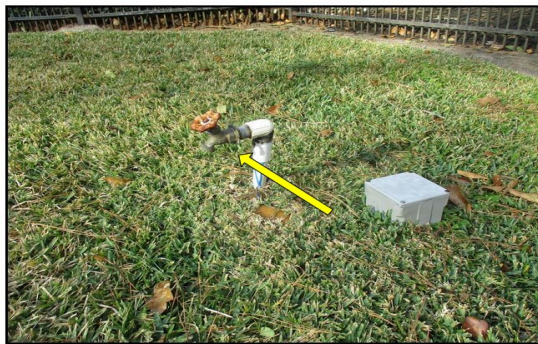
No water from exterior hose bib; **Yard near pool.**

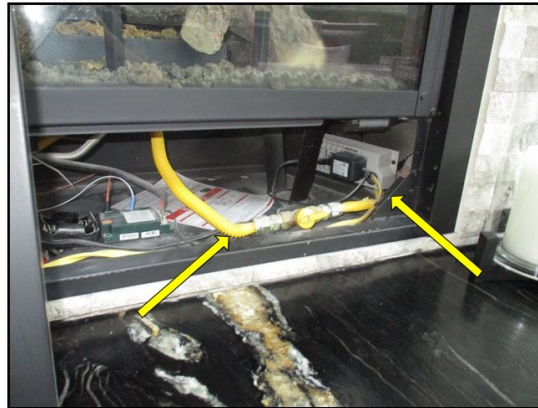
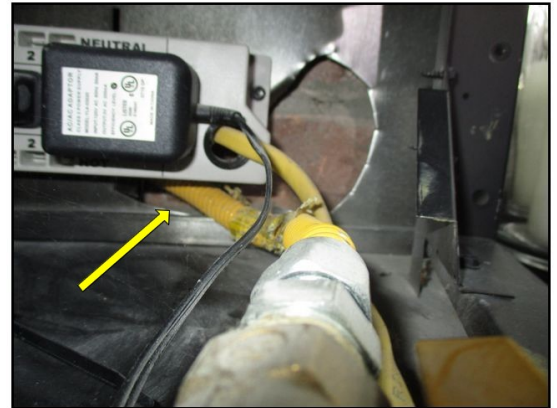
Flexible gas line is not allowed to pass through cabinet. Ref. 2006 IRC G2422.1.2.3 (411.1.3.3) Prohibited locations and penetrations. Connectors shall not be concealed within, or extended through, walls, floors, partitions, ceilings or appliance housings; Family room fireplace.

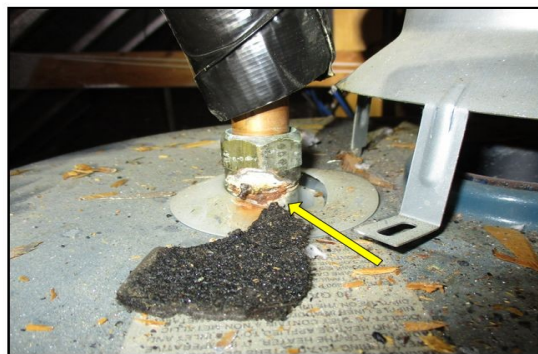
Corrosion observed at shut off valve and/or connections on top of the water heater; South unit.

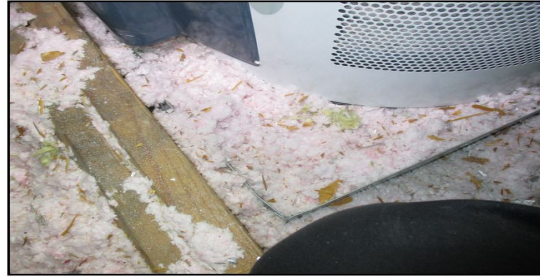
Insulation/debris in drain pan needs to be removed to prevent clogging of the drain line; Both units..

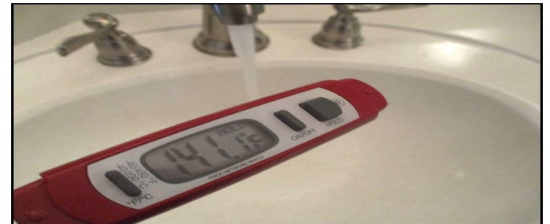
Water temperature too hot - scalding hazard. Temperature was measured above 140°F. The following temperatures will produce 2nd & 3rd-degree burns on adult skin:

- 160°F in about 1/2 second
- 150°F in about 1-1/2 seconds
- 140°F in less than 5 seconds
- 130°F in about 30 seconds
- 120°F takes more than 5 minutes.

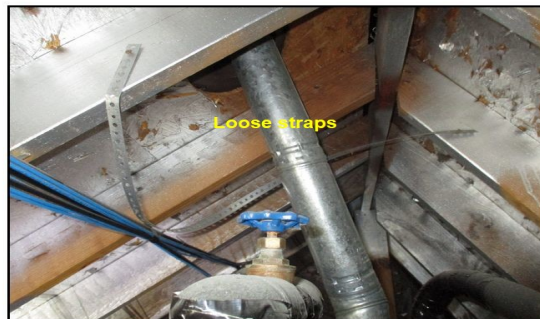
WATER HEATER EXHAUST VENT(S):
Vent pipe(s) not properly secured (strapped) in place.

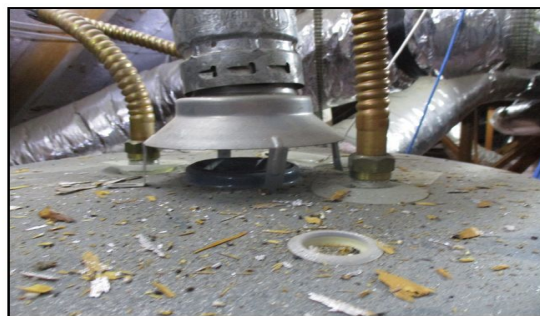
Improperly vented - vent pipe not properly aligned / secured at the top of water heater. May be allowing products of combustion (bad gas) to vent into house/garage/attic; North unit.

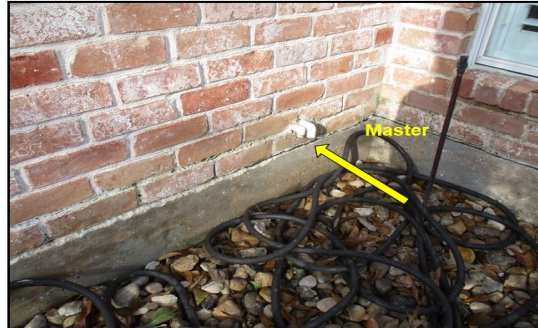
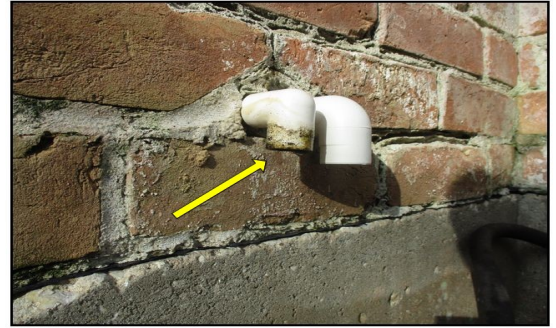
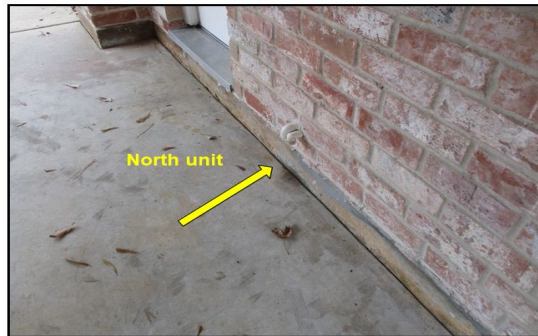
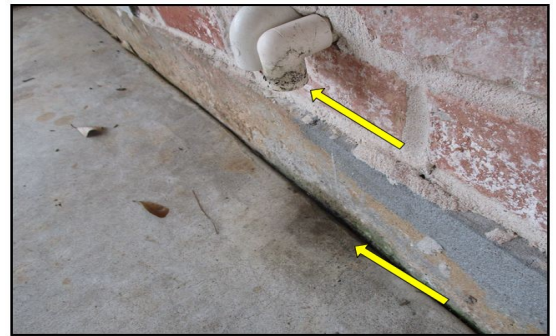
TPR valve leaks water, service/repair/replace as necessary; Both units.

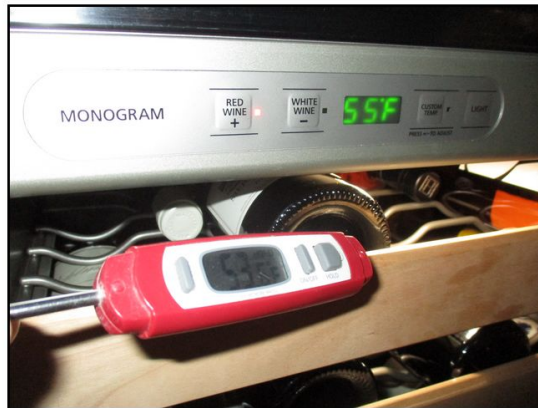
WINE COOLER: LEFT: *Temperature measures:*

No significant deficiencies or anomalies observed at the time of inspection.

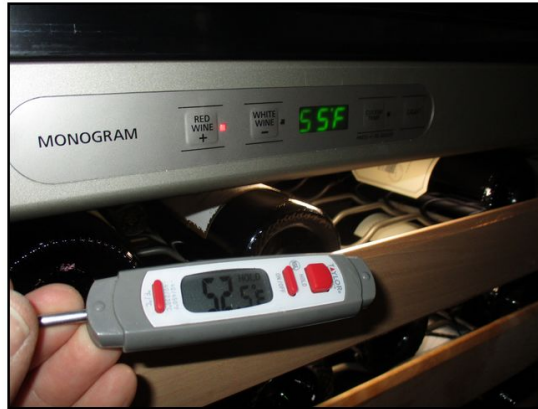
WINE COOLER: RIGHT: *Temperature measures:*

No significant deficiencies or anomalies observed at the time of inspection.

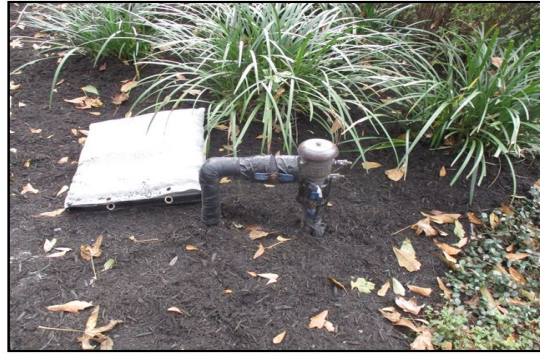
Code required back-flow prevention device on the sprinkler system is not installed at proper height - a minimum of 6" above highest the head. Per IRC 2902.3

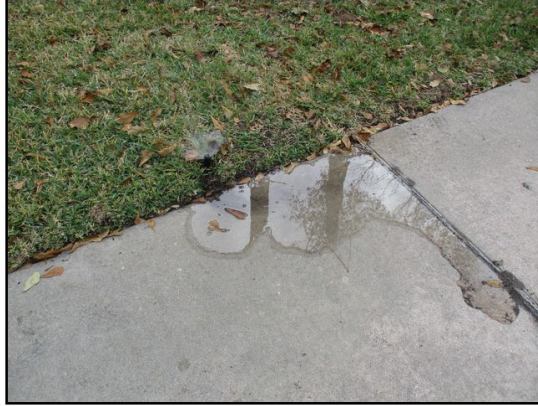
Low pressure noted to one or more sprinkler heads; zone # 9.
