# **Inspection Report**

1115 W 15TH STREET Houston TX 77008

## PROPERTY INSPECTION REPORT

Prepared For:	Mr. Tim Davis			
	(Name of Client)			
Concerning: 1115 W 15TH STREET, Houston, TX 77008				
	(Address or Other Identification of Inspected Property)			
Ву:	Damien Stout. TREC#20374 / Prolook Home Inspections	8/6/2019		
	(Name and License Number of Inspector)	(Date)		
	(Name, License Number of Sponsoring Inspector)

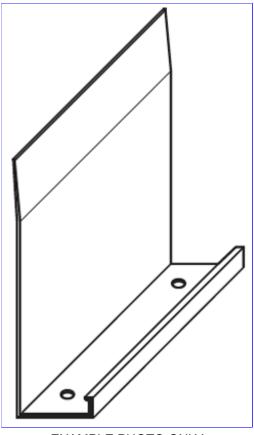
(3) The right side of the homes exterior siding was not readily accessible for inspection at this time. This side of the home is on the neighboring property which was not entered. I viewed the wall structure to the best of my ability with no obvious signs of damage or deficiencies found during the inspection. NOTE: Not fully inspected.
