## Property Inspection Report

1109 Eugene St, Port Neches, TX 77651  
Inspection prepared for: Cynthia Lusignolo  
Real Estate Agent: Melissa White - Remax One

Date of Inspection: 4/28/2021 Time: 10:00 am  
Weather: Fair

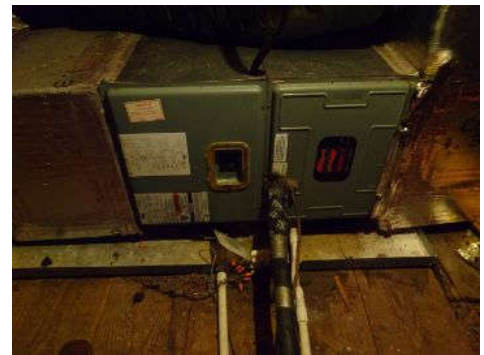
HEATING, VENTILATION AND AIR CONDITIONING SYSTEMS Heating Equipment

There is no insulation on the primary drain line in the attic from coils as required.

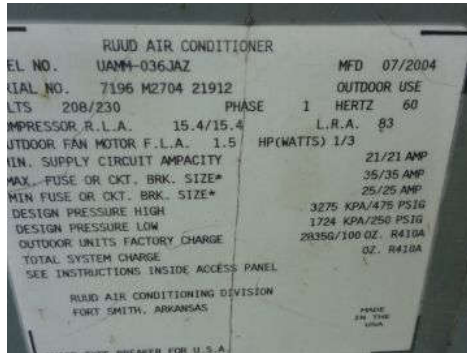
HEATING, VENTILATION AND AIR CONDITIONING SYSTEMS Cooling Equipment

The exterior condensing unit is un level at time of inspection, unit should be level on its foundation / pad.

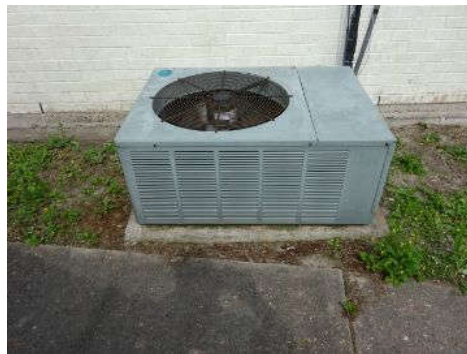
HEATING, VENTILATION AND AIR CONDITIONING SYSTEMS Cooling Equipment

Missing / worn insulation at suction line at exterior AC unit.

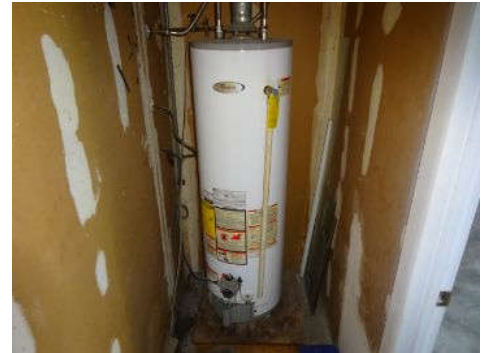
PLUMBING SYSTEM Water Heating Equipment

Observed surface rust to upper supply fitting atop water heater.
