# HOUSTON INSPECTIONS

**Clayton Carlson  
6130 Sugar Hill Dr  
Houston, TX 77057**

**March 21, 2019**

## PROPERTY INSPECTION REPORT

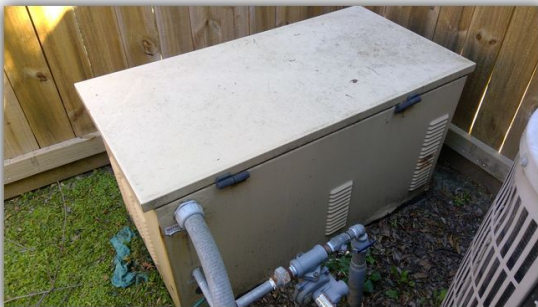
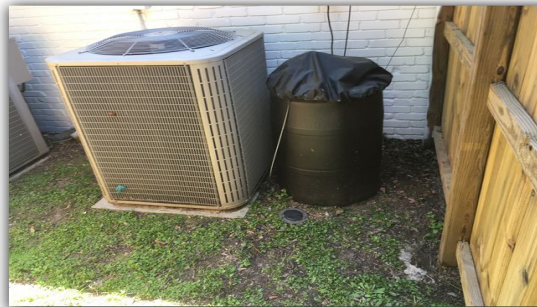
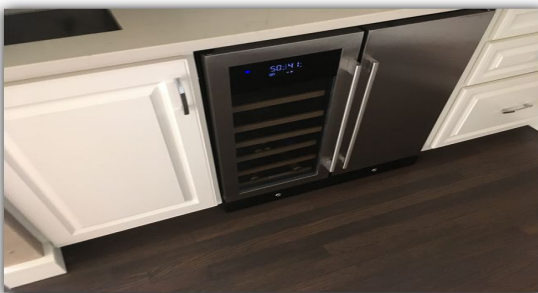
1. Generator
2. Wine chiller
3. Espresso/Coffee machine
4. Mosquito system

These systems are beyond the scope of this inspection and were not inspected. The client is urged to have the system(s) along with associated components evaluated prior to closing to insure proper installation and performance.

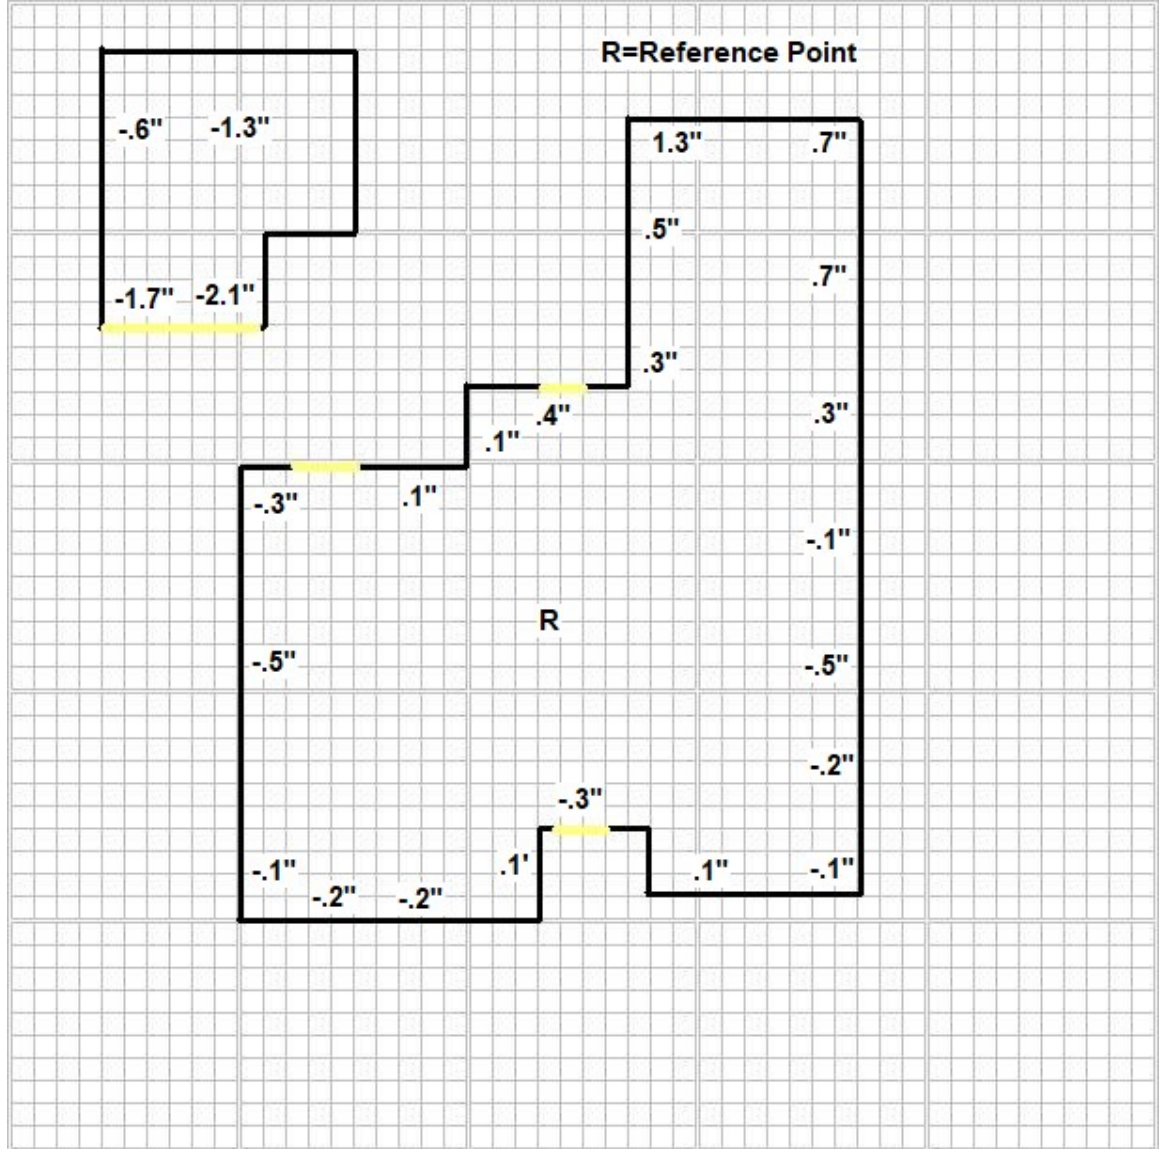
The below graph reflects measurements taken during the inspection to assist with determining the performance of the foundation. The outline / drawing is not to scale and does not accurately reflect every detail of the foundation walls.

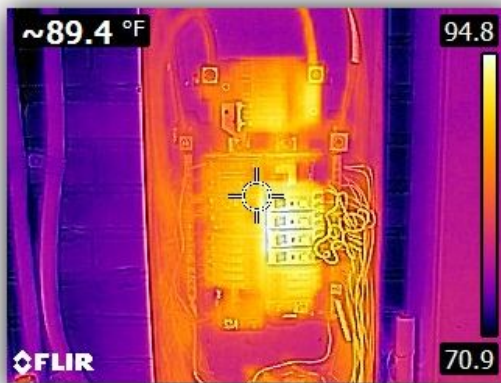
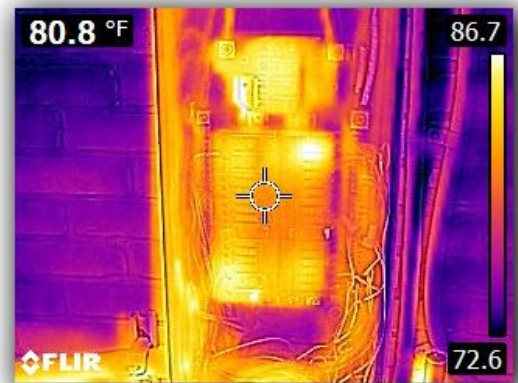
During the inspection of the electrical panel with a infrared camera significant abnormalities were not noted. The picture(s) below are a sampling of some image(s) taken during the inspection.

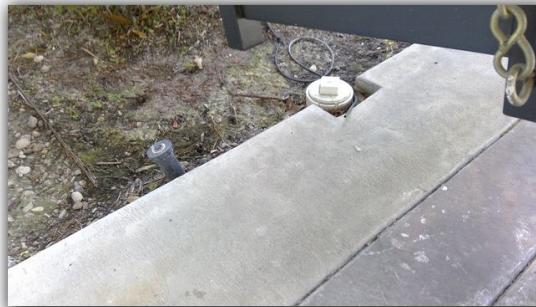
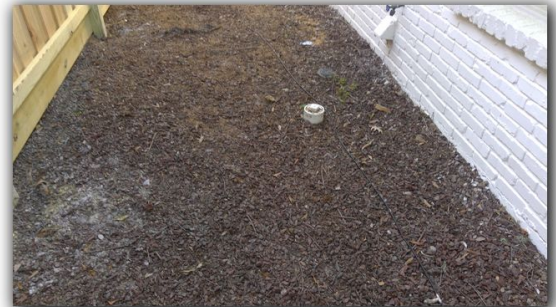
**Main Sewer Cleanout Location:** Multiple

- PVC piping exposed on exterior not painted to protect from UV rays
- Improper style drain material installed at fixture, i.e. missing smooth rigid pipe.

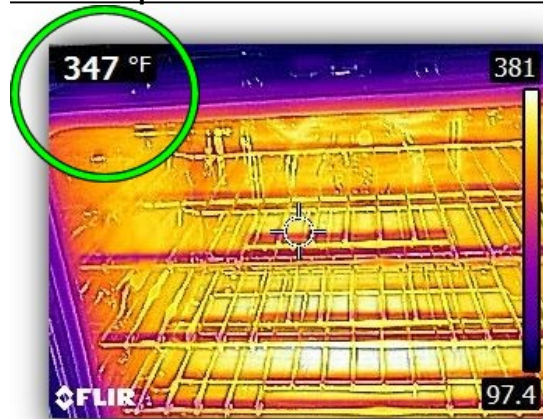
**Oven Temperature Measured When Set at 350 Degrees F = 347**

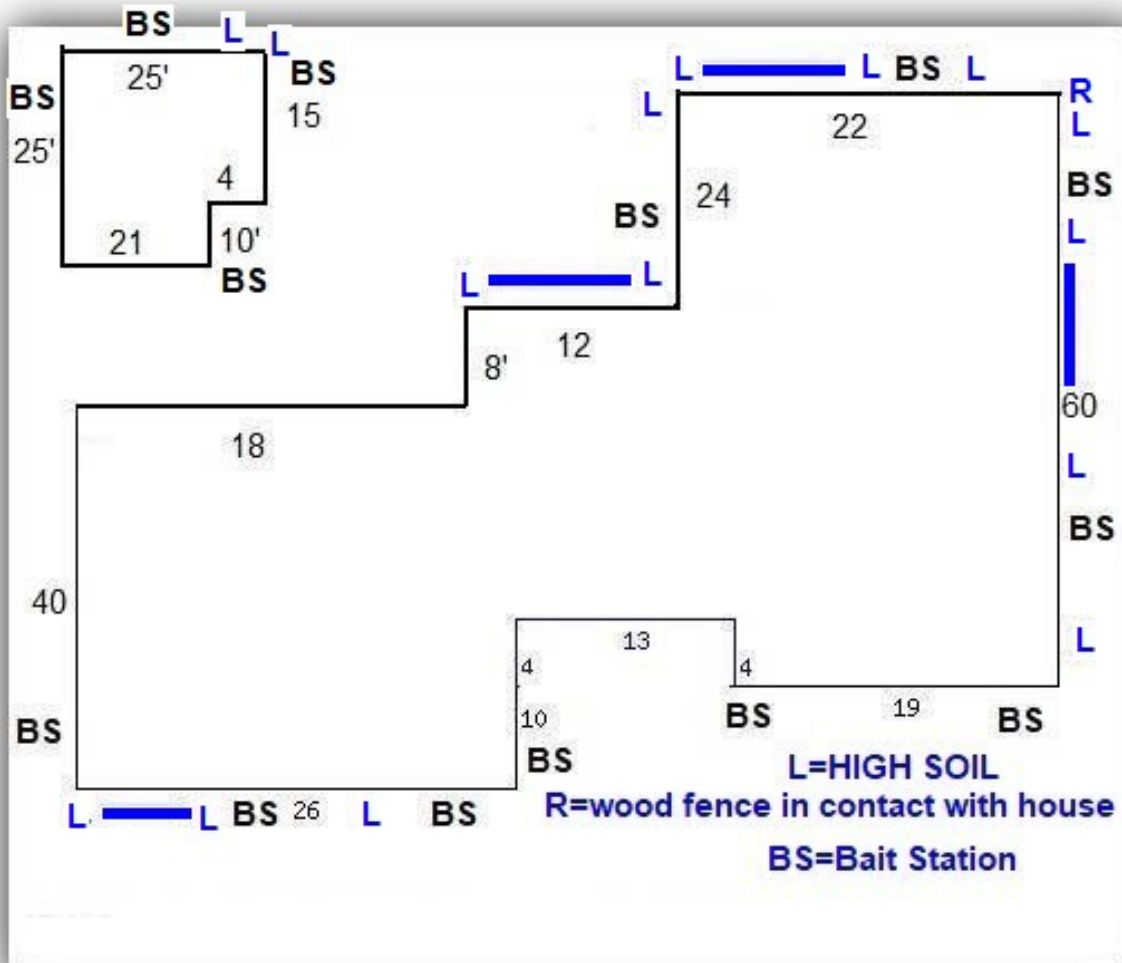
Diagram of Structure(s) Inspected

Additional Comments Conducive conditions were found during the inspection of the property, which could conceal insect activity or promote future insect activity or conceal damage. DUE TO THE CONDUCTIVE CONDITIONS FOUND WE CANNOT GUARANTEE THE ABSENCE OF WOOD DESTROYING INSECTS. The conducive conditions should be corrected. After the conducive conditions have been corrected it is recommended that the property be re-inspected for wood destroying insects. The client should take into consideration the cost of associated with correcting the conducive and / or performing a subterranean termite treatment and plan accordingly.
