SELLER'S DISCLOSURE NOTICE

CONCERNING THE PROPERTY AT 3311 Sunset Field Ln Missouri City TX 77459

Client: Alberto Bazan / 346-816-8149 / Email: 4bazans@comcast.net
Inspection Date: February 20, 2019
Project Address: 3311 Sunset Field Missouri City Texas 77459
Propose Repair: Installation of 34 Exterior Pilings and 20 Interior Pilings

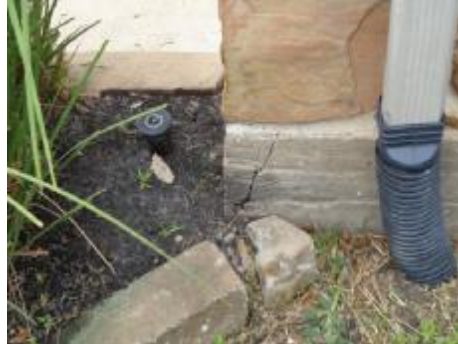
Popped corner front right

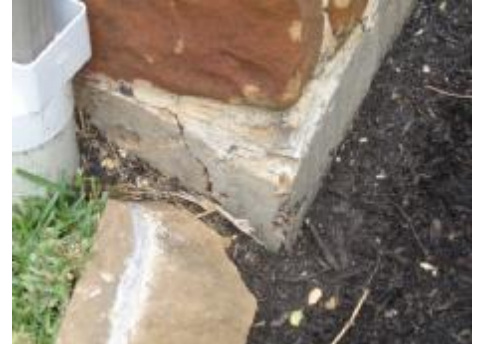
Popped corner left front

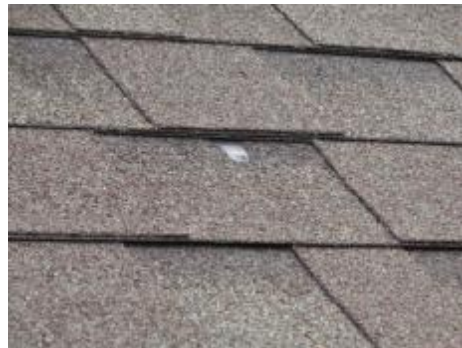
Roof aggregate loss

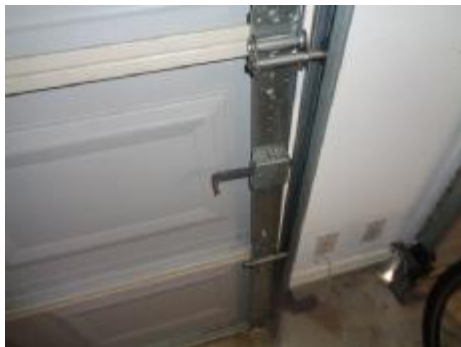
Comments: The manual lock was not disabled properly. Install a bolt lock to allow manual lock to work. The garage door sensors are not below 6 inches. Adjust garage door sensors to be 6 inches or lower.

Garage bolt lock

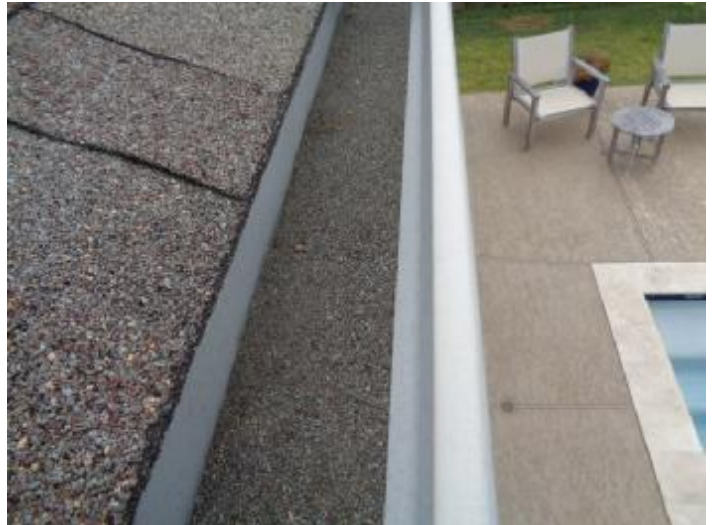
Gutter clogged with debris (Close up)

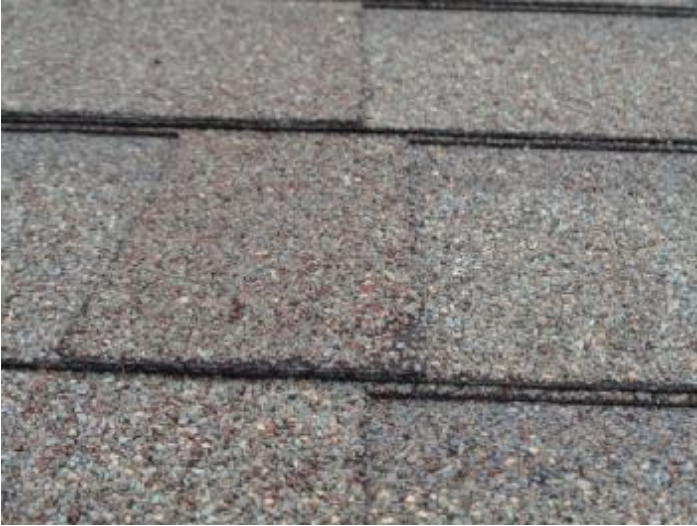
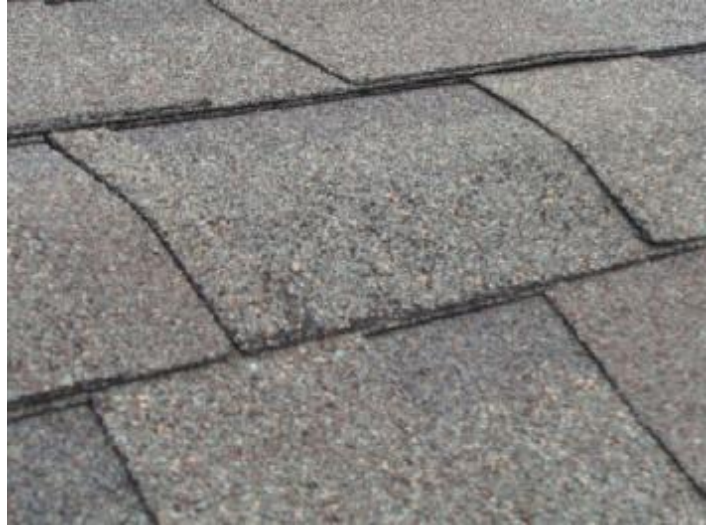
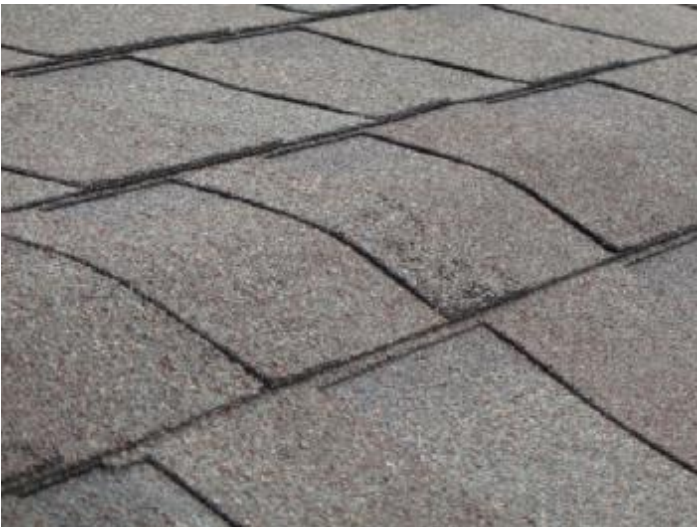
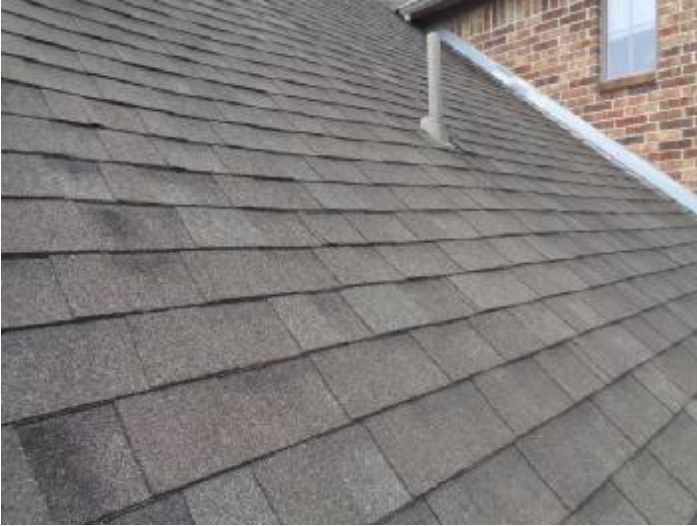
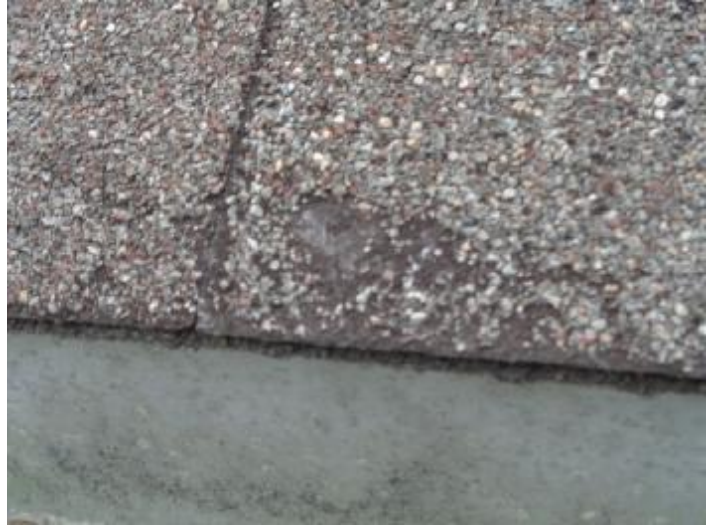
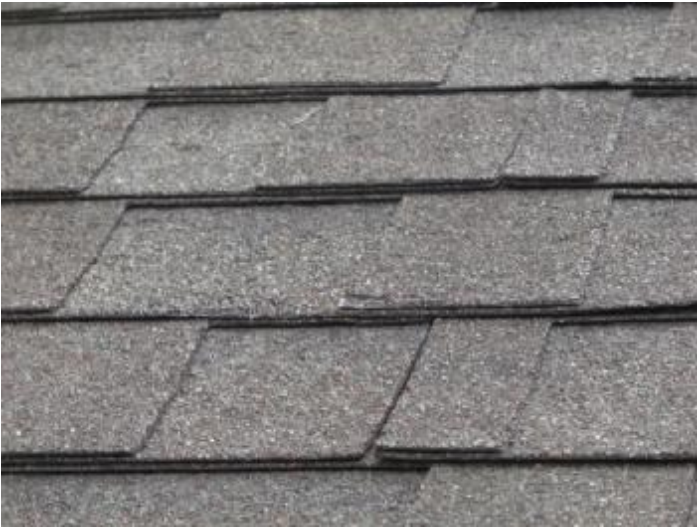
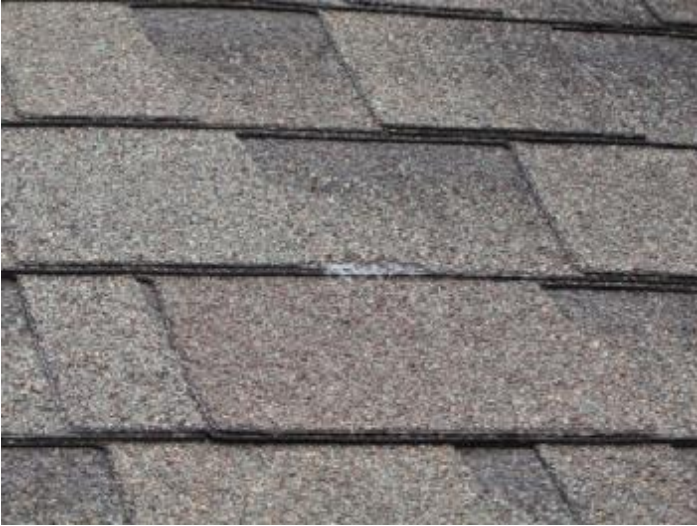
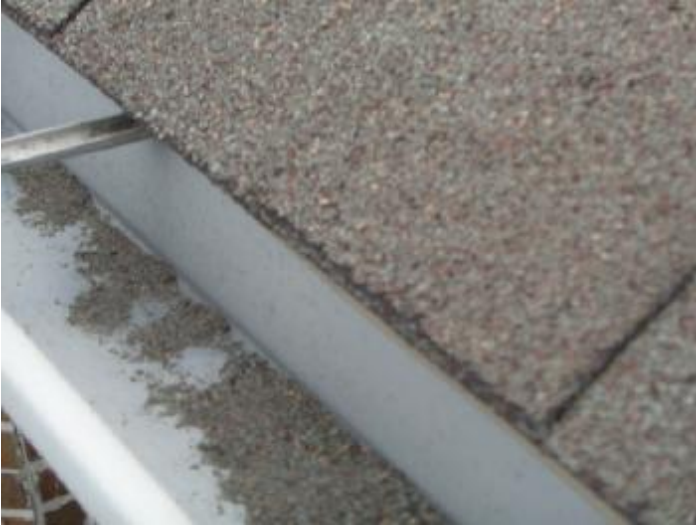
Granular/aggregate loss at roof surface

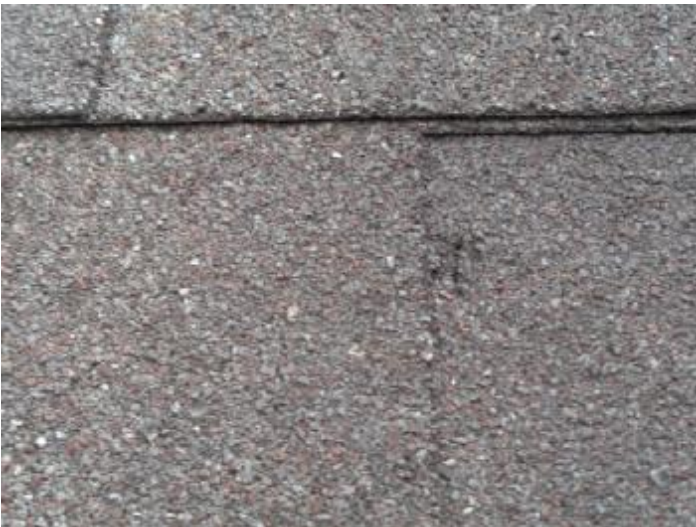
Pitting at rear of roof

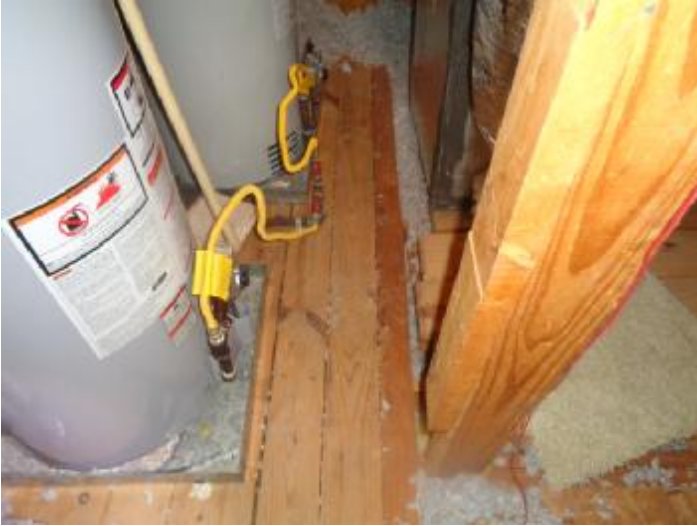
Service platform at water heaters is undersized

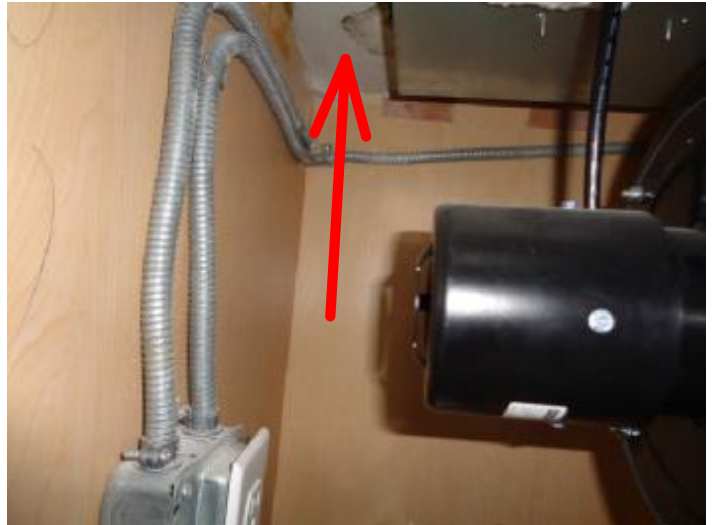
Suspected fungal growth in the cabinet below the stovetop at the top of the cabinet

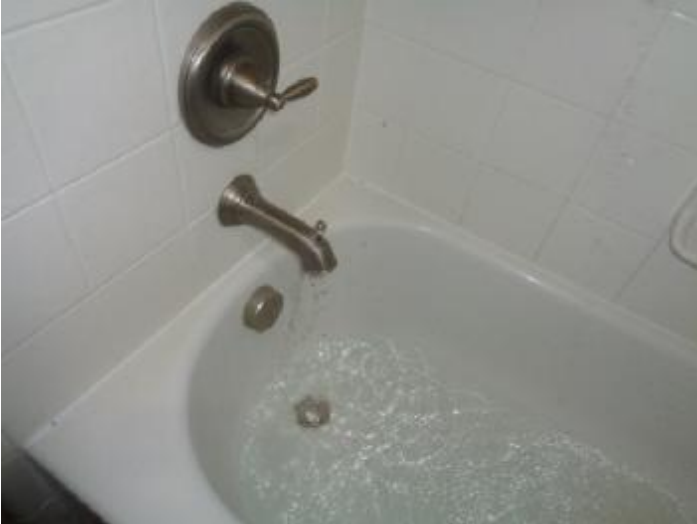
Shower diverter does not direct all water to shower head when in shower position in 2nd floor hall bath

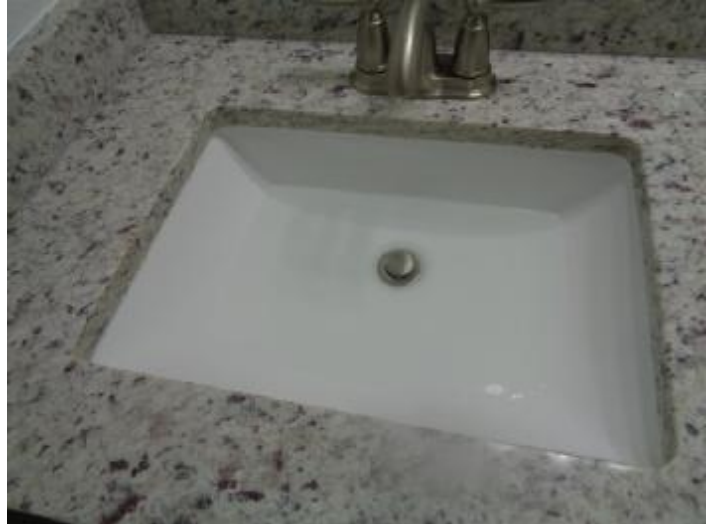
Drain stopper inoperative at sink in 2nd floor hall bath

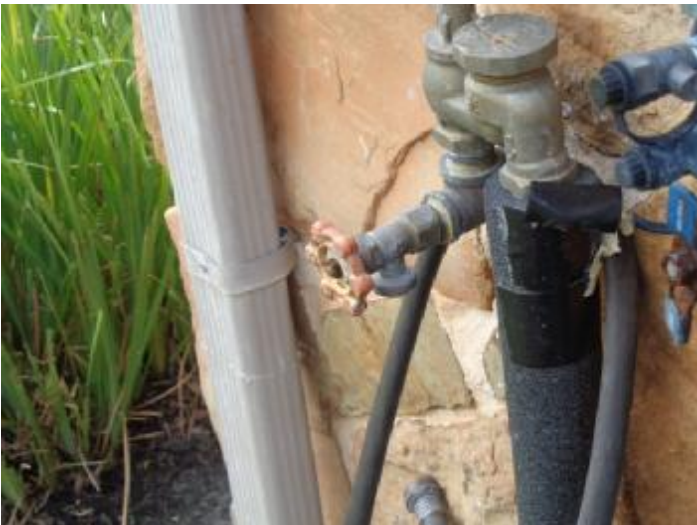
Right front hose faucet lacks an anti-siphon device

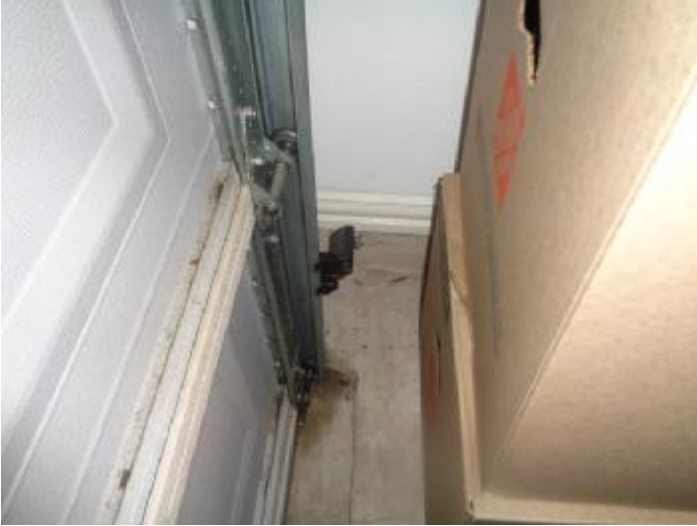
Electronic eye sensors installed to high from garage floor

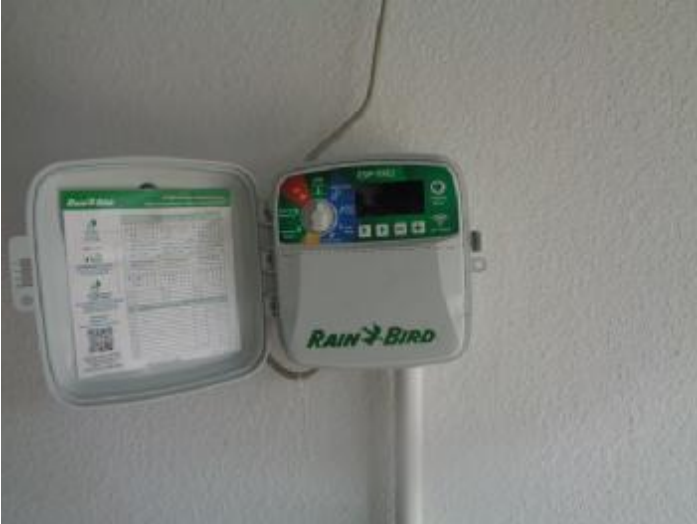
Sprinkler system control box

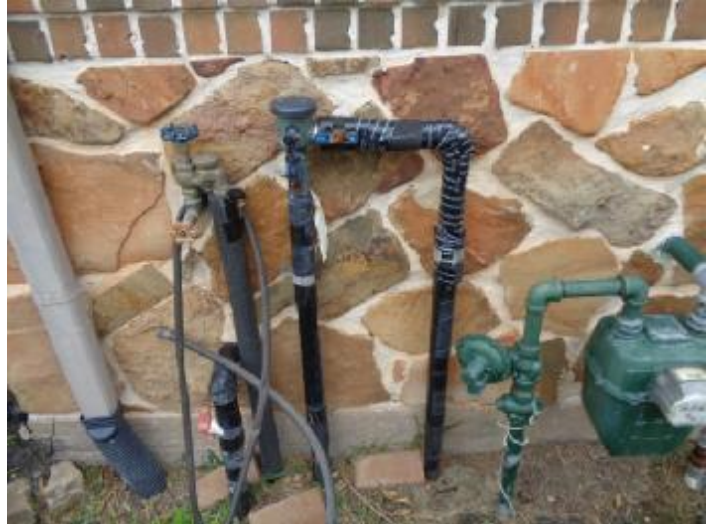
Sprinkler system backflow prevention device
