### HOME INSPECTION REPORT

# PROPERTY INSPECTION REPORT

**Concerning:** 275 County Rd 3015, Dayton, TX, 77535  
 (Address or Other Identification of Inspected Property)

**By:** Charles Rowden 22155 Tina Paz 24081 Bertrand Lemelle 24610 5-26-2021  
 (Name and License Number of Inspector) (Date)

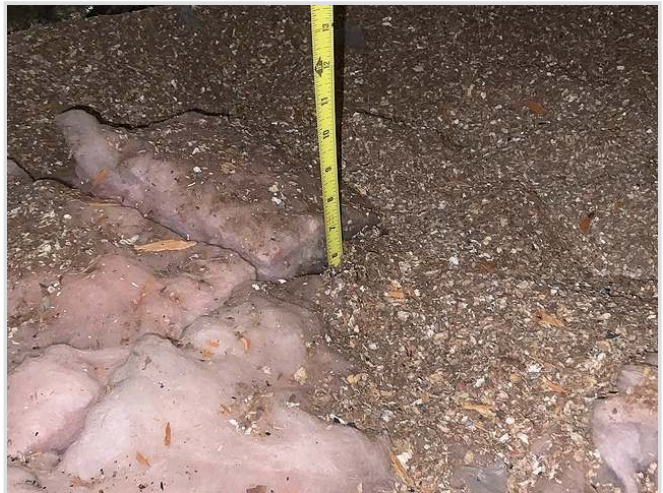
Insulation depth (approximately 12" - 14")

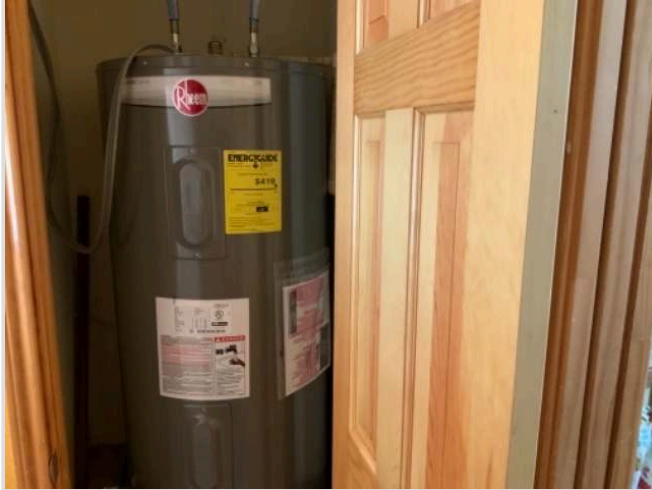
Water heater (utility room closet)

Relief valve was not tested (discharge pipe into wall)

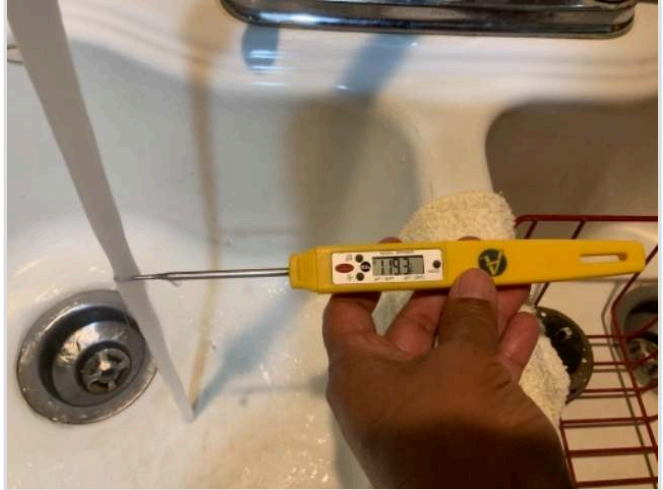
Measured water temperature at kitchen sink (119.3)

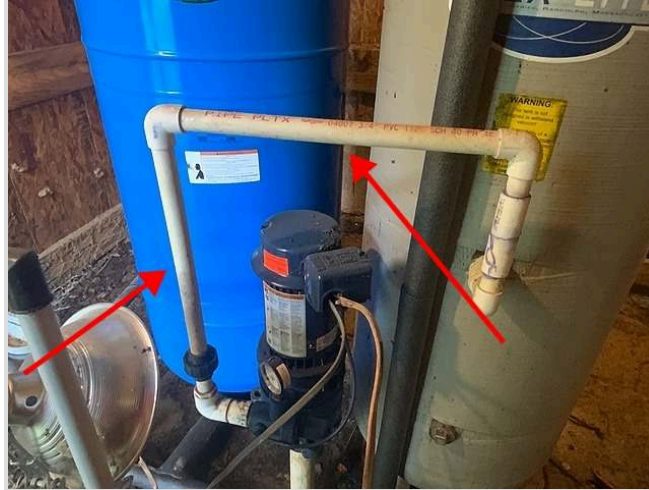
Portions of the visible water supply piping were not sufficiently insulated against freezing temperatures. All hot and cold water piping in non-air conditioned spaces should be protected from freezing. (UPC 313.6).

Supply pipe not insulated
