PROPERTY INSPECTION REPORT

3618 Appalachian Trail , Kingwood , TX 77345
Inspection prepared for: Matt Messer
Real Estate Agent: Open House - Open House

Date of Inspection: 3/17/2023 Time: 3:30 PM
Age of Home: 1990 Size: 1,778
Weather: Clear 53 Degs F
Structure Type: Structure is a wood framed structure
on a concrete slab foundation.

Inspector: Steve McElwee
License 21679
Deer Park, TX 77536

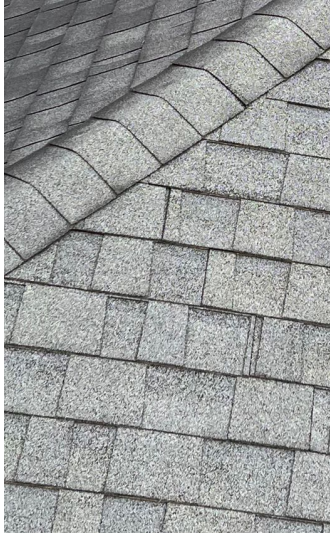
Picture of roof

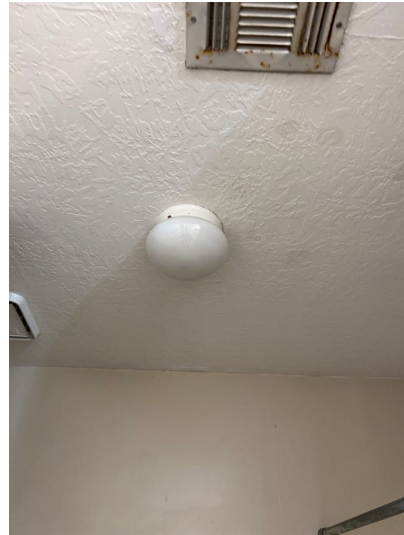
Light fixture not working

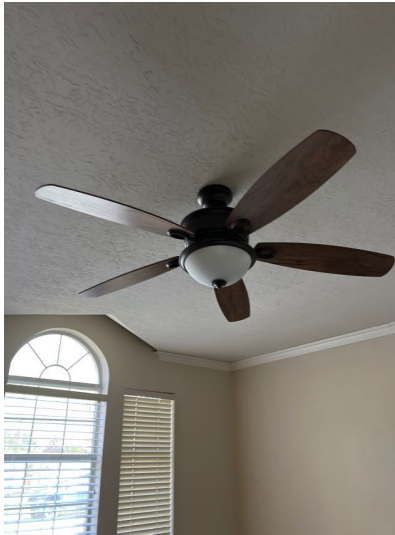
Ceiling fan not working
