Smith Group Property Inspections

Property Inspection Report

12223 Kingslake Forest Dr, Houston, TX 77044
Inspection prepared for: Edwin Jimenez

Date of Inspection: 04/05/2023 Time: 8:00AM
Age of Home: 1980 Size: 1248 sqft

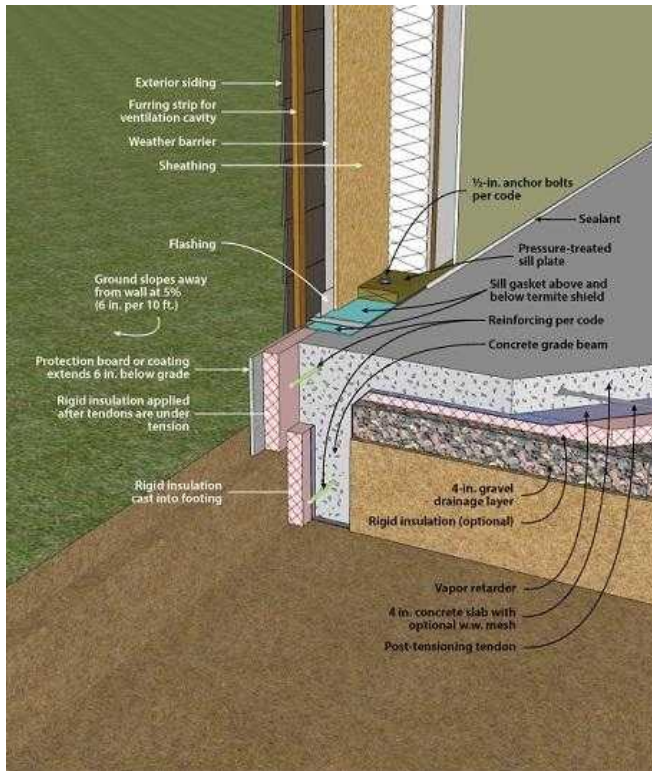
Exposed tensioning cables can possibly allow moisture / pest intrusion.

Correction recommended by qualified contractor.

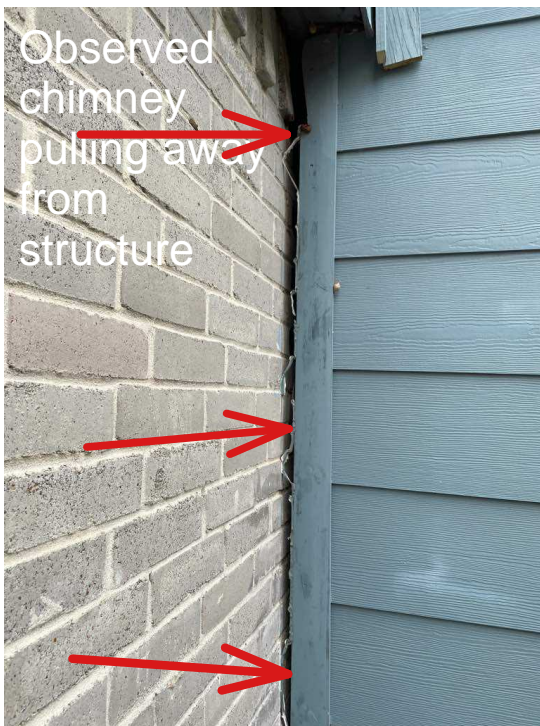
2. Unable to test fire place due to being a wood-burning fireplace.

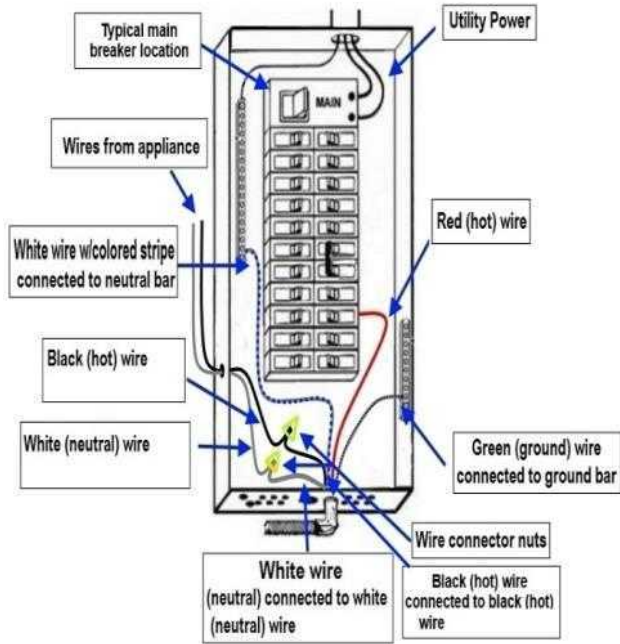
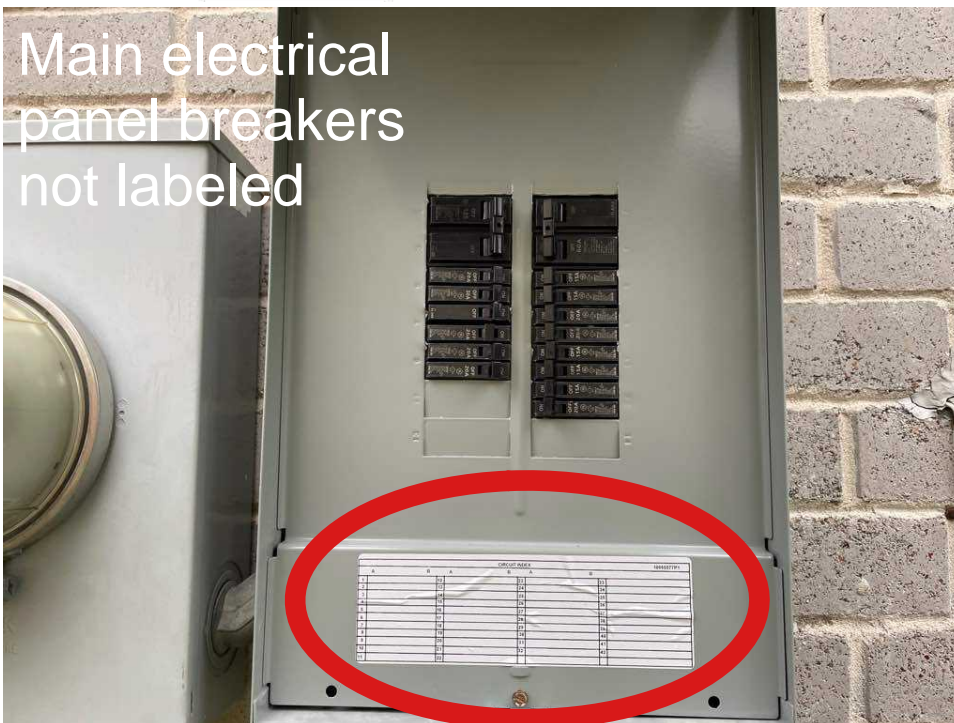
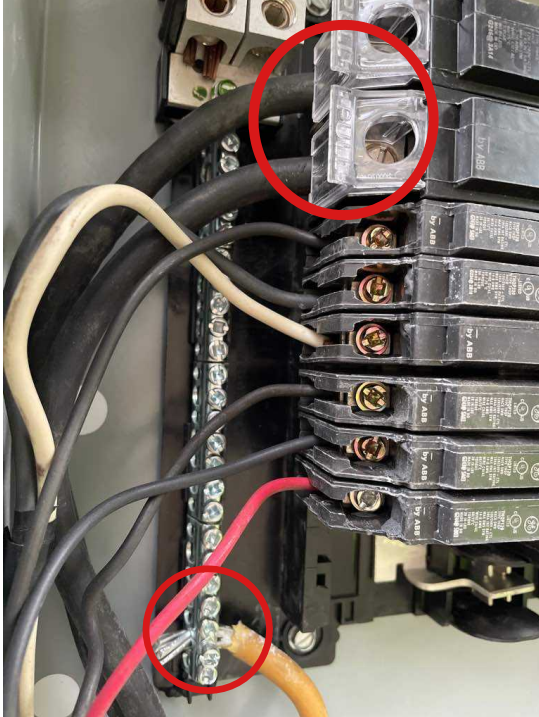
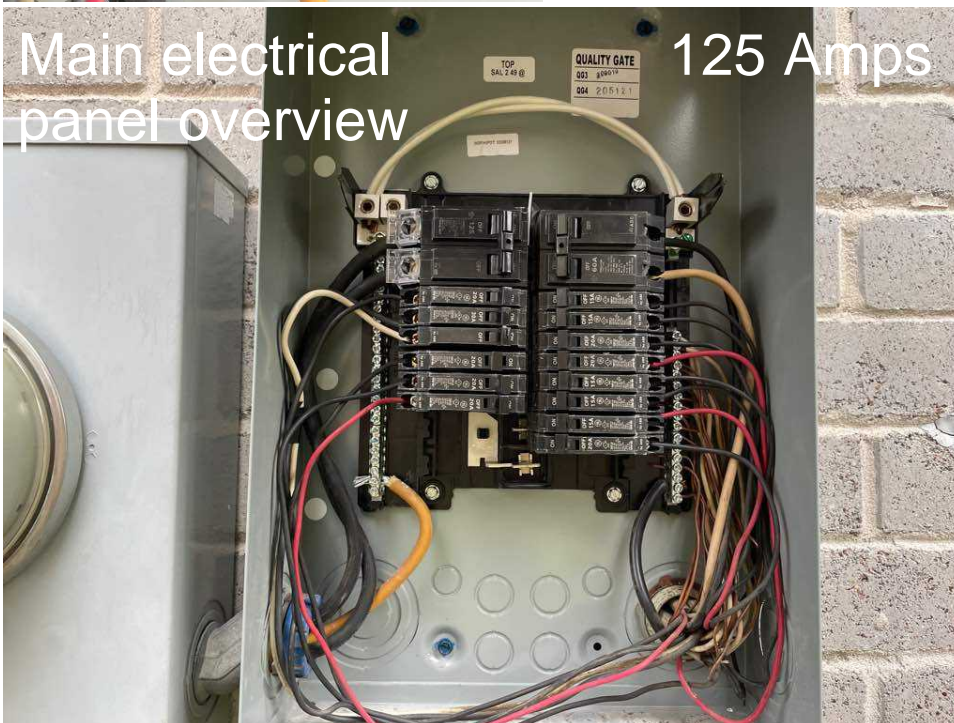
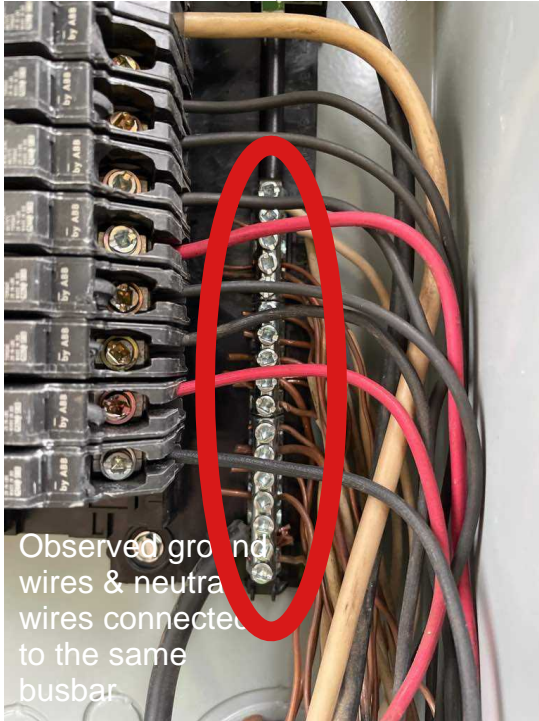
2. No anti-oxidant paste observed at main electrical aluminum cables in panel.

Anti oxidant paste is recommended for aluminum cables because (without the paste) aluminum can overheat & become fire hazard.

3. Observed ground wires & neutral wires connected to the same busbar - potential safety item

Further evaluation & correction recommended by qualified contractor.

Further evaluation and correction recommended by qualified contractor

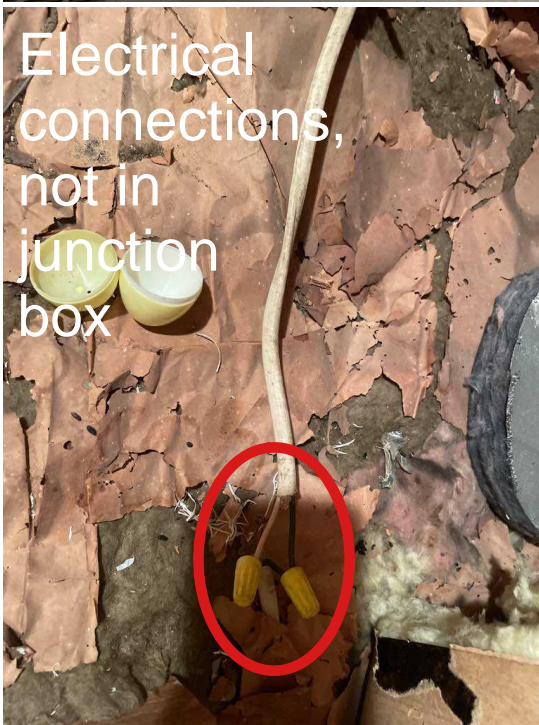
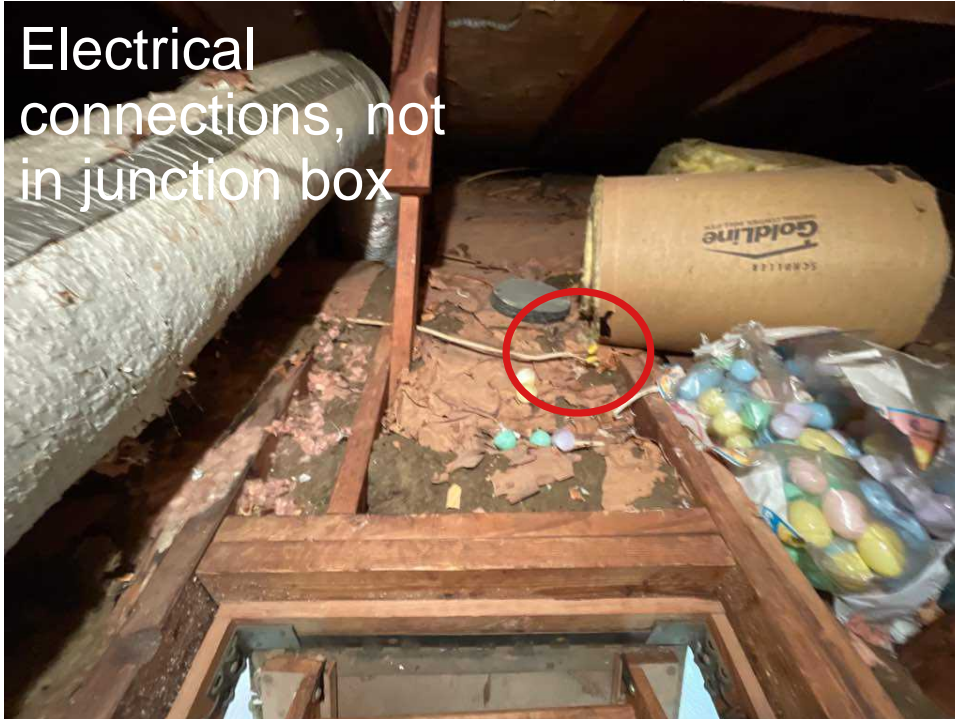
1. Electrical covers missing from outlets (multiple).

2. Observed electrical connections not made in junction box - safety item.

Correction recommended by qualified contractor.

Correction recommended by qualified contractor

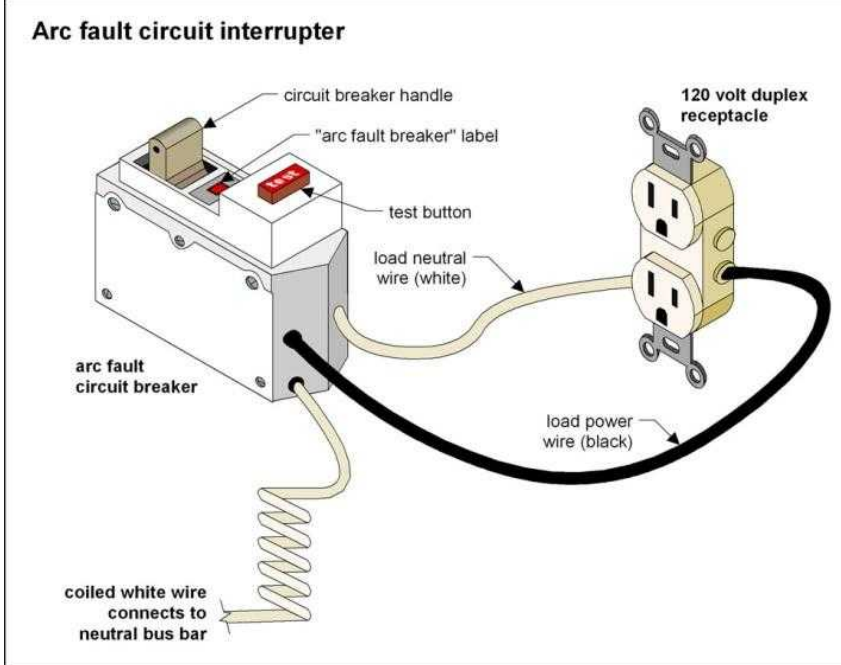
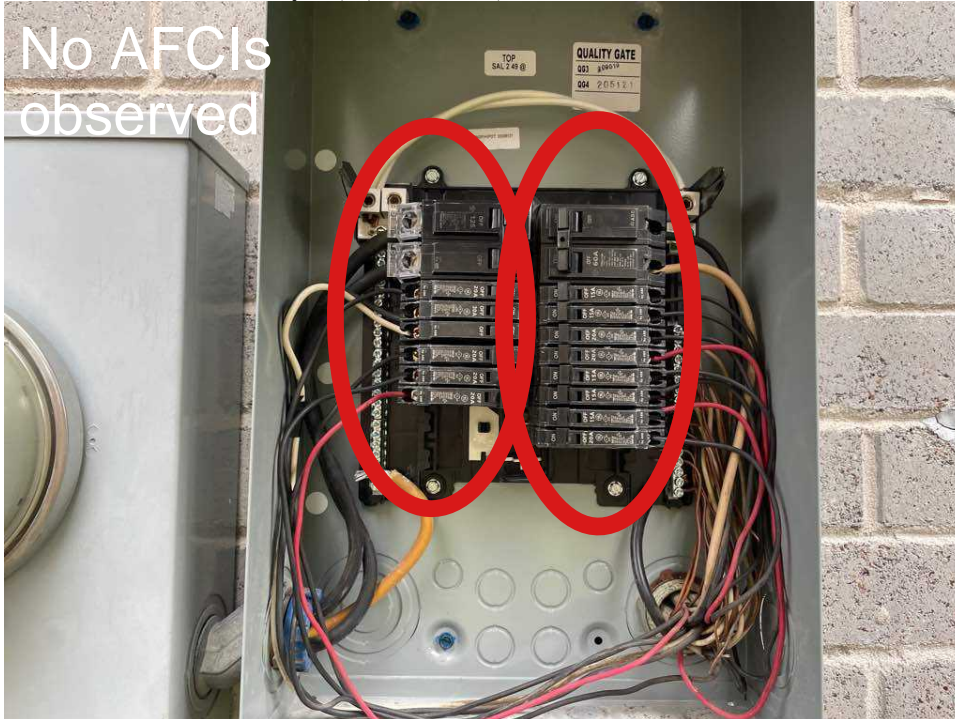
Comments: Arc Fault Circuit Interrupter: Required at by current building standards, Observe no installed AFCI (Arc Fault Circuit Interrupt) device protection, as required by current building standards, for all: family rooms, dining rooms, living rooms, parlors, libraries, dens, bedrooms, sunrooms, recreations rooms, closets, hallways, or similar rooms or areas.

AFCI devices are intended to protect against fires caused by electrical arcing faults in the homes wiring.

Arc faults are a common cause of residential electrical fires.

Arc faults can be created by damaged, deteriorated, or worn electrical plugs, cords, and/or branch circuit conductors.

deficient condition exists if any home does not have this protection, regardless of date the home was constructed

Correction recommended by qualified contractor.

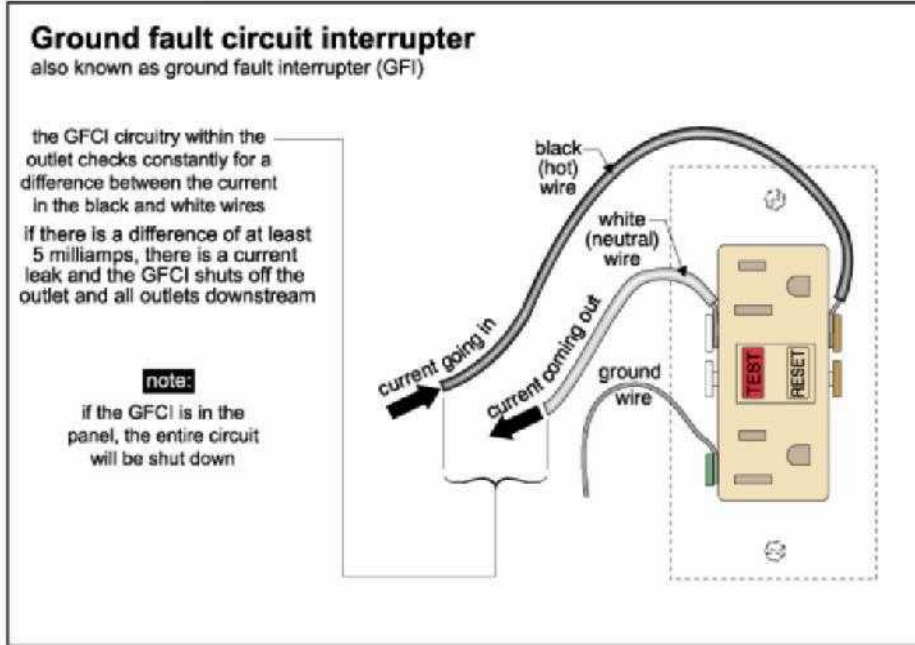
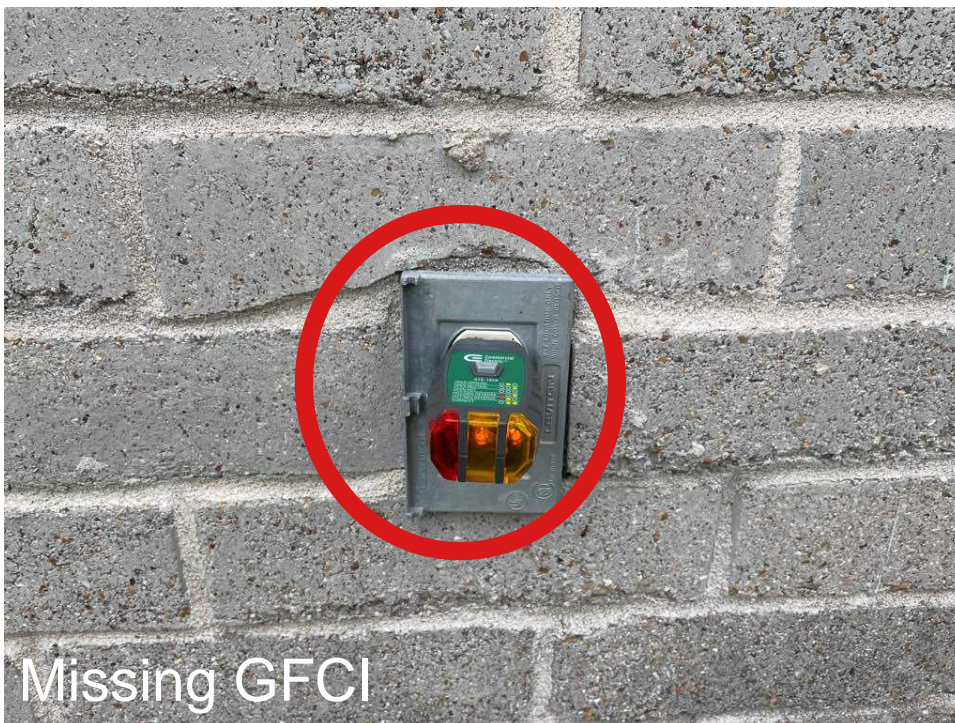
Comments: GFCIs (Required) Locations: Kitchen, Bathrooms, & Garage, Missing GFCIs observed at time of inspection (kitchen, bathrooms, & garage).

GFCIs are recommended for fire & electrical shock prevention.

Correction recommended by qualified contractor.

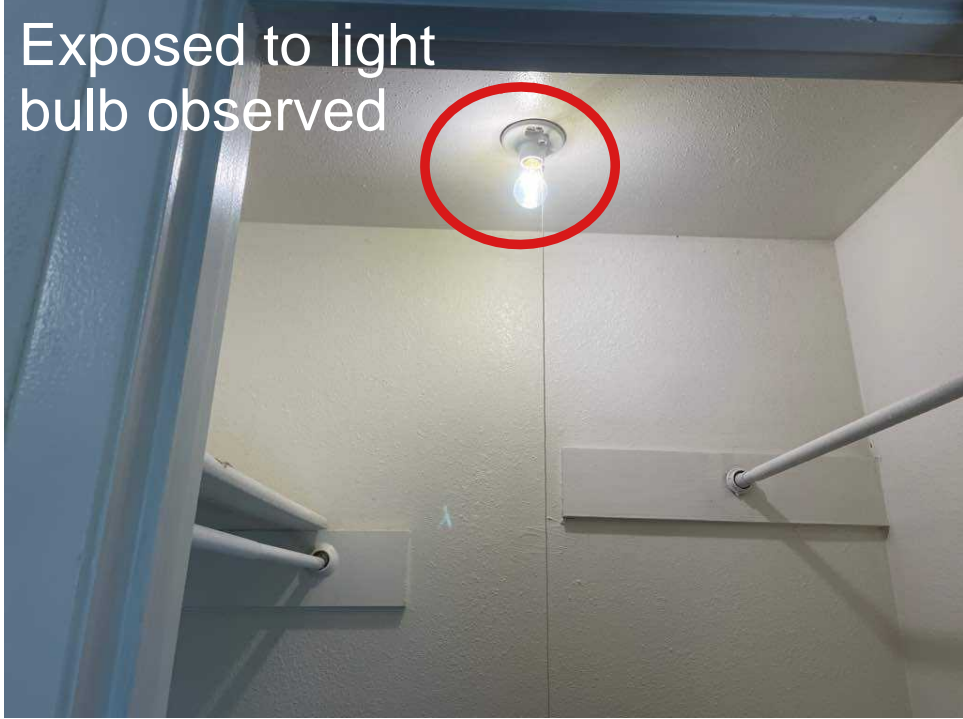
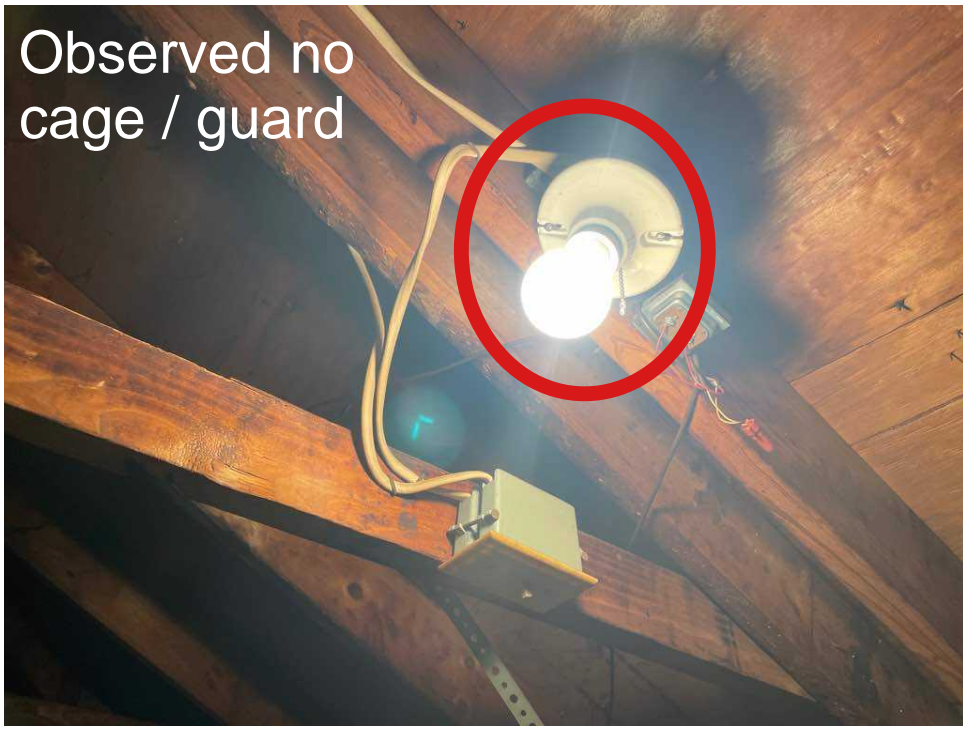
Comments: Interior / Exterior,
Observed no cage / guard for closet and attic light bulbs- safety item.

Correction recommended by qualified contractor

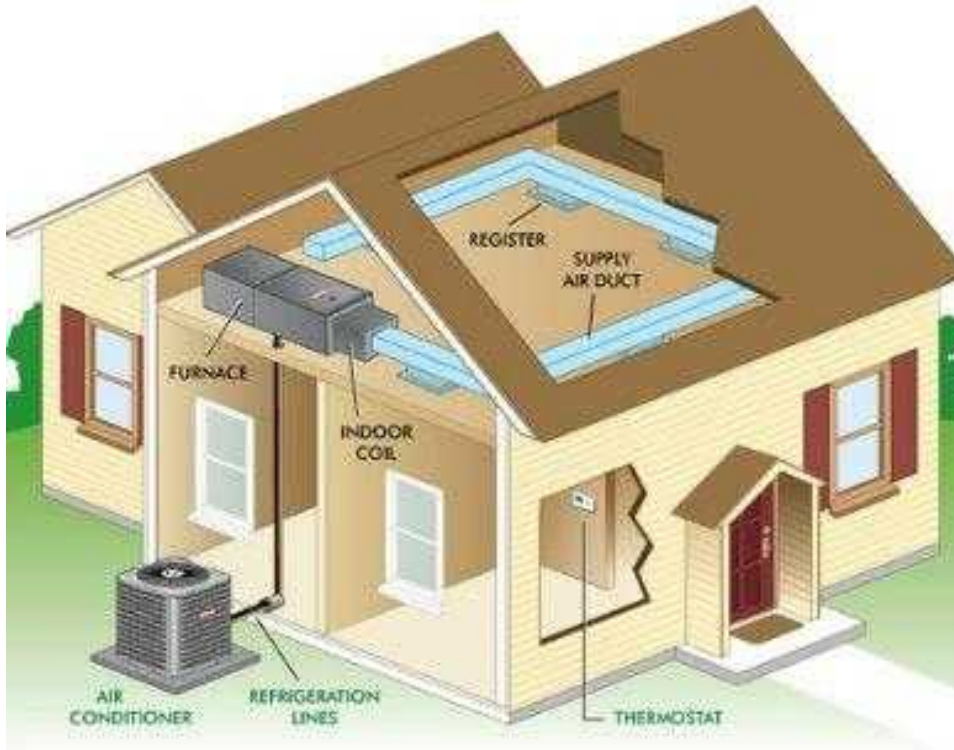
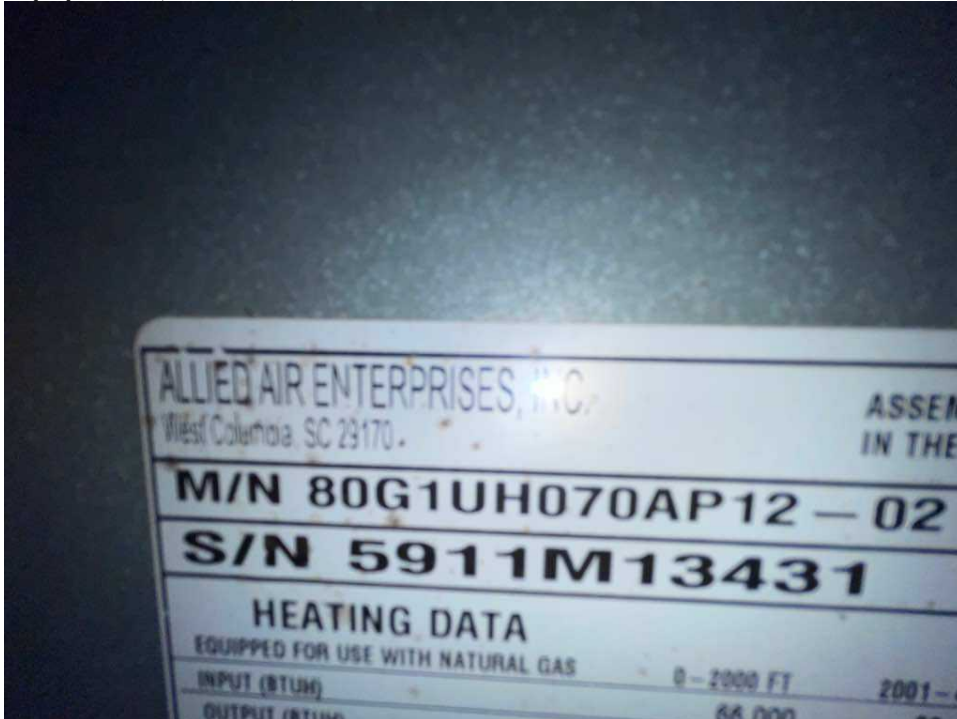
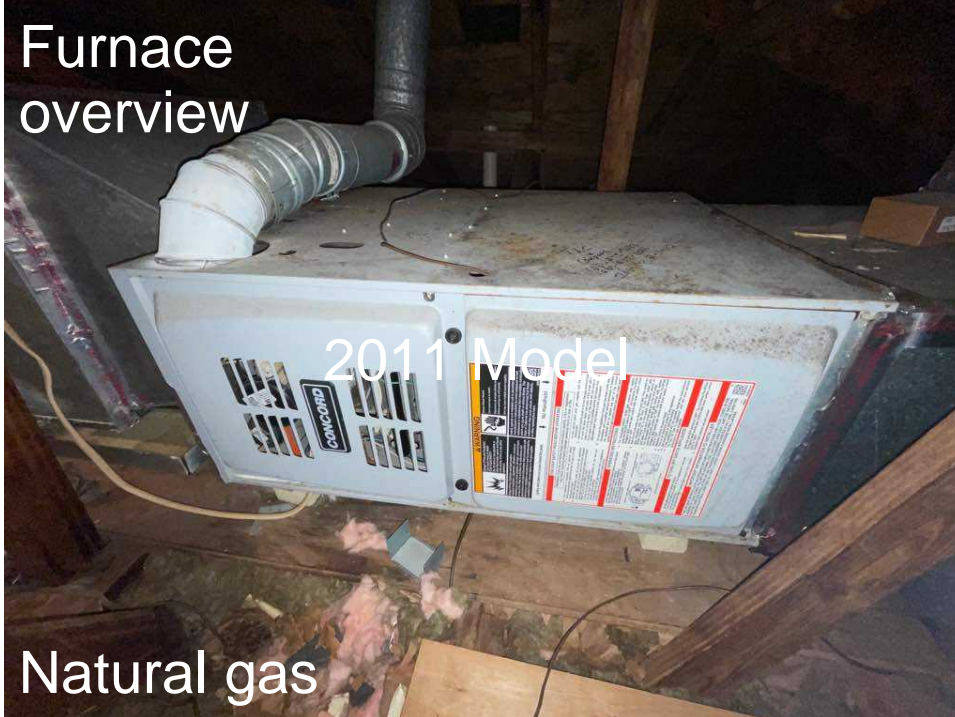
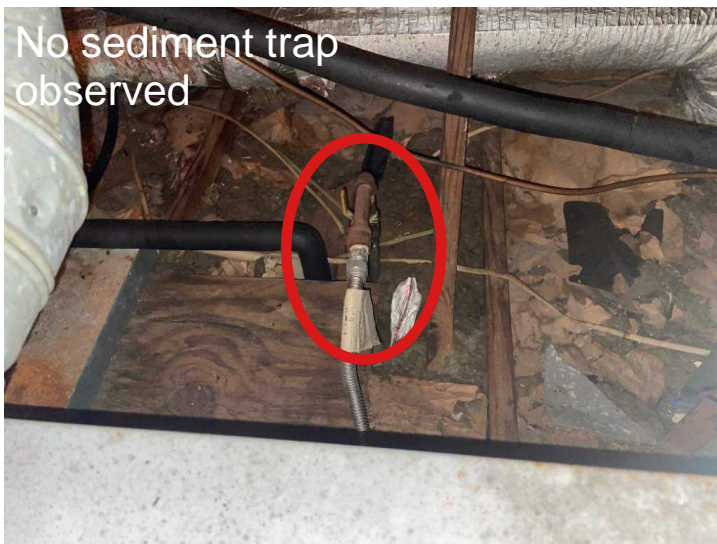
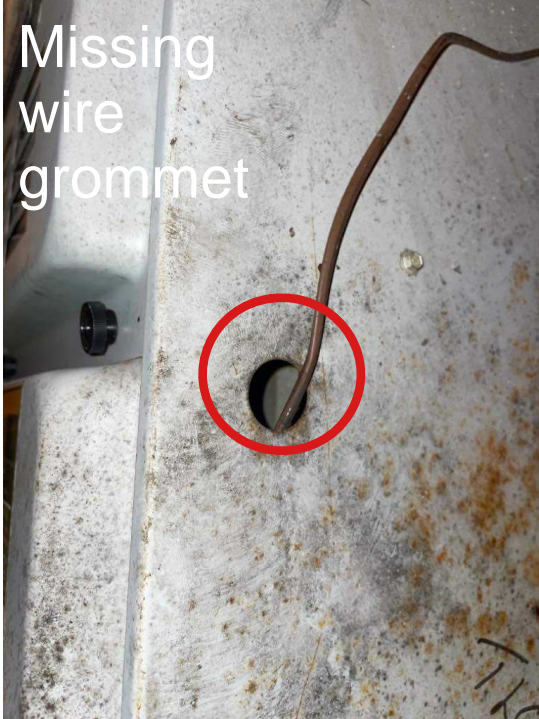
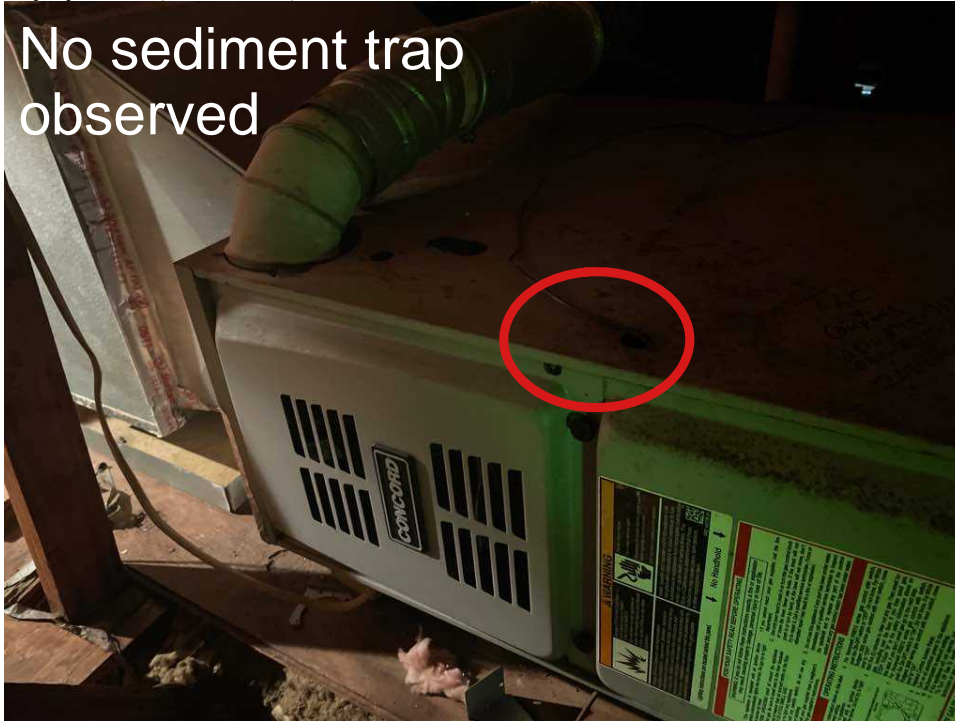
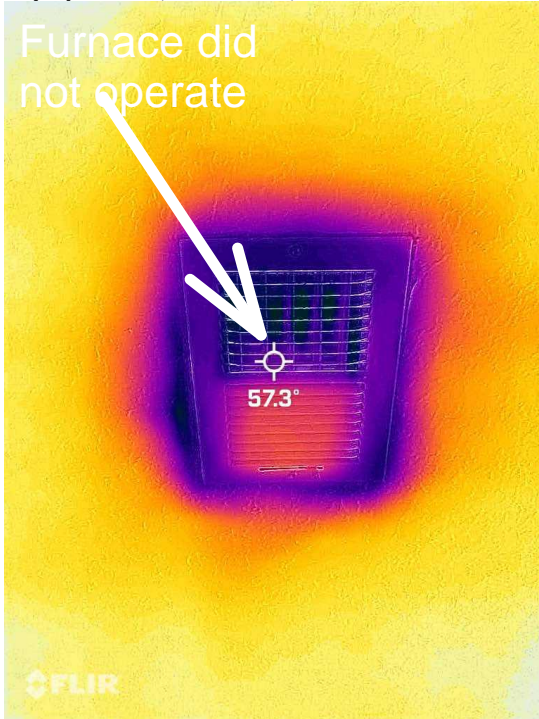
2. No sediment trap observed / installed at furnace at time of inspection.

3. Observed wires passing through furnace without protective grommet.

Correction recommended by qualified contractor.

Correction recommended by a qualified contractor to prevent wire damage.

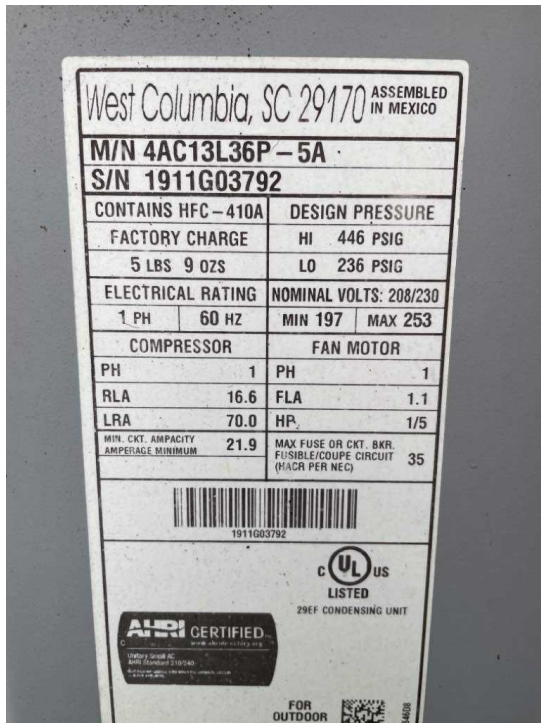
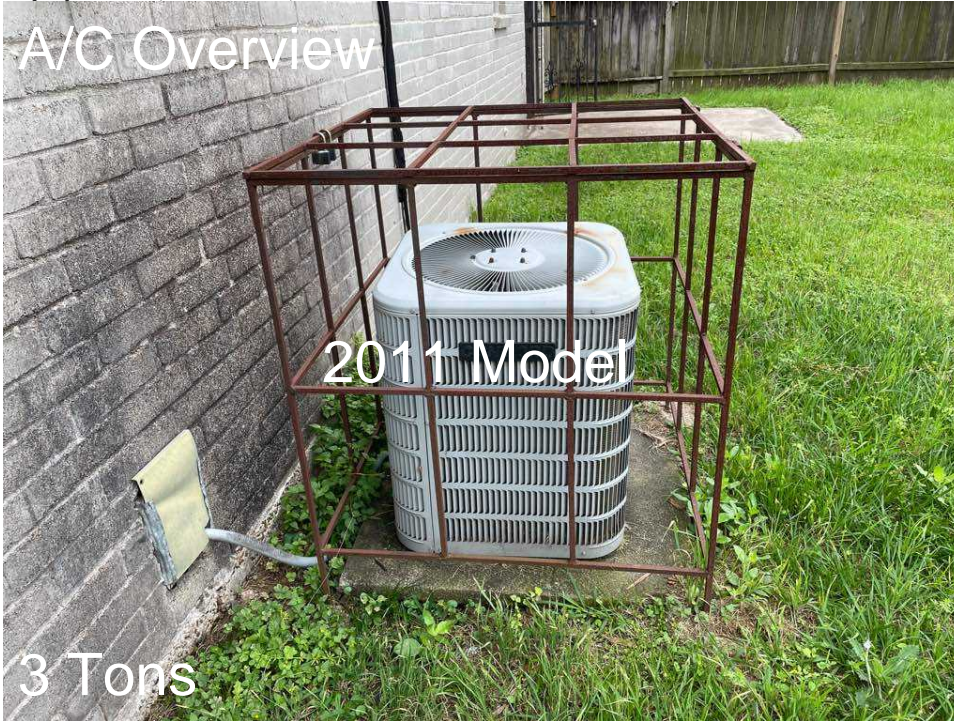
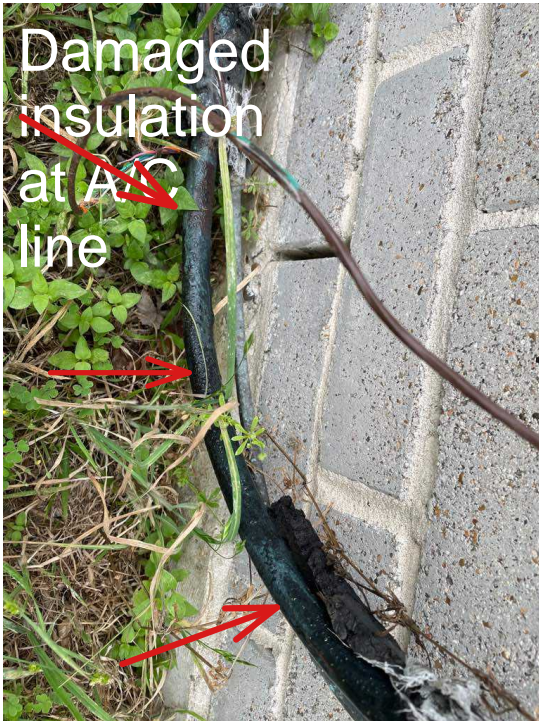
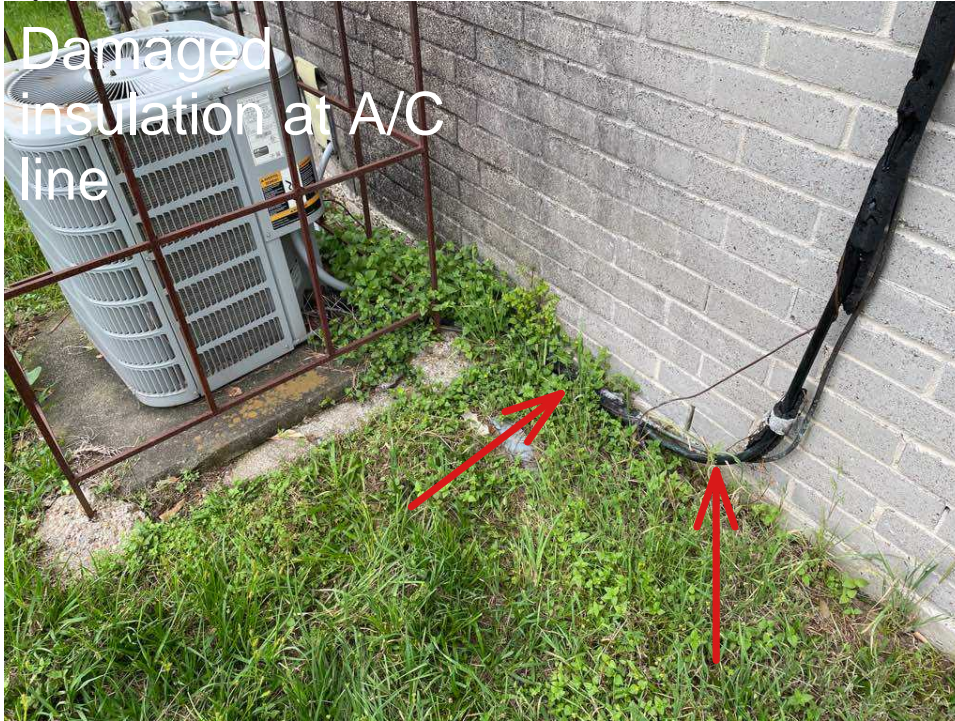
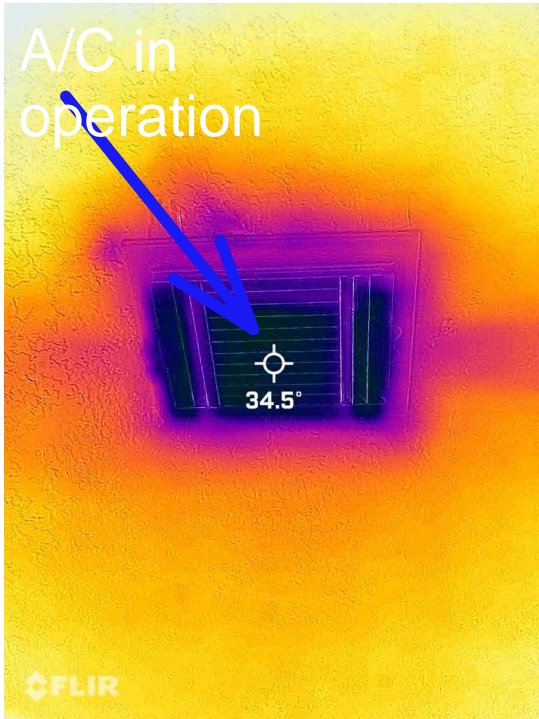
1. Damaged insulation at A/C line (exterior).

Insulation helps optimize A/C efficiency.

Correction recommended by qualified contractor.

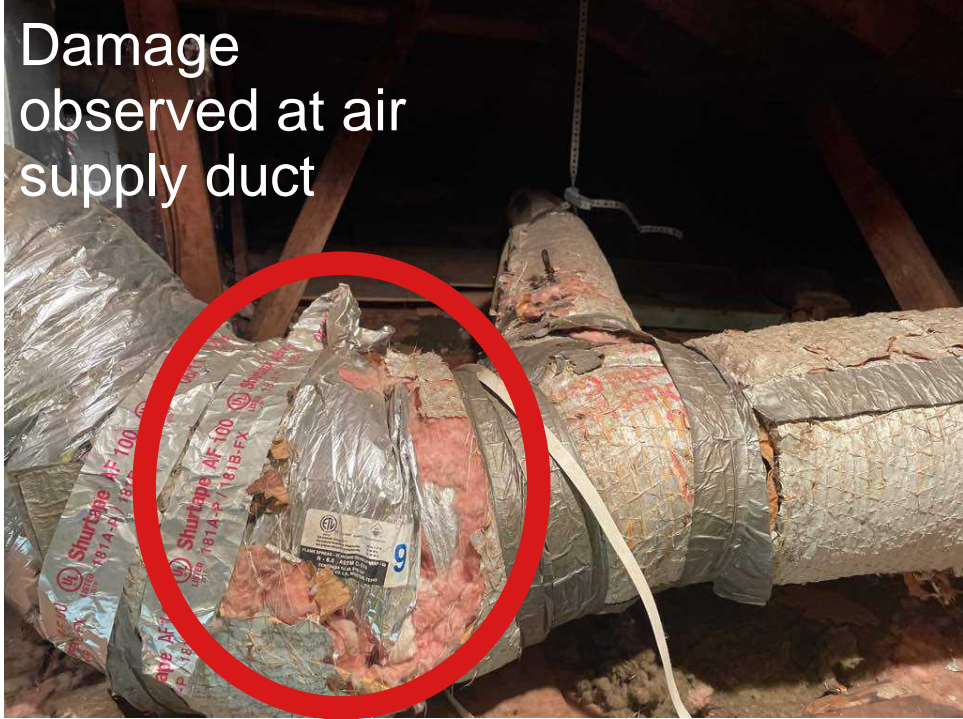
1. Damage observed at air supply duct in the attic.

Correction recommended by qualified contractor.

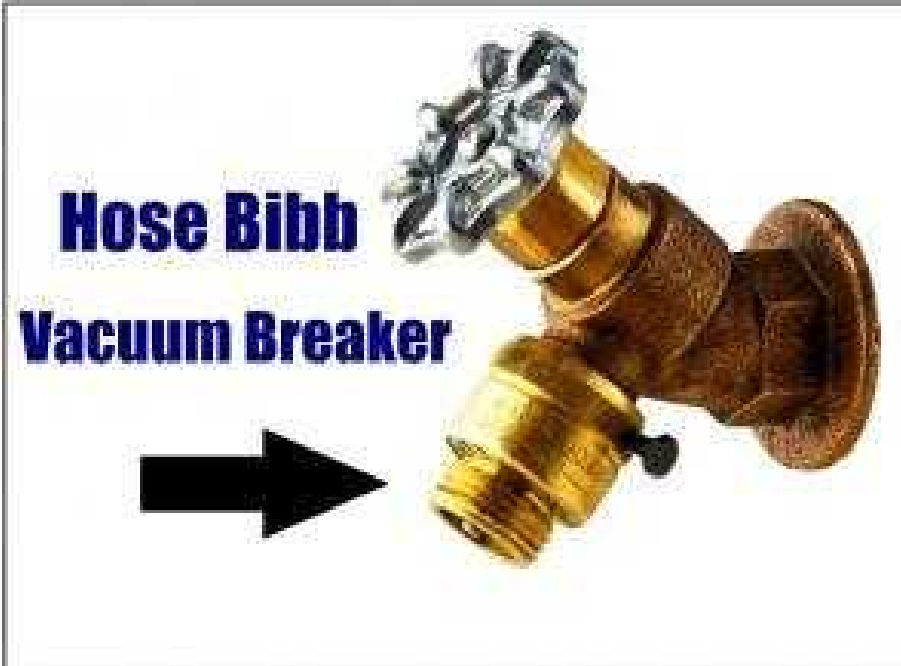
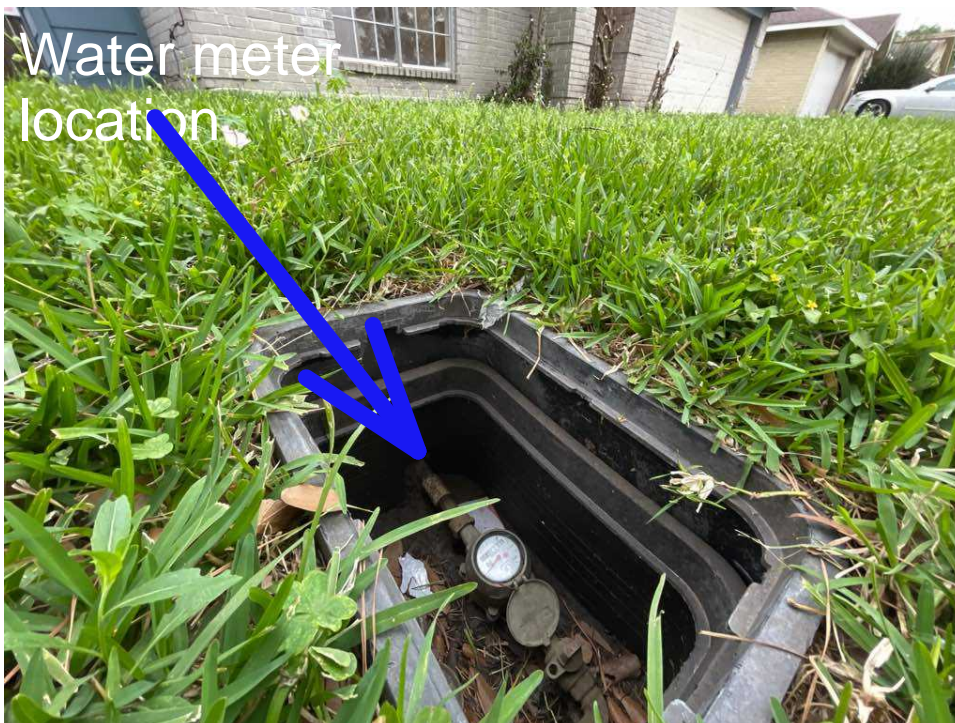
- 1. Observed damaged water meter casing lid.

- 3. Observed uninsulated water pipe at hose bib.

- 4. Observed insufficient water pressure.

Correction recommended by a qualified contractor to prevent unwanted debris entering water meter casing.

Correction recommended by qualified contractor to prevent freezing .

Further evaluation and correction recommended by a qualified contractor.

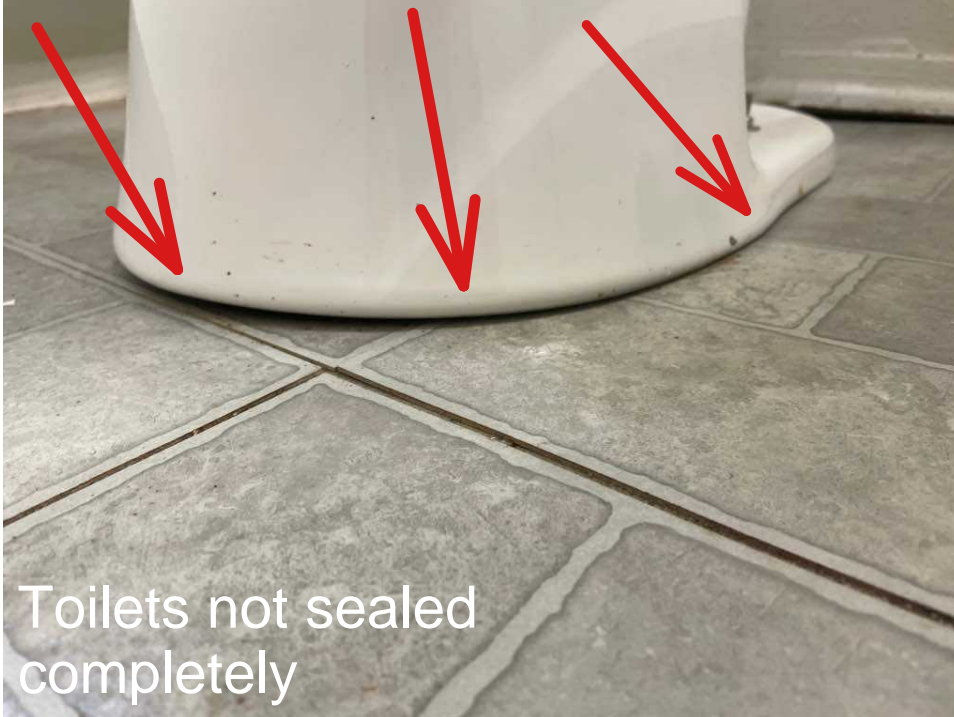
Comments: Flushing (Two-Piece) Toilet,
1. Observed toilet loose at floor mounting.

Correction recommended by qualified contractor.

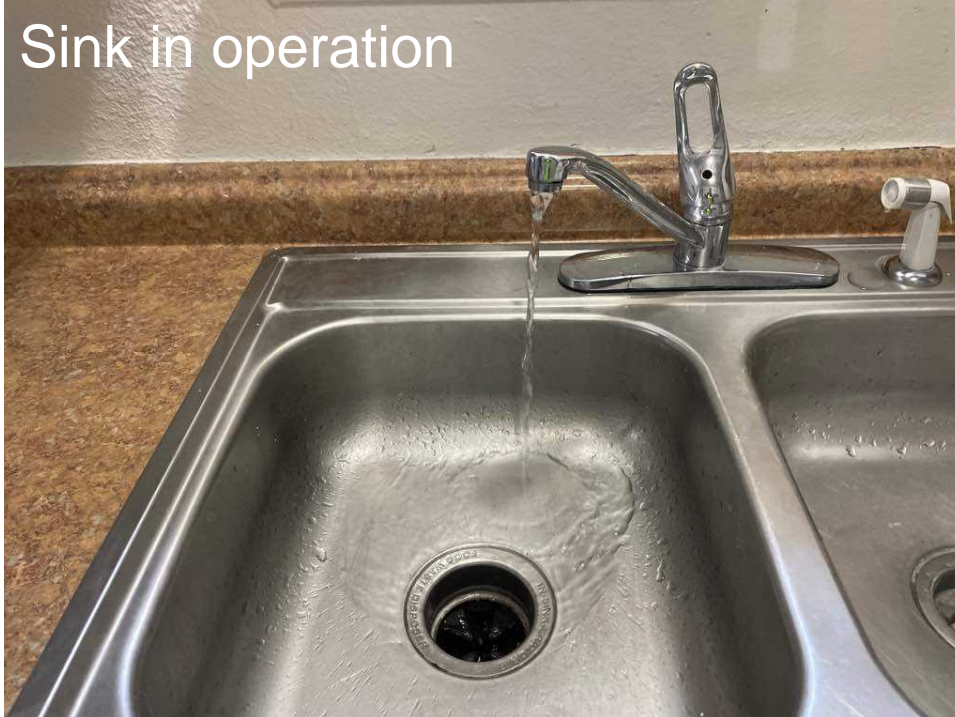
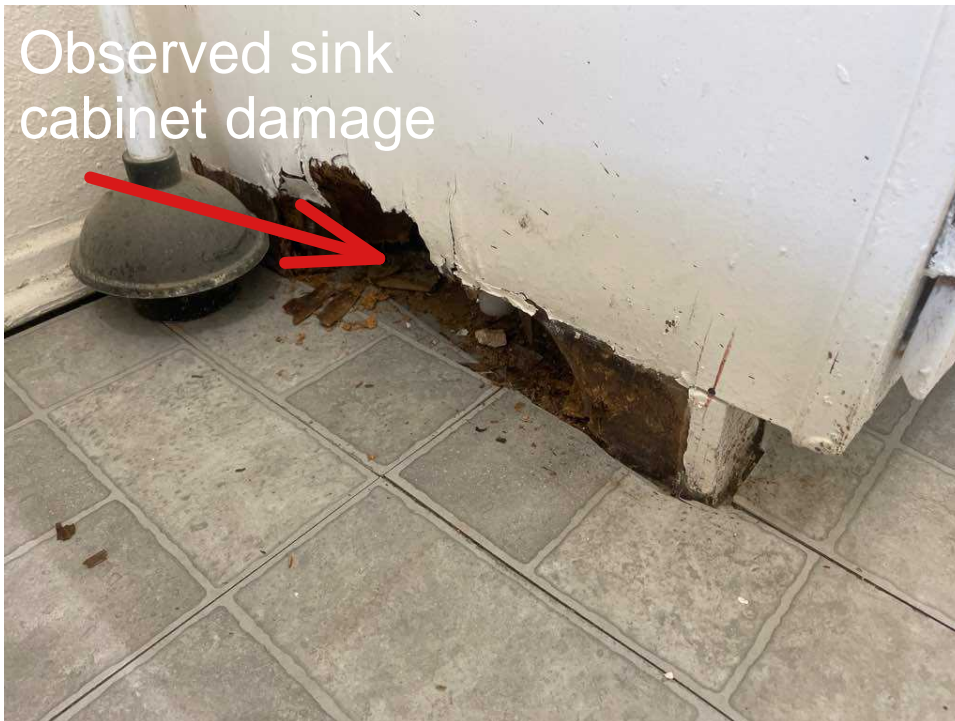
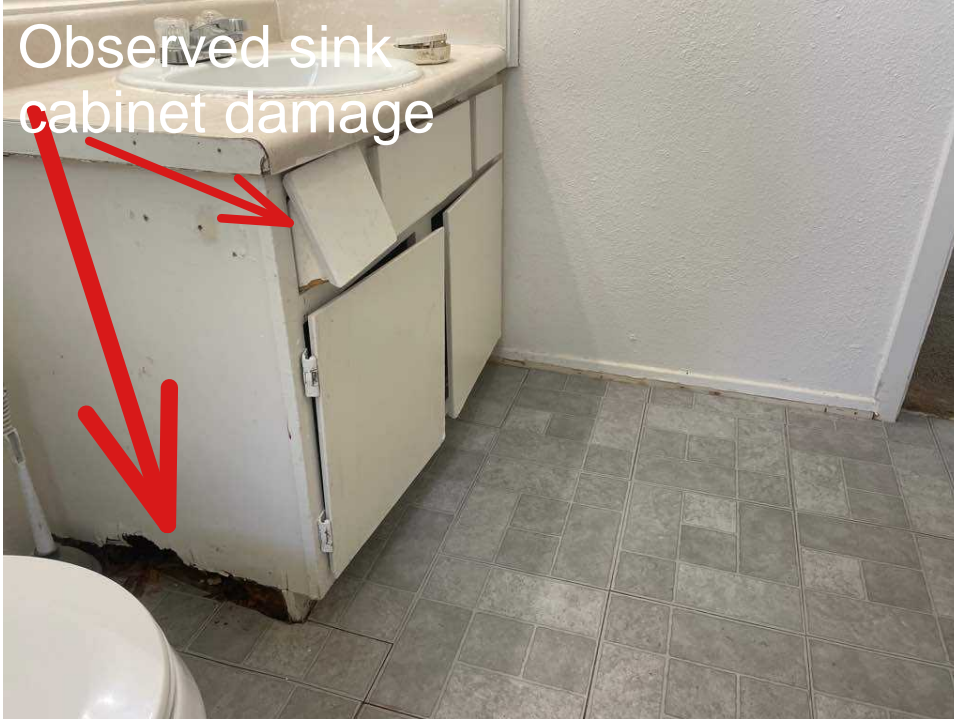
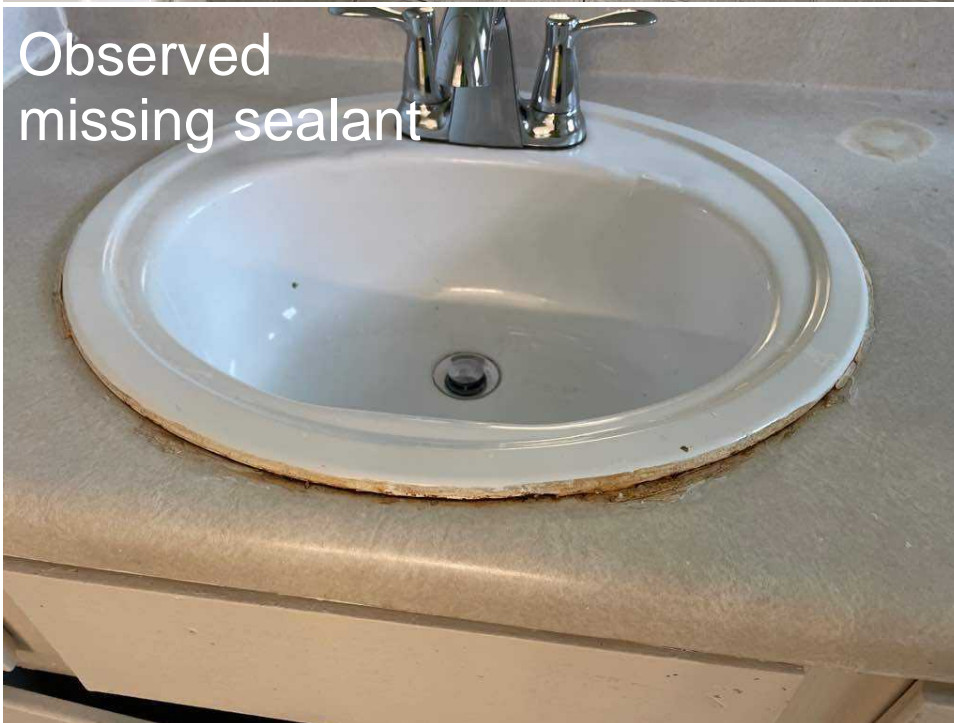
Comments: Built In Sink, 1. Observed sink cabinet damage.

2. Observed missing sealant at sink and countertop interface.

Correction recommended by a qualified contractor.

Correction recommended by a qualified contractor to prevent moisture damage .

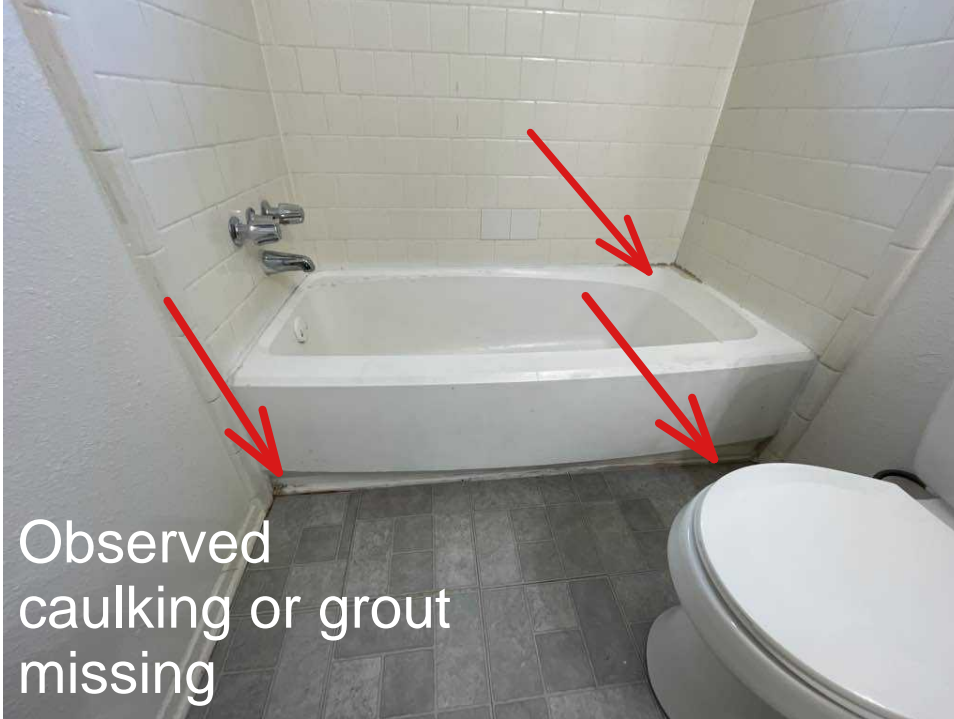
Comments: Built In bathtub / shower,
Observed caulking or grout missing or damaged at bathtub / shower.

Correction recommended by qualified contractor to minimize possible moisture intrusion.

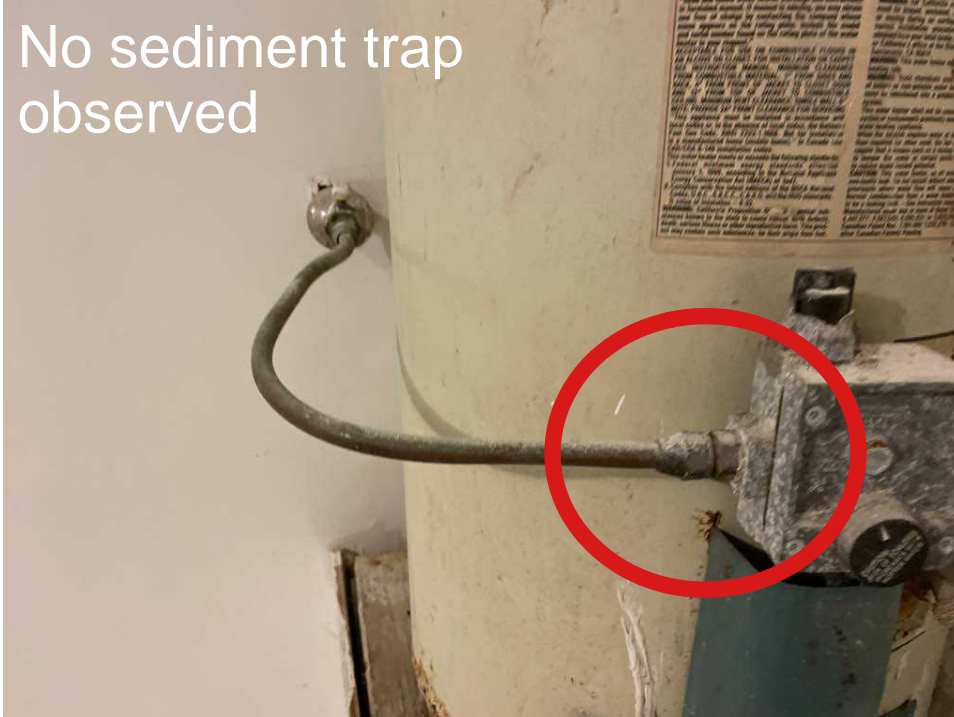
1. No sediment trap observed / installed at hot water heater at time of inspection.

No sediment trap
observed

Correction recommended by qualified contractor.
