Smith Group Property Inspections

Property Inspection Report

12223 Kingslake Forest Dr, Houston, TX 77044
Inspection prepared for: Edwin Jimenez

Date of Inspection: 04/05/2023 Time: 8:00AM
Age of Home: 1980 Size: 1248 sqft

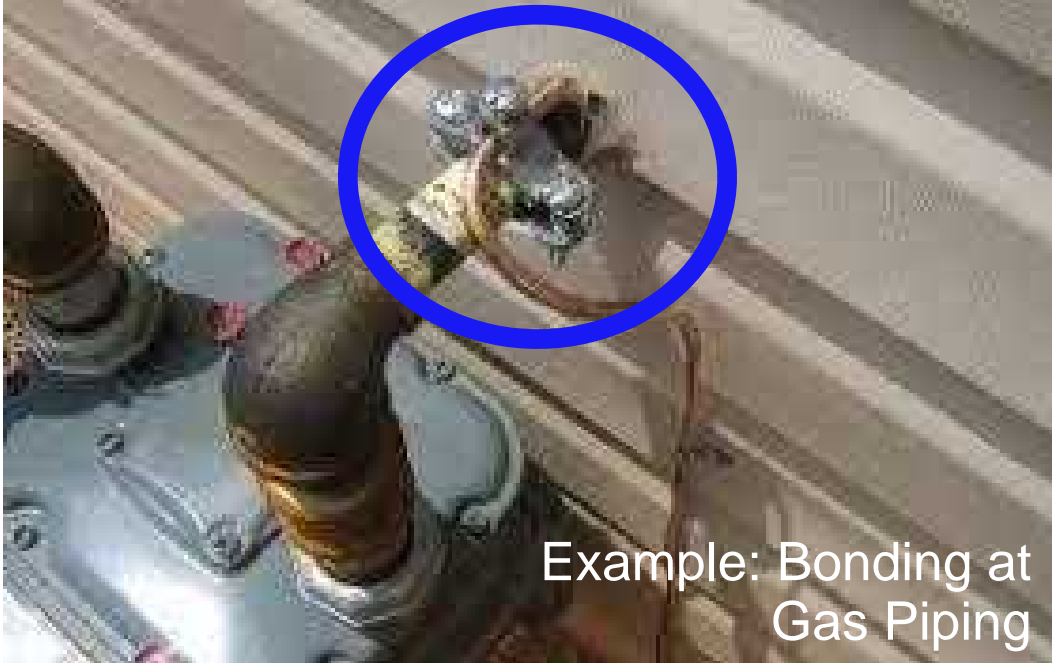
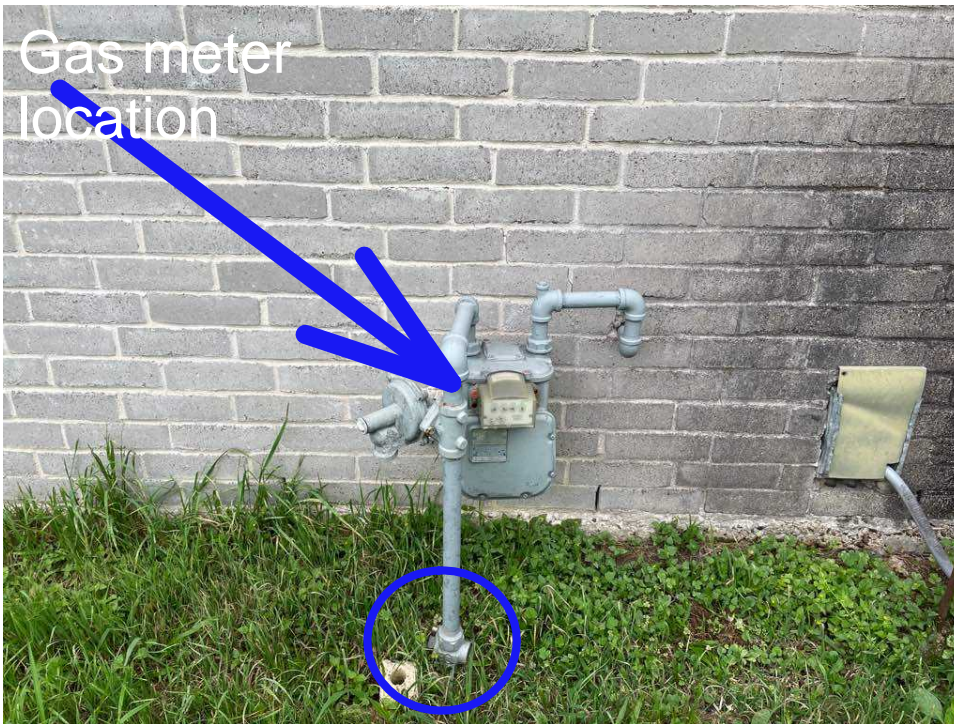
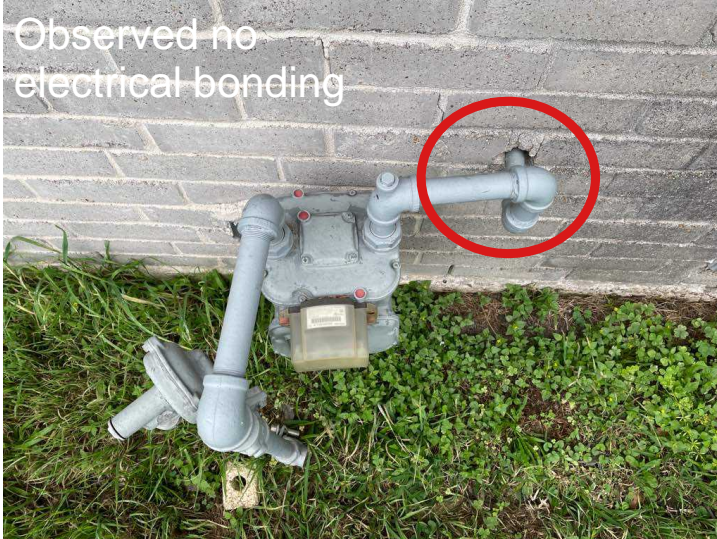
1. Observed no electrical bonding at gas meter.

Further evaluation and correction recommended by qualified contractor

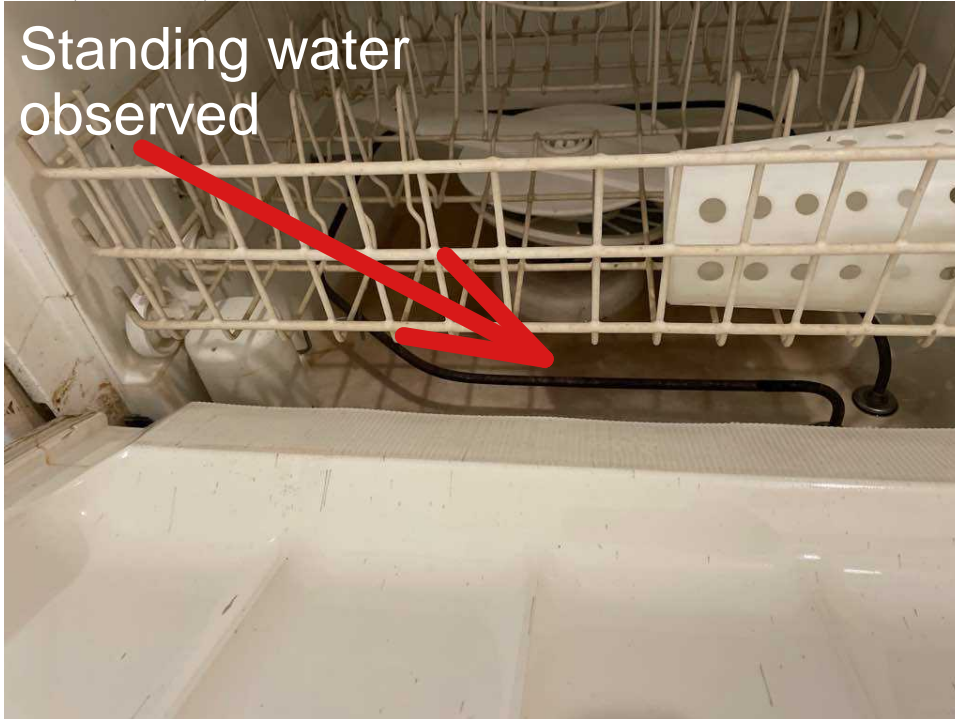
Comments: Hotpoint,
Standing water observed in dishwasher

Further evaluation and correction recommended by qualified contractor

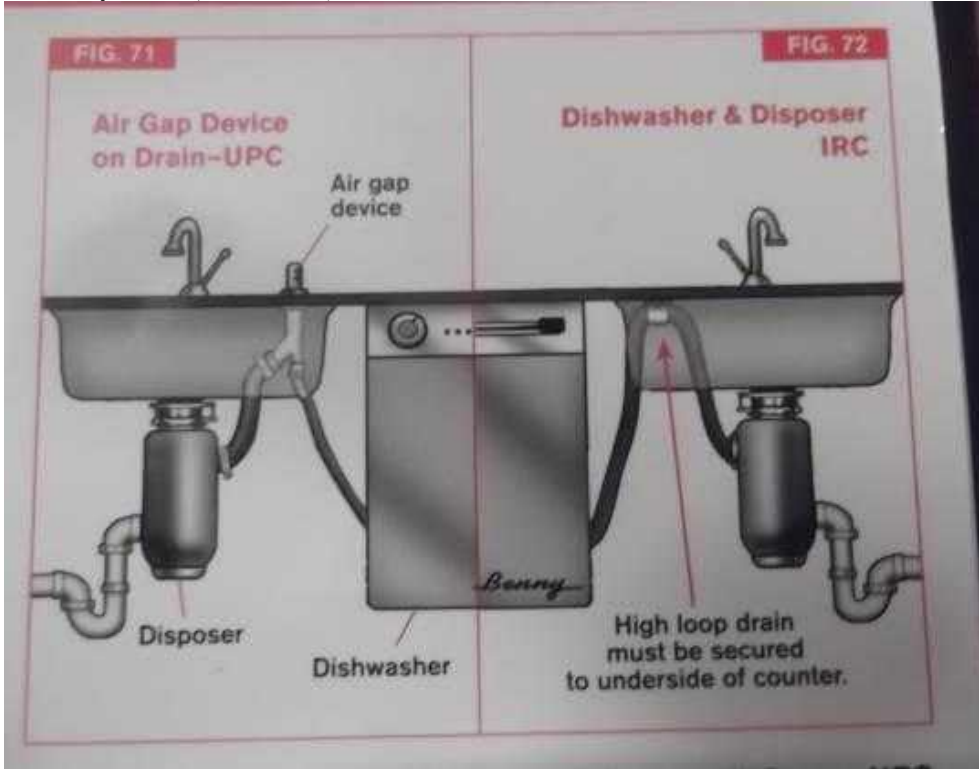
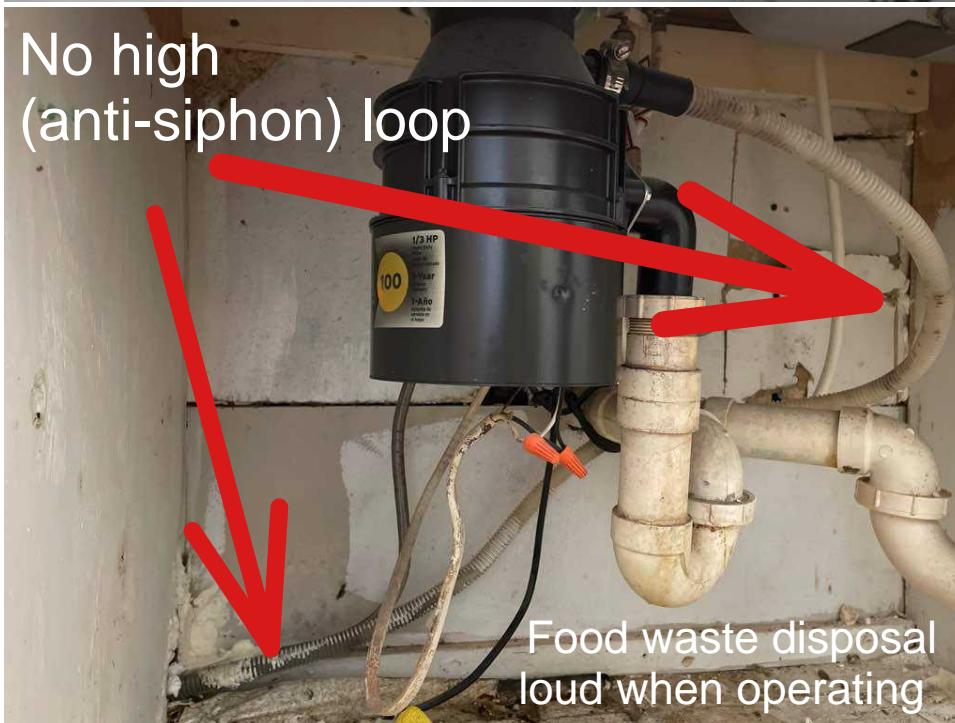
2. Observed food waste disposer loud during operation (possible loose item in sink).

Correction recommended by qualified contractor.

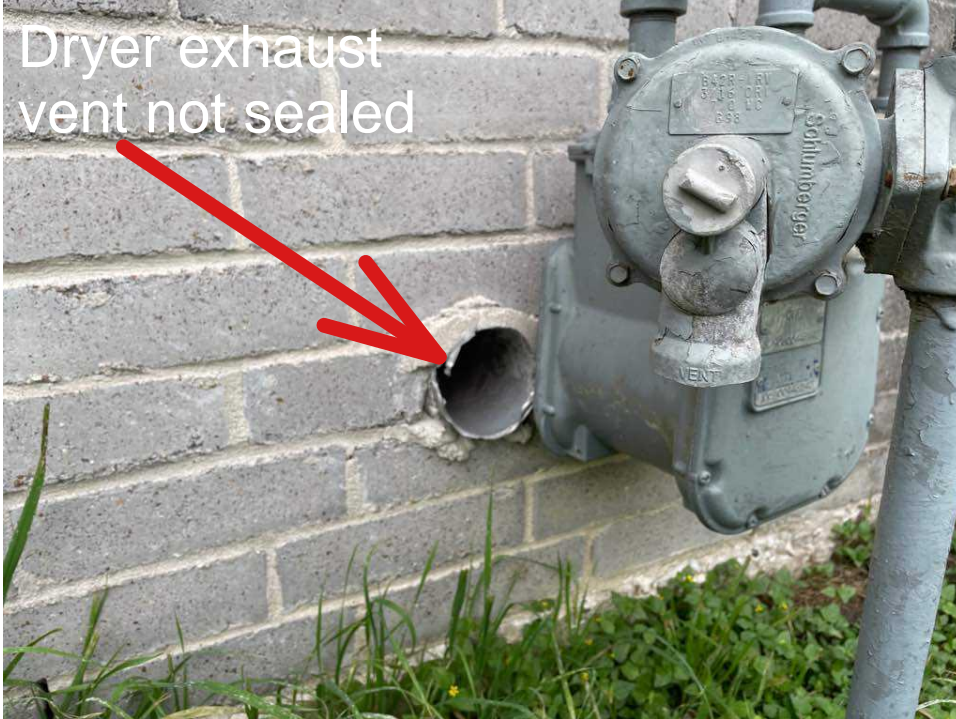
1. Observed dryer exhaust vent located within 3 feet of gas meter (possible safety issue).

Further evaluation and correction recommended by a qualified contractor.
