East Texas

HOME INSPECTION & PEST CONTROL

Michael & Theresa Huckabay
786 County Rd 308
Cleveland, TX 77327
November 17, 2023

PROPERTY INSPECTION REPORT FORM

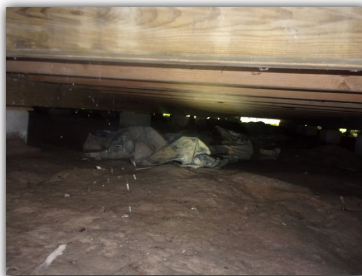
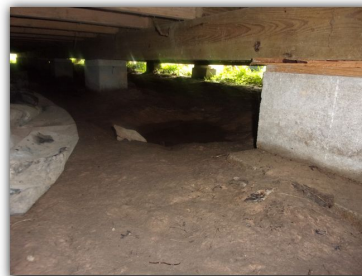
There was excessive moisture noted in the crawlspace at the time of inspection. This is a conducive condition for wood destroying insects.

Moister will also cause foundations to shift or move over time. I recommend maintaining a dryer climate under the structure.

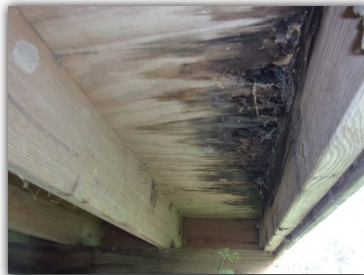
Previous moisture damage noted under the master tub

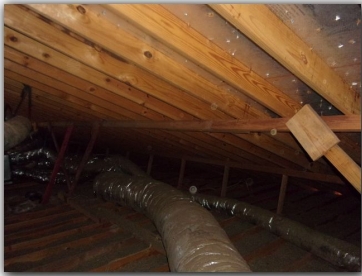
Purlins noted that were improper. Purlins shall be continuous and the same size as the rafters, and shall be supported by 2x4 braces installed to bearing walls at a slope of not less than 45 degrees from the horizontal. The braces shall be spaced not more than 4 feet on center and the length not to exceed 8 feet. And may not be cut or notched in any manner.

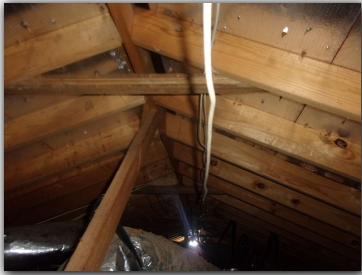
Collar ties noted on every fourth rafter.

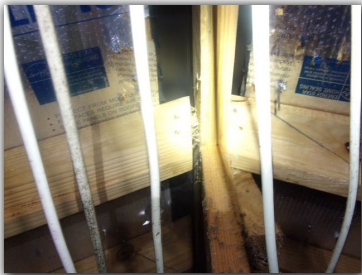
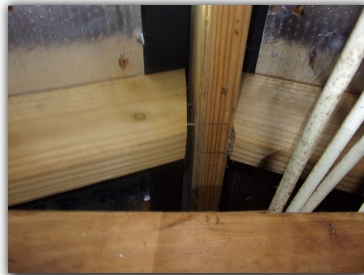
Separations were detected between the rafters and the ridge board in the attic. This condition is usually the result of past deferential deflection in a structure. We recommend consulting a qualified roofing contractor so a corrective course of action can be evaluated.

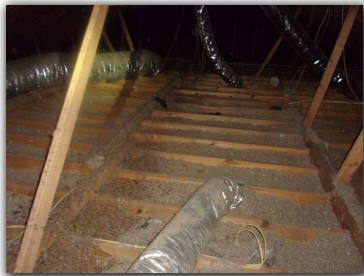
Missing insulation noted in various areas.

Insulation improvements may be cost effective, depending on the anticipated term of ownership.

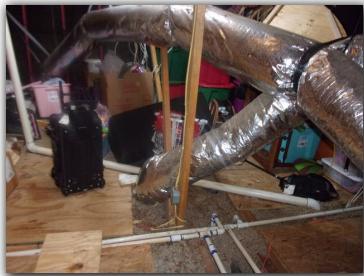
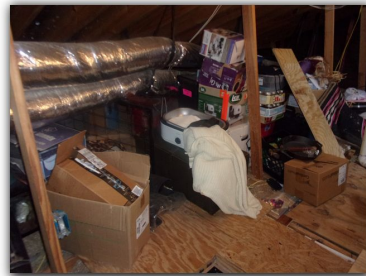
There were items store in the attic space at the time of inspection. Various areas were obstructed from view.

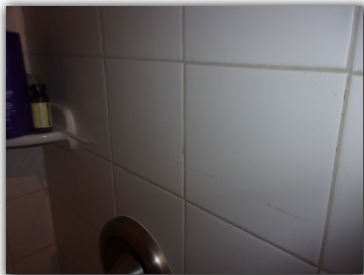
Cracked tiles noted in the hall shower area.

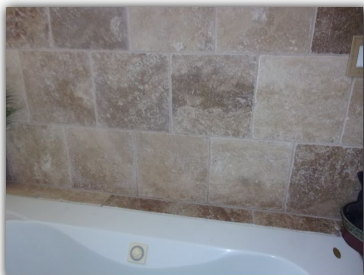
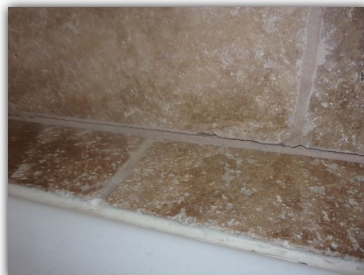
Crack noted at the master tub area.

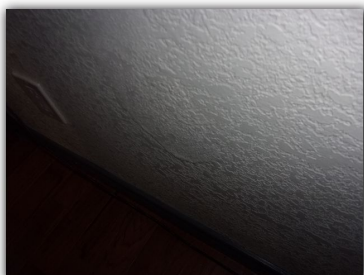
Previous moisture damage noted at the back bedroom window area.

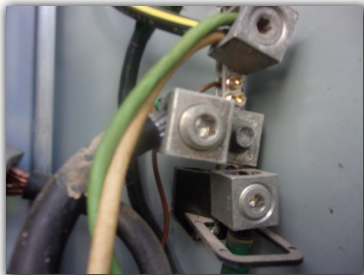
At the time of the inspection there was not any anti-oxidant paste on the lugs in the main panel where the aluminum main wires attach to the panel.

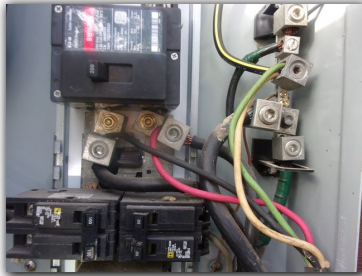
Circuits within the main distribution panel that are doubled up (referred to as “double taps”) should be separated. Each circuit should be served by a separate fuse or breaker.

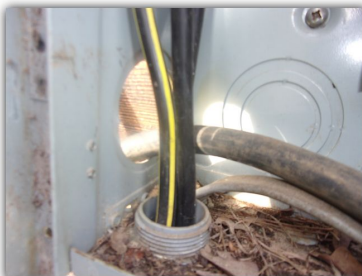
Cable clamps (sometimes referred to as bushings or grommets) are required where wiring passes into the main distribution panel. Cable clamps serve to protect the wiring from the metal edges of the panel openings.

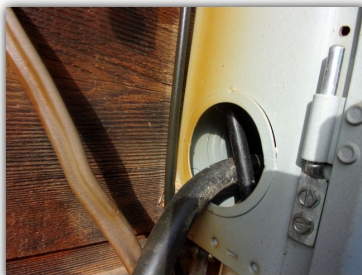
Any openings in the main panel are recommended to be covered.

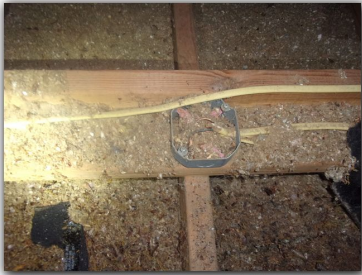
All junction boxes should be fitted with cover plates, in order to protect the wire connections.

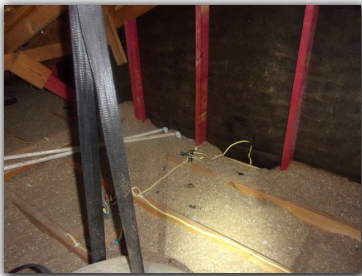
Improper electrical connections are recommended to be improved. All electrical connections should be made inside junction boxes fitted with cover plates.

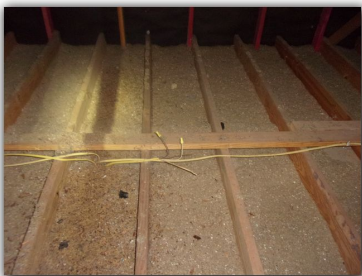
Wires were improperly terminated were noted in various areas. Wire ends or splices are recommended to be in junction boxes that are properly mounted. This condition is considered an electrocution/fire hazard and should be serviced by a qualified, certified & licensed electrician.

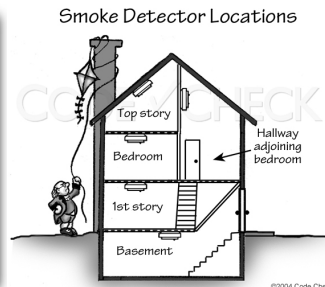
Your Smoke detectors are not installed to today's standards.

BN - It is suggested that all smoke alarms be interconnected. The alarm shall be clearly audible in all bedrooms over background noise levels with all intervening doors closed. All smoke detectors should be installed in accordance with the NFPA guidelines. It is recommended to replace the batteries in all of the smoke detectors once a year for reasons of safety.

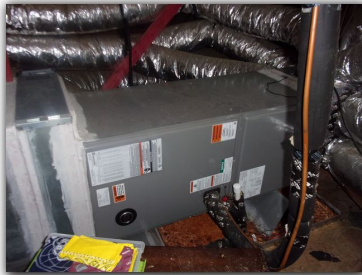
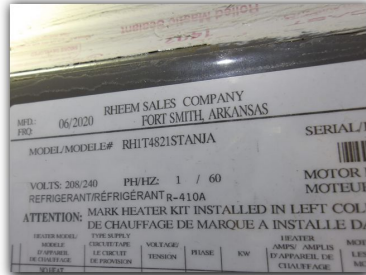
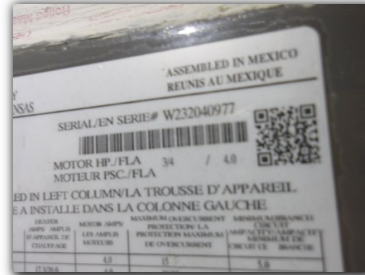
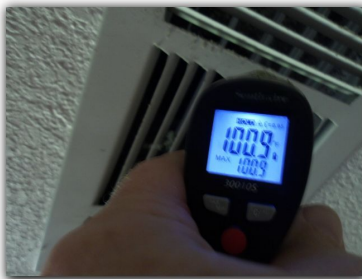
The unit appeared to be in good condition on the day of the inspection.

BN - These units should be serviced regularly, if the service date is unknown, then it is recommended that the unit be serviced prior to closing as well as annually.

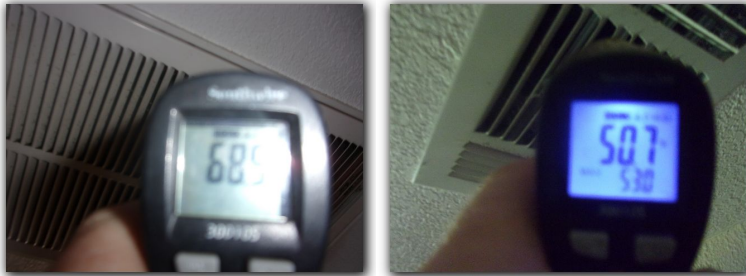
The unit appeared to be in good condition on the day of the inspection.

BN - These units should be serviced regularly if the service date is unknown, then it is recommended that the unit be serviced prior to closing as well as annually.

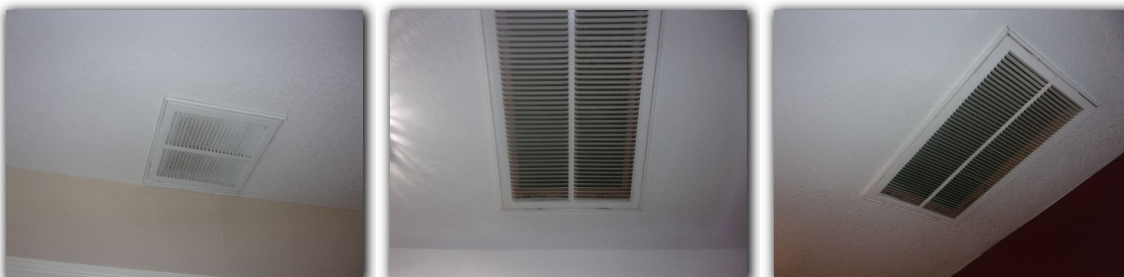
noted, 12x12, and 14x25.

Various ceiling units

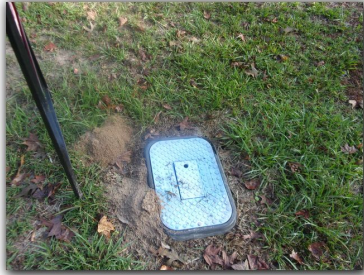
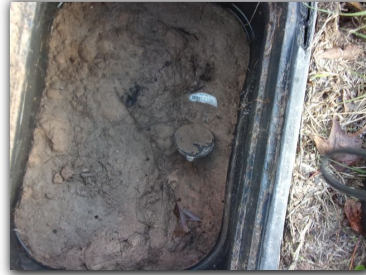
The water supply system and fixtures appeared to be in good condition on the day of the inspection.

Note-Pvc pipes in the attic area are recommended to be insulated.

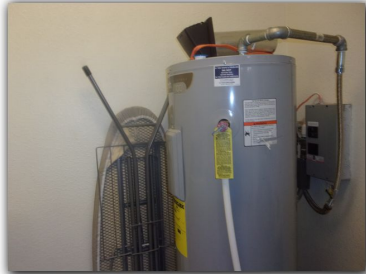
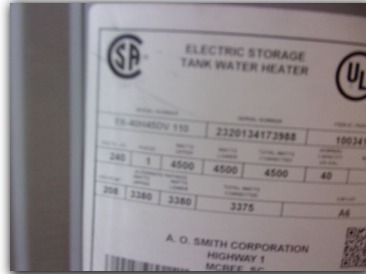
The unit appeared to be in serviceable condition on the day of the inspection.

Temperature & pressure relief valve (TRP) should drain into a line that is plumbed horizontally or down, but cannot go back up. (this keeps debris from going back to the valve) this line can be 3/4 inch C.P.V.C. plastic (not reduced in size) and should terminate to the exterior and from 6 to 24 inches from the ground. Remember to test the valve and replace it if it leaks or does not operate or every 3 years.

BN - The recommended hot water setting should between 115° & 120°

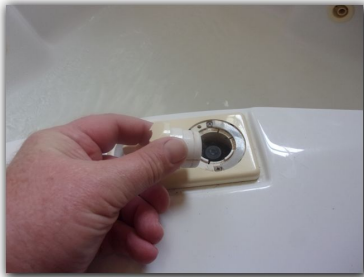
The button was not functioning.

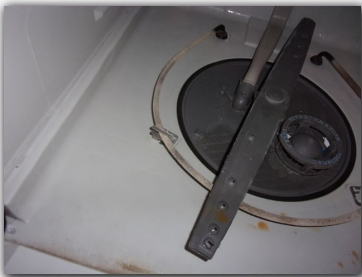
Note - some corrosion noted on the heating element.
