PROPERTY INSPECTION REPORT

Concerning: **227 Rose Gum Ct. Willis, TX 77318**

By: **Rodney Sims / Lic # 10271**

09/03/21 / 10:00

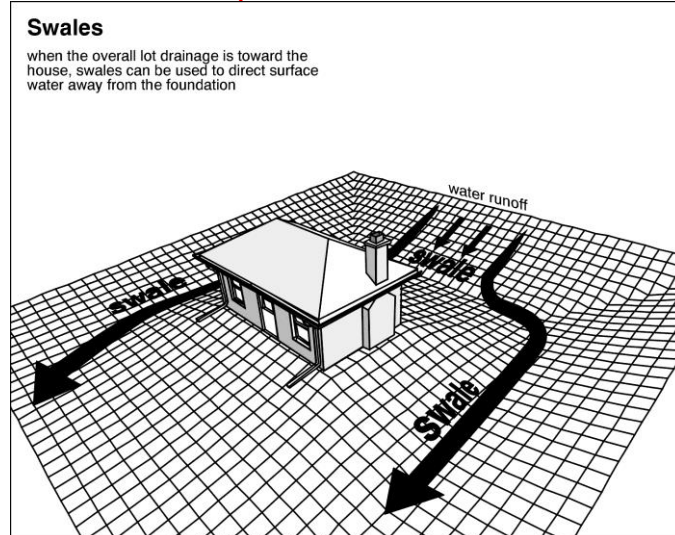
**(SEE diagram below for 'proper' use of Swales fro Drainage Type-A)
(all toward the front) to direct water to a Collection Point**

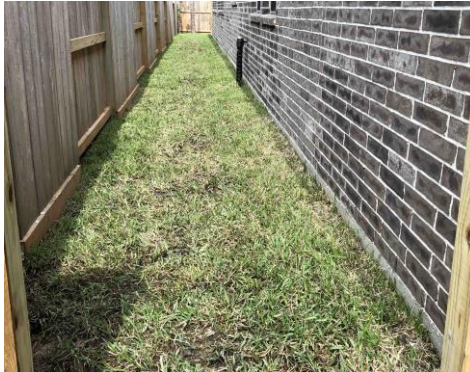
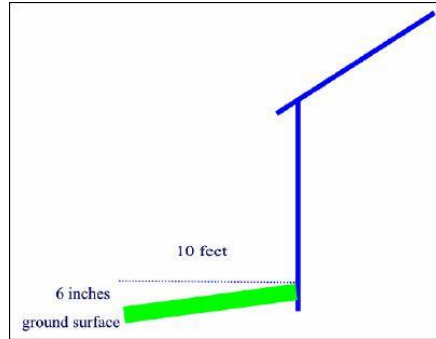
(SEE diagram below for 'proper' Grading as per Building Code)
