Web Presentation

Property Address: 10303 Horsehose Bend Dr., Houston, TX 77064

American Dream Inspections TX, llc

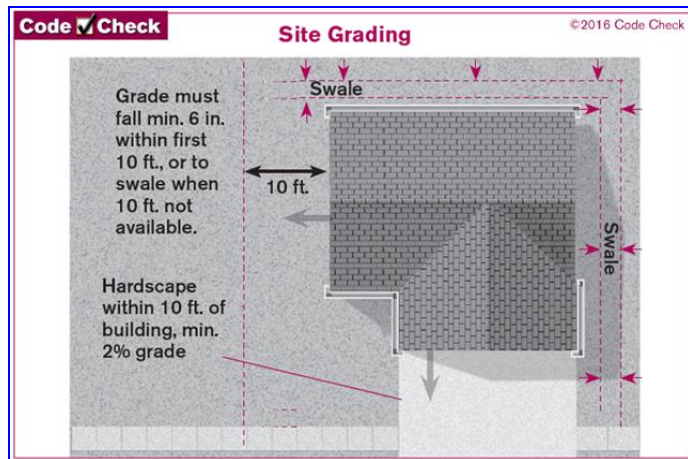
B. Item 2(Picture)

Rear grading is sloped toward the foundation at time of inspection. Soil was too high to the foundation and siding in several areas at time of inspection. Soil should be graded 6" in 10' away from the foundation. Soil should be at least 4" from bottom of brick and 6" from bottom of

siding. Conducive to moisture intrusion and causing possible damage.

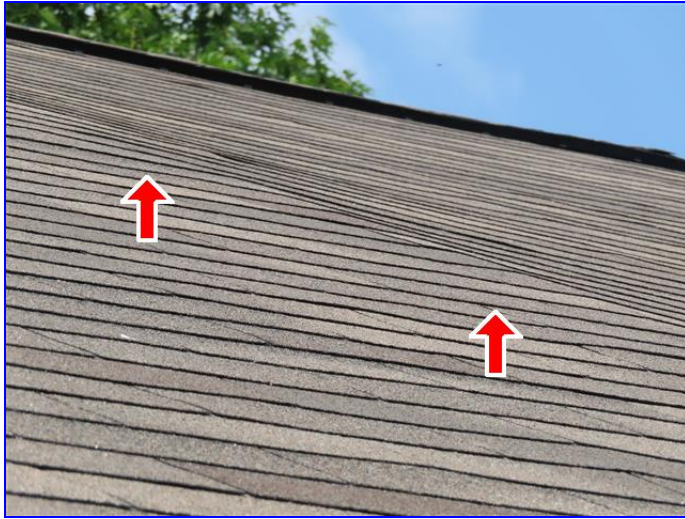
C. Item 1(Picture)

(1) Roofing has deflections and lifting at ridge in several areas at time of inspection. Should have a professional roofer evaluate.

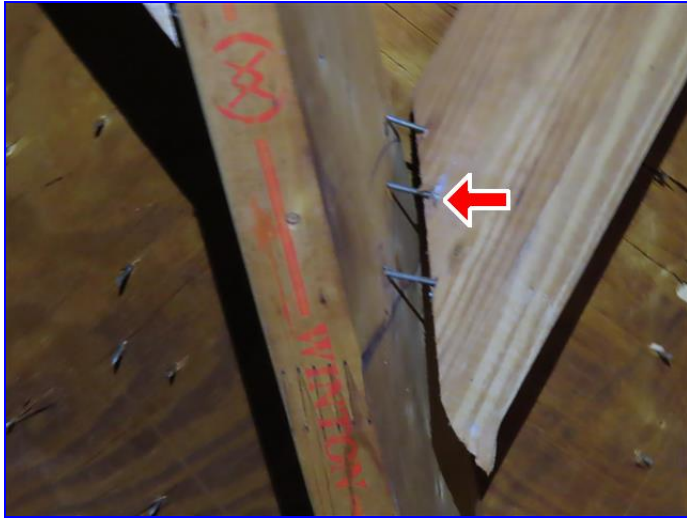
D. Item 6(Picture)

(4) Rafters in the attic were separating in several areas at time of inspection. Should have a professional correct properly. This is a possible structural issue.

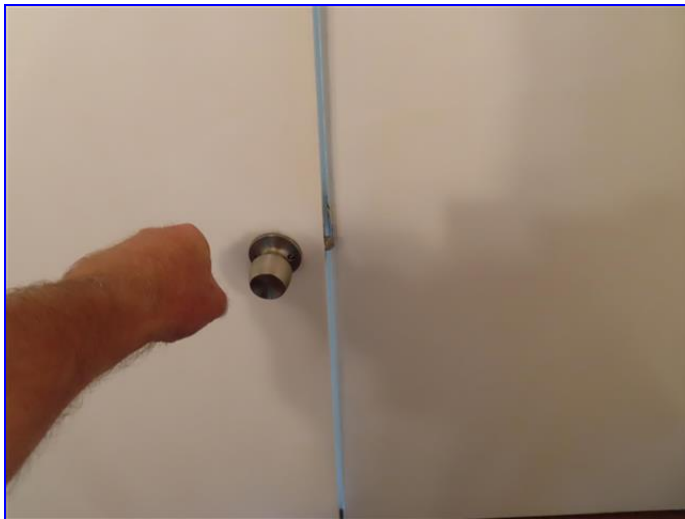
G. Item 5(Picture)

(4) Double door was not latching properly and top latch was not operating properly at time of inspection. Should have a professional correct properly.

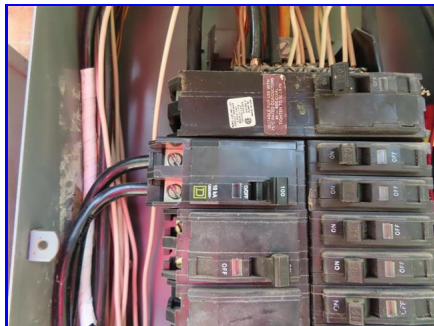
A. Item 3(Picture)

(3) Connector between meter and breaker box was missing electrical bonding at time of inspection. Should have a professional electrician correct.

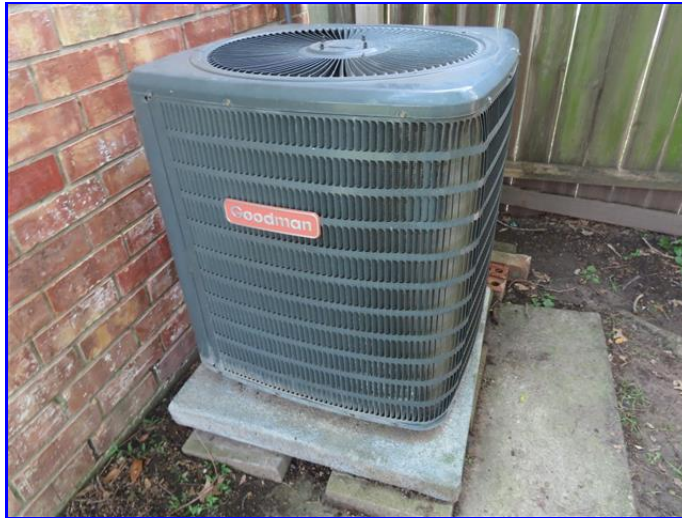
A. Item 1(Picture)

20215 Goodman 3 ton AC unit was not balanced properly in the interior with temperature differences in several rooms at time of inspection. Should have a professional AC Tech inspect and balance system properly.

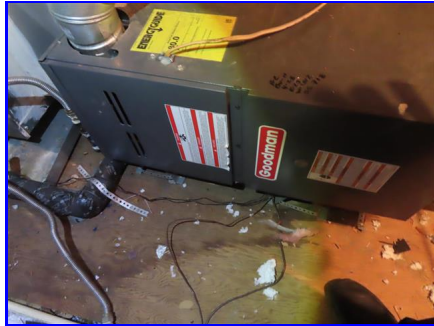
B. Item 1(Picture)

Goodman gas furnace in the attic was working properly in Cool Mode at time of inspection. Did not test in Heat Mode since the outside temperature was over 60 degrees at time of inspection.

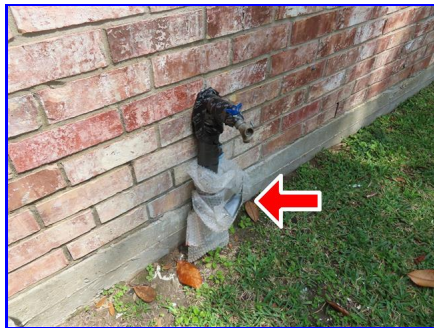
A. Item 1(Picture)

(1) Main water line and shut off valve to the structure. (This is for informational purposes only)

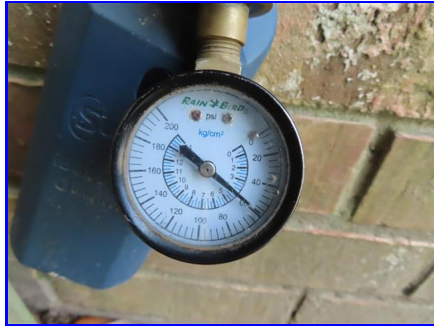
A. Item 3(Picture)

(3) Static water pressure was 60 psi at time of inspection. (This is for informational purposes only)

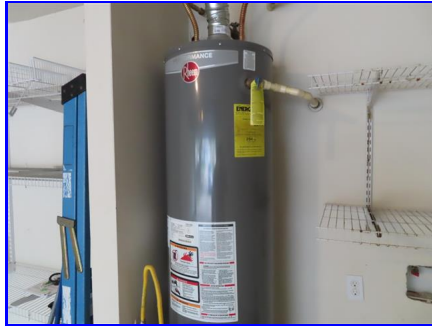
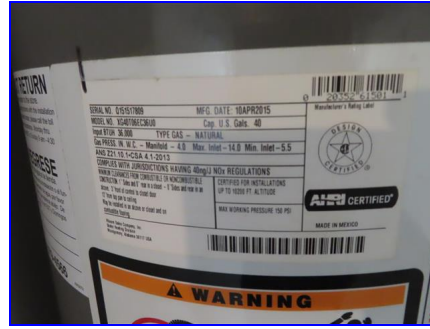
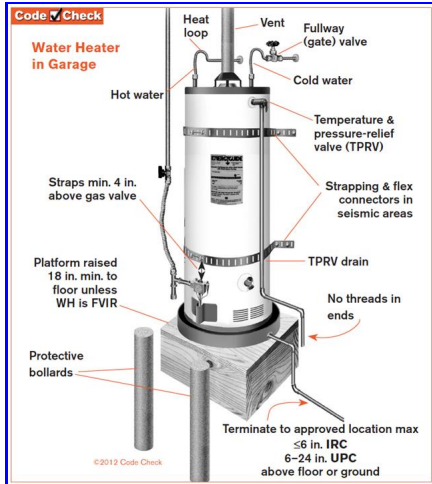
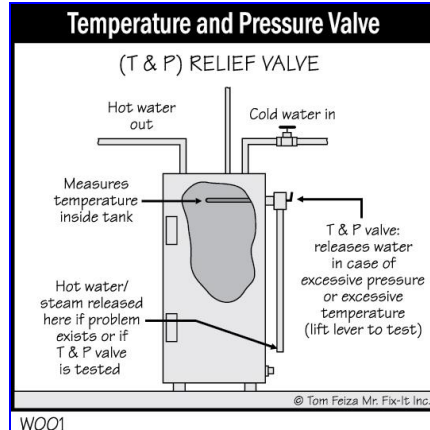
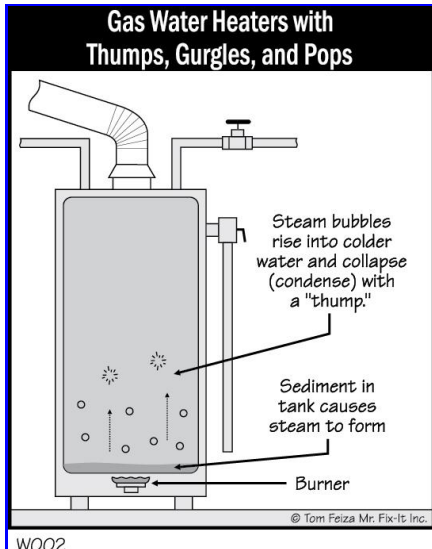
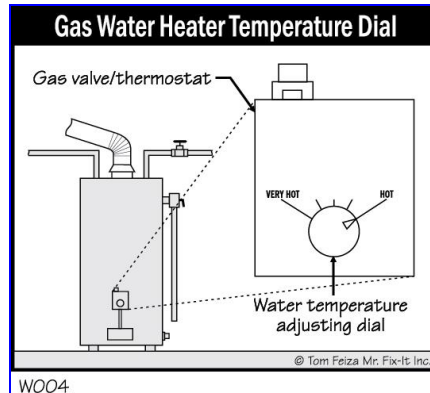
2015 Rheem gas 40 gallon hot water heater in the garage was operating properly at time of inspection.

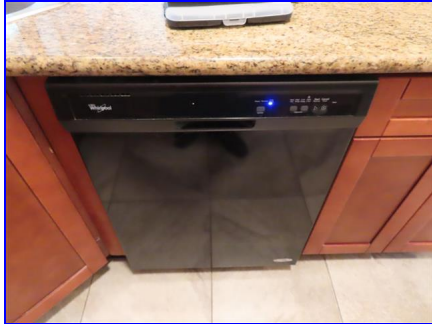
A. Item 1(Picture)

Whirlpool dishwasher was working properly at time of inspection.

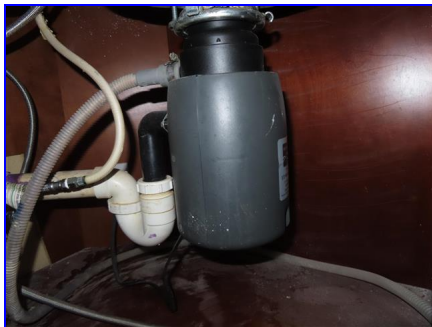
B. Item 1(Picture)

Kenmore disposal was working properly at time of inspection.

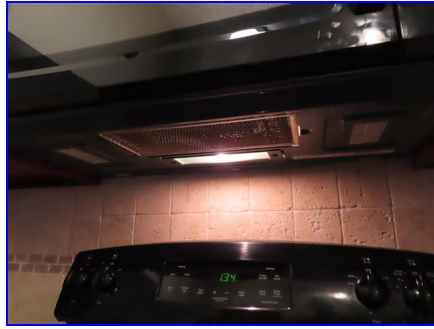
C. Item 1(Picture)

Whirlpool built in microwave exhaust fan and light was working properly at time of inspection.

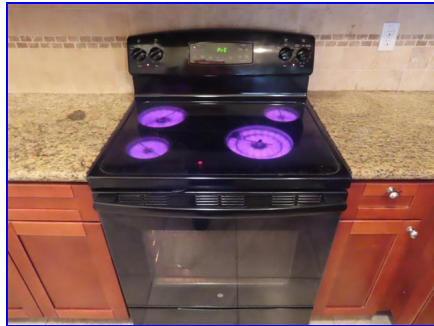
D. Item 1(Picture)

GE electric cooktop and oven was working properly at time of inspection.

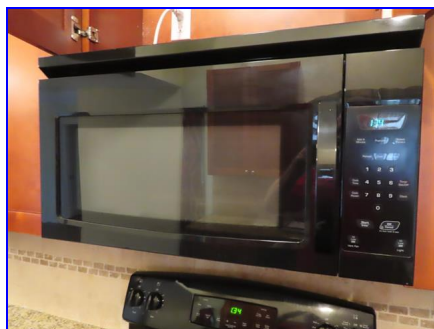
E. Item 1(Picture)

Whirlpool built in microwave was working properly at time of inspection.

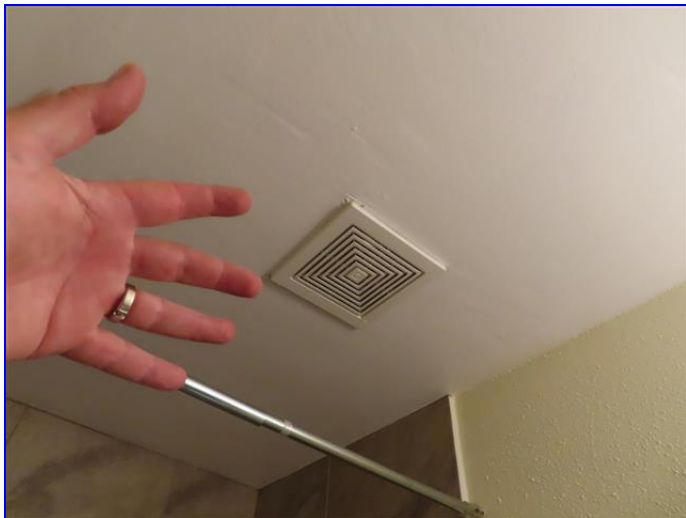
F. Item 2(Picture)

(2) Bathroom exhaust fan was making loud noise during operation at time of inspection. Should have a professional inspect and correct properly.

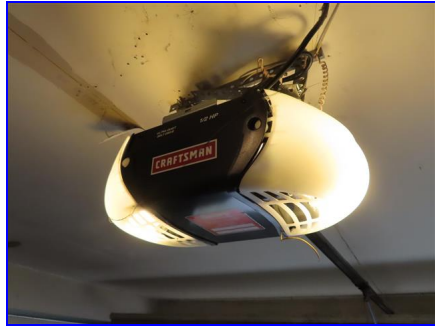
G. Item 1(Picture)

Craftsman garage door opener was working properly at time of inspection.
