KEENEYE INSPECTIONS LLC

COMPREHENSIVE HOME INSPECTION REPORT (7-6)

7714 Atwood Manor Ct
Richmond, TX 77407

| Nazir Ahmad <i>Name of Client</i> | 05/08/2023 9:00 am <i>Date of Inspection</i> |

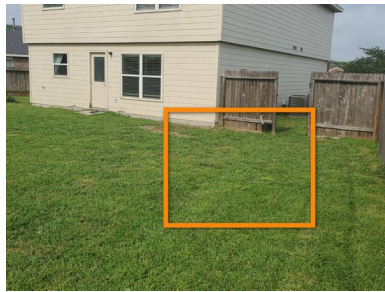
2: Inadequate grade to street

Observed inadequate grade to street preventing proper ground water runoff.

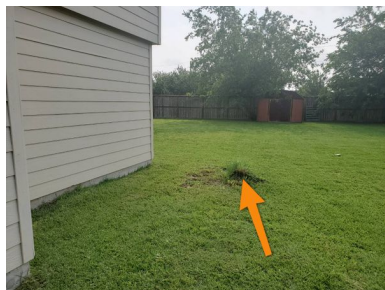
Right back

3: Rotten roots and dead vegetation

Observed rotten roots and dead vegetation from previously removed trees. Recommend removal to prevent WDI infestation.

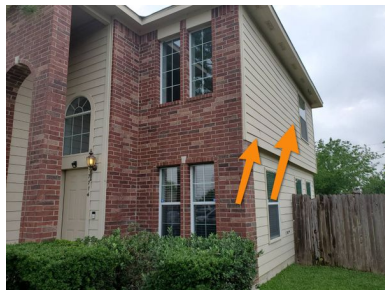
Right side

Observed cement board siding and/or trim loose.

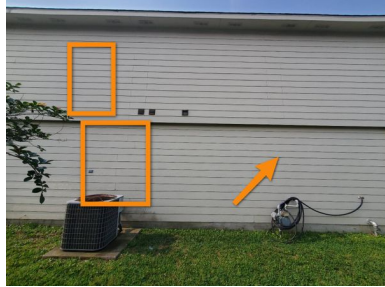
Left

2: Exterior Wall(s) - Cement board siding - broken / damaged

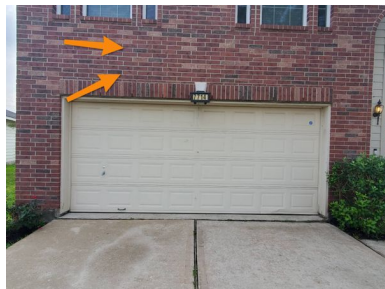
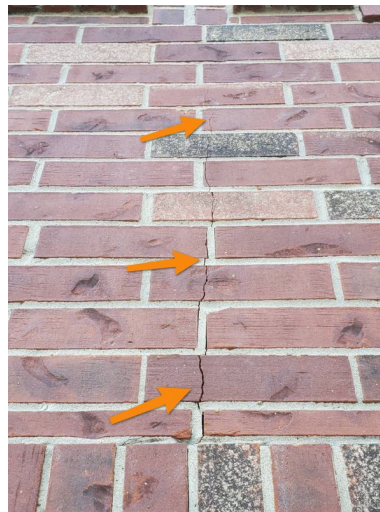
3: Exterior Wall(s) - Contraction cracks

Expansion and contraction cracks (thermal cracks) in the exterior brick/stone veneer masonry walls were observed. Expansion and contraction cracks in the exterior brick/stone veneer masonry walls should be repaired and closely monitored.

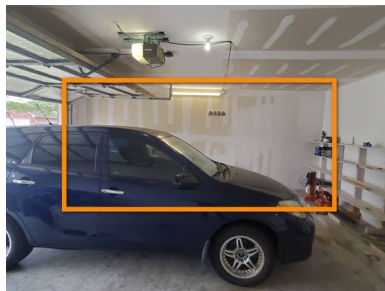
Garage

4: Interior Wall(s) - Incomplete paint work

Observed incomplete paint work at required areas of Interior walls.

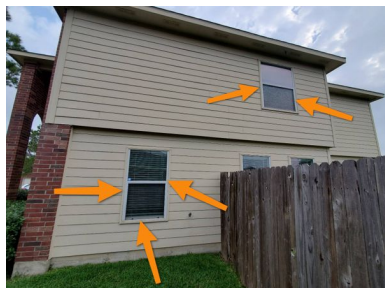
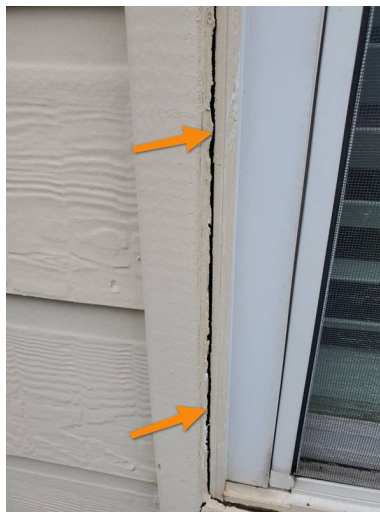
5: Exterior Wall(s) - Sealants (caulking) deteriorated

Exterior sealants (caulking) were deteriorated in some areas. Sealants applied in appropriate locations prevents moisture intrusion and insect penetration. Recommended locations are: around window openings, door openings, wall penetrations, between brick and siding/trim, between stone and siding/trim.

As per InterNACHI institute, average life span for exterior grade sealant is approximately 7 years.

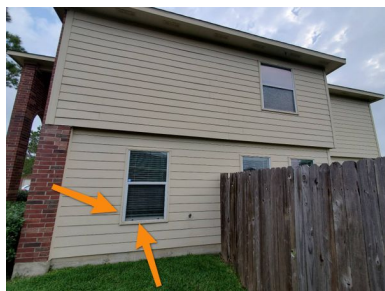
Right side

Water damage and/or wood rot was observed at the exterior siding and/or trim. Damaged and deteriorated exterior wooden siding should be repaired to prevent wall damage, moisture penetration and wood destroying insects.

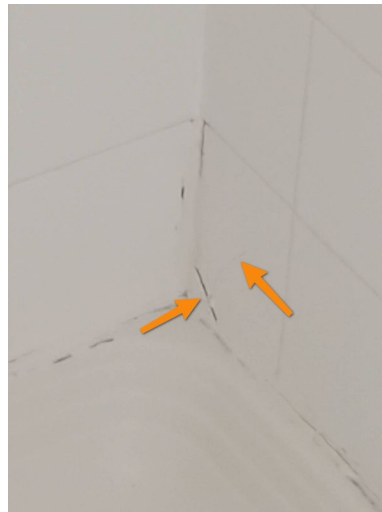
Master bath

8: Interior Wall(s) - Bathroom wall tile - crack

Observed crack(s) at bathroom wall tile(s)

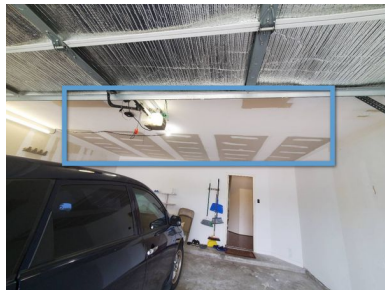
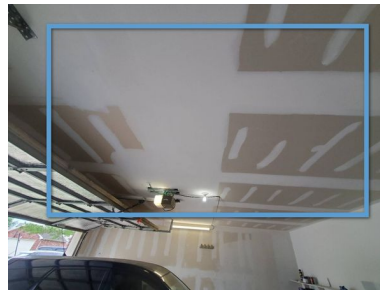
Garage

3: Finished ceiling - paint incomplete

Observed paint incomplete at interior finished ceiling.

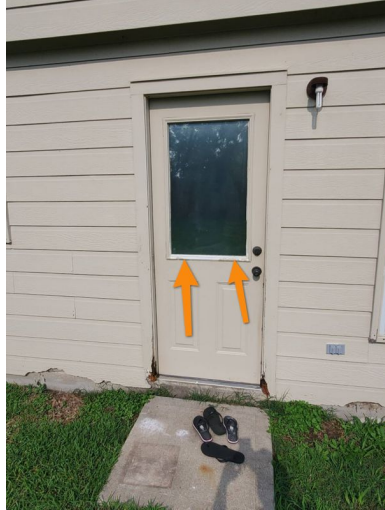
Back door

Observed cosmetic damage to exterior door(s) such as paint/stain fading, peeling or deteriorating, and in need of repair.

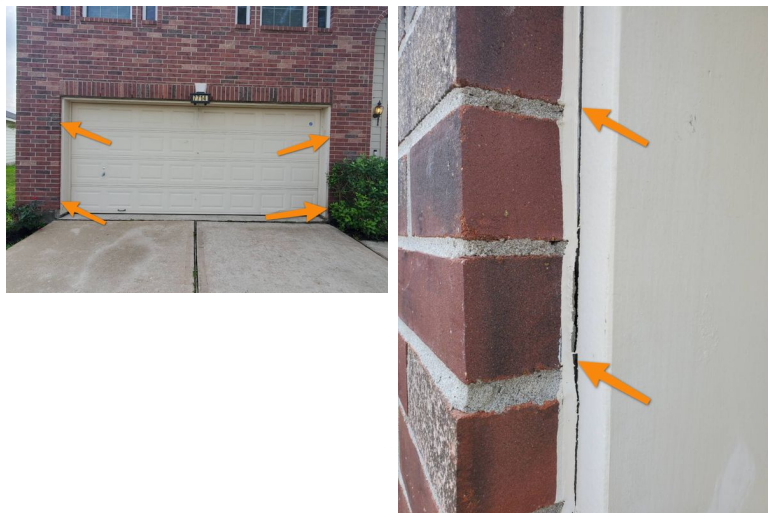
3: Exterior Door(s) - Sealant deteriorating

Observed sealant at perimeter of exterior doors pulling, with gaps and deficient at the time of inspection. Recommend repair as needed.

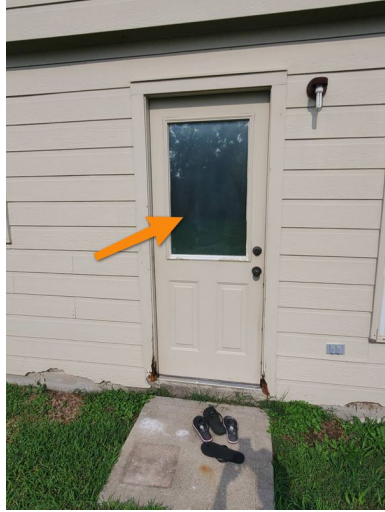
Back

5: Exterior Glass doors - thermal seal broken

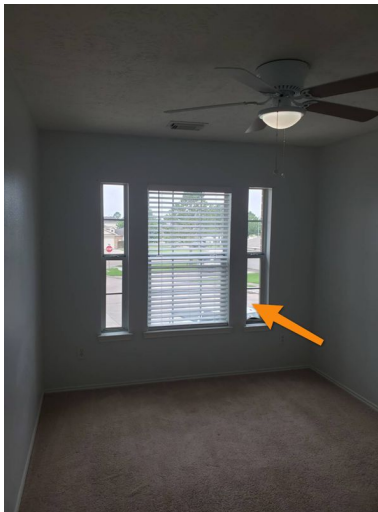
2nd Floor 1st Bedroom

1: Thermal pane window seals have failed

Moisture and or discoloration is present between window glass panes. This has resulted in condensation or a fog like film to develop between the panes of glass. The thermal pane windows no longer function as designed when they loose their seal and repair or replacement is needed.

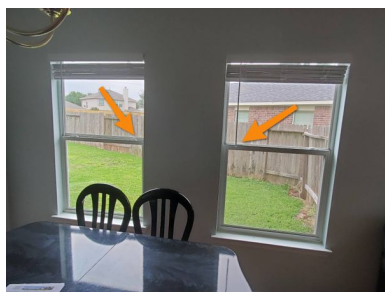
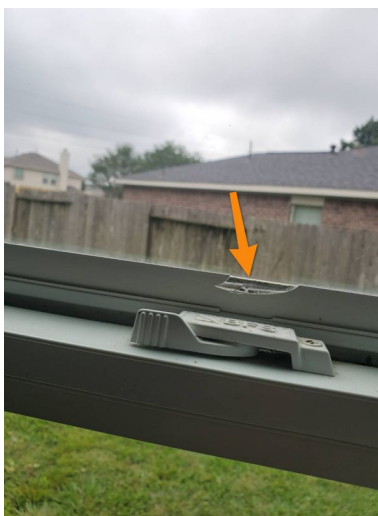
2: Vinyl stripping damaged

Observed several vinyl stripping damaged at several windows. Representative images attached.

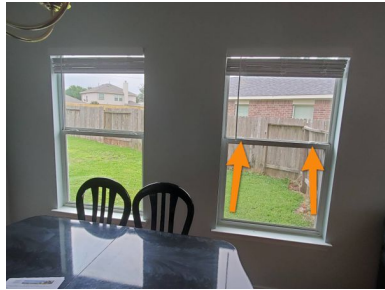
3: Window locking mechanism - deficient

Observed window locking mechanism not securing in place, loose or defective. Recommend further evaluation and repair.

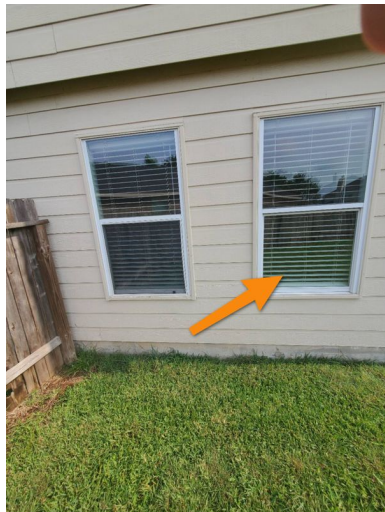
4: Window screen(s) - Missing

One or more Windows were observed to be missing window screens.

Window screens help protect window glass from minor impact damage and prevent insect penetration at the windows. Missing window screens should be replaced.

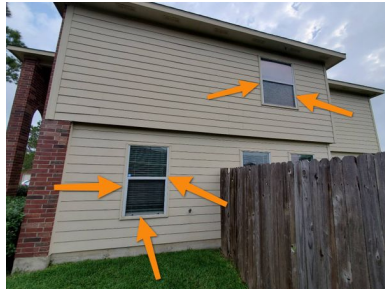
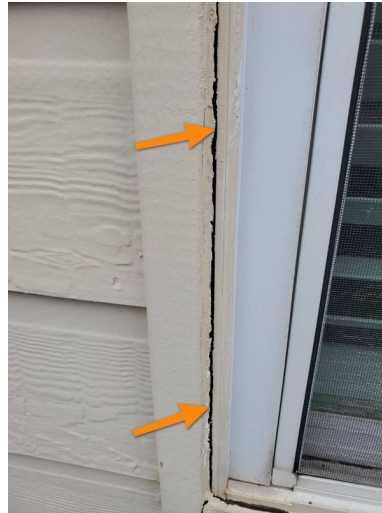
5: Window(s) - Sealant cracked and deteriorated

Observed sealant applied to window pans. Observed sealant cracked, deteriorated several windows and in need of repair.

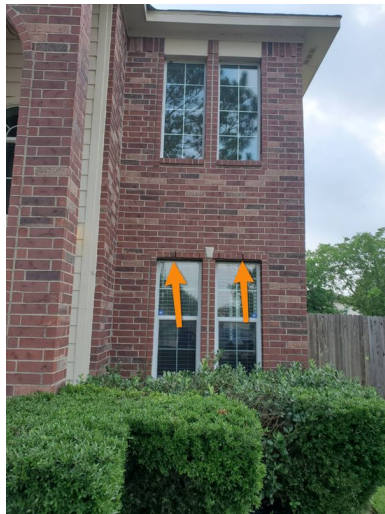
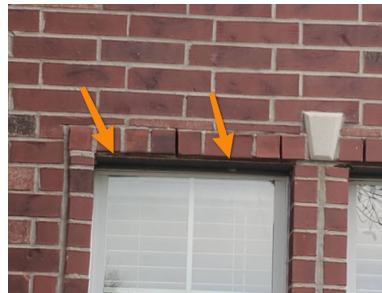
6: Windows - Steel lintels re-paint needed

Observed paint peeled or faded at steel window lintels. Steel window lintels should be cleaned and painted to prevent rusting and corrosion. Steel window lintels provide support to the wall cladding above and should be regularly maintained.

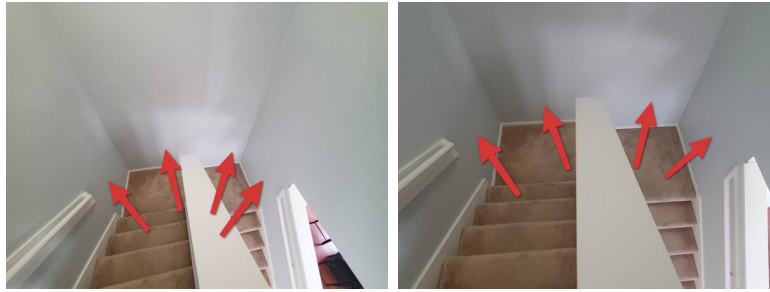
1: Lack of continuous handrail at stairs

The stairway handrail was not installed to be continuous at all steps and is a SAFETY HAZARD. A graspable handrail installed at the proper height is required at all stairway steps according to current building standards.

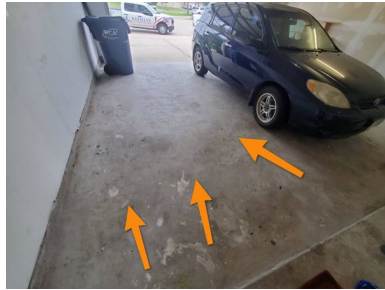
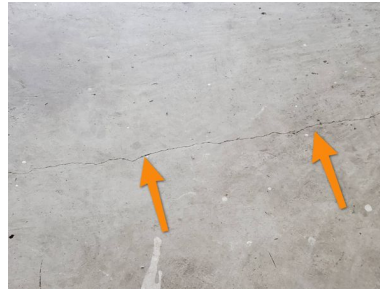
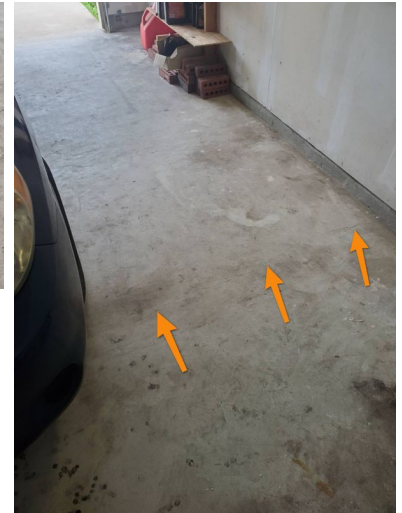
2: Shrinkage cracks at exposed concrete floor

Observed shrinkage cracks at exposed concrete floor at garage. Hairline shrinkage cracks are common in concrete slabs. Recommend periodic monitoring.

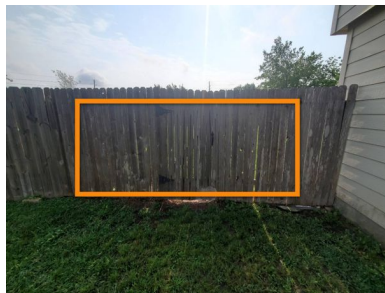
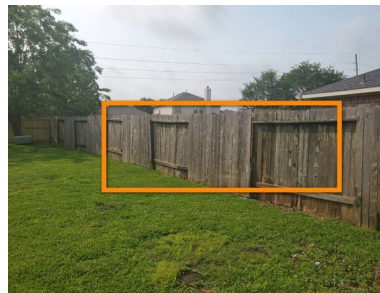
Left

Observed fence leaning / tilted and in need of repair.

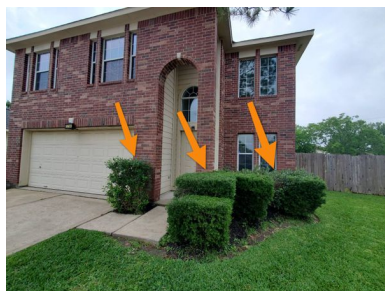
Front

2: Heavy foliage around fence

Areas of the fence were heavily covered in plant material and/or foliage and was not visible at the time of the inspection

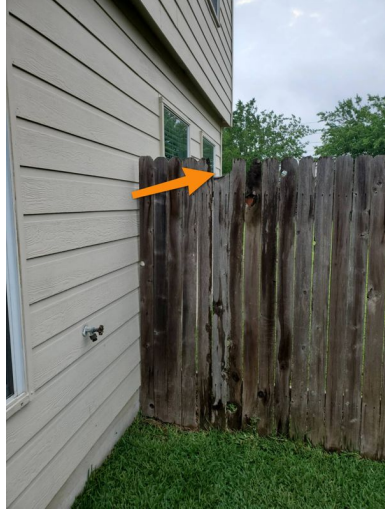
Right

3: Physical damage to fence

Observed physical damage to fence.

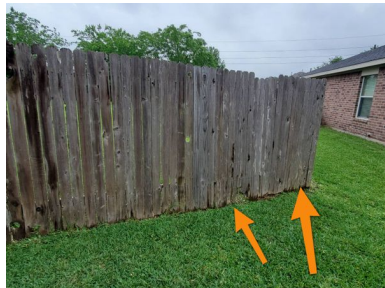
Right side

4: Wood fence - Damaged or loose

Observed fence panel and/or rot board damaged or loose. See pictures.

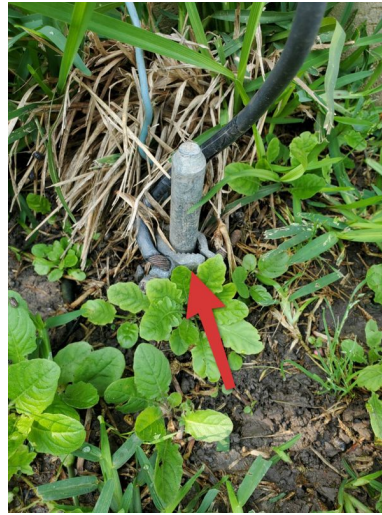
1: Grounding wire to rod - improper connection

Observed grounding wire to grounding rod connection clamps to be improper or not connected and in need of repair by license electrician.

Wrong clamp

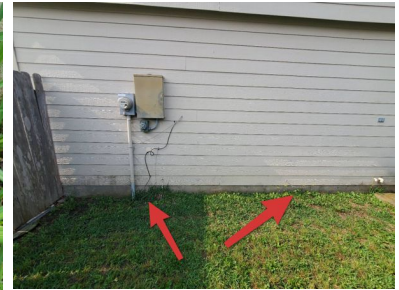
Lack of connection

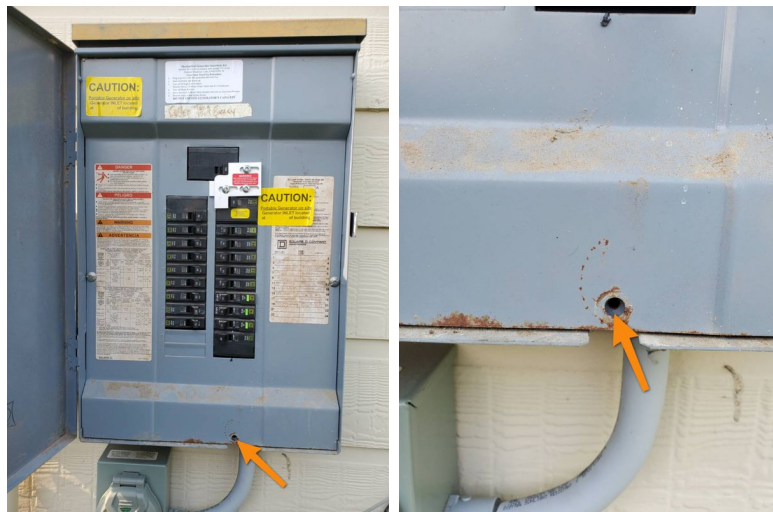
2: Service panel dead front panel screws missing

Observed lack of screws on service panel dead front cover.

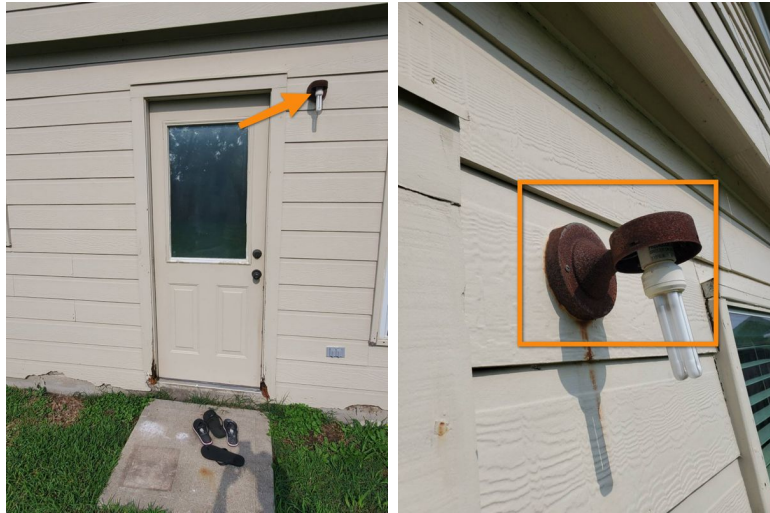
1: Exterior light fixture - rust / paint fading

Observed rust/corrosion or faded paint on metal component of exterior light fixture. Recommend further evaluation and repair.

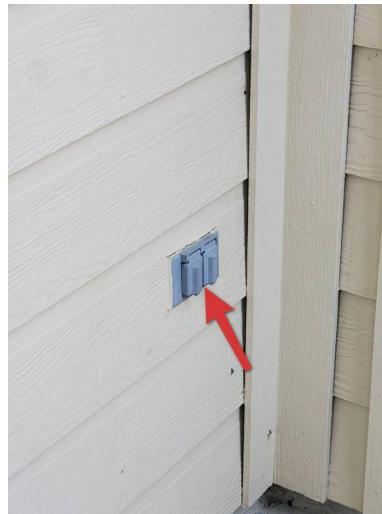
4: Receptacles (EXTERIOR) - lacking weather tight bubble covers

Lack of weather proof bubble covers at electrical receptacles in wet locations is a SAFETY HAZARD and should be repaired by a certified, licensed electrical specialist.

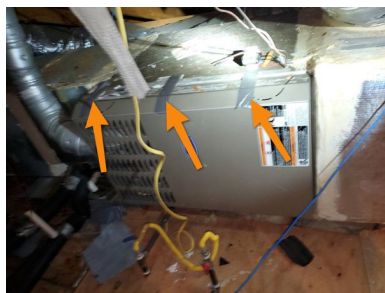
Observed furnace unit cover doors taped closed. It is not necessary to tape the access doors. The access doors should be secured to the unit using their normal screw knobs or snug tight manner, depending on type of system.

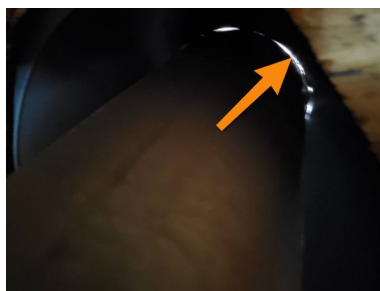
2: Furnace exhaust flue to roof jack connection - sealant missing

Observed lack of sealant / seal at furnace exhaust flue to roof jack connection.

As per observed condition, it is possible for the exhaust air to draft back into the attic space which is a safety hazard.

Also, due to lack of seal, there may be water intrusion from rain during heavy or windy rain conditions..

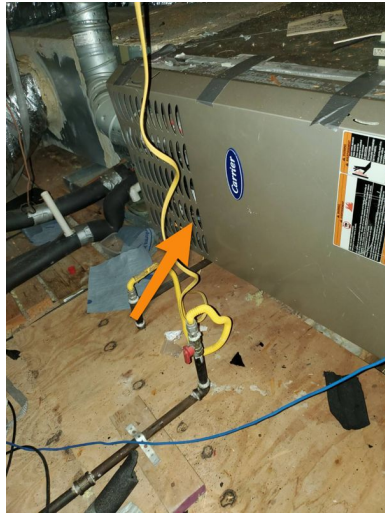
4: Furnace unused vent

Furnace unused vent observed at the time of the inspection. May be it was from previous unit. Recommend removing if not in used.

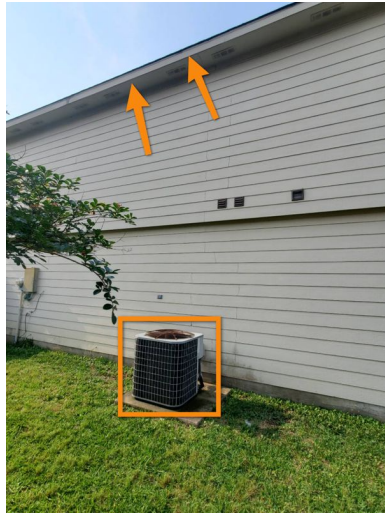
6: Rust/ Corrosion at Exterior condenser unit

During inspection Inspector observed Rust/Corrosion at Outside condenser unit.

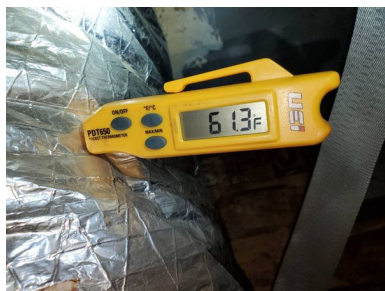
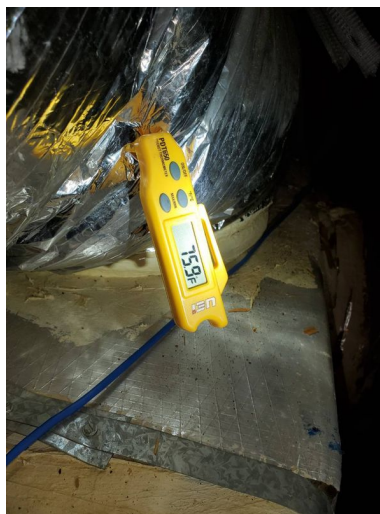
9: Temp. Differentials - Not in range

Cooling equipment temperature differentials were not within range of 15-22 degrees Fahrenheit (Above). The inspector recommends that the cooling equipment be further evaluated and serviced by a licensed specialist when the temperature differential is not within the acceptable range. Temperature differential readings are a fundamental standard for testing the proper operation of the cooling system. The normal acceptable range is considered to be approximately between 14 to 22 degrees F. total difference between the return air and conditioned air. Unusual conditions such as excessive humidity, low outdoor temperature and restricted

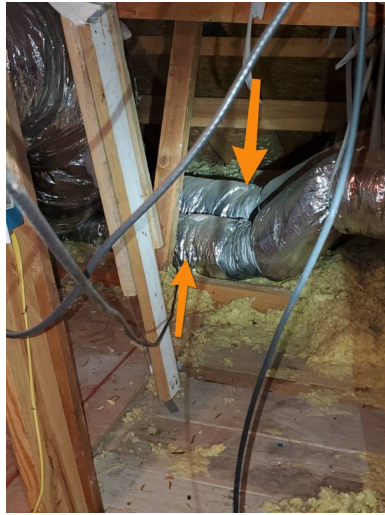
4: Lack of adequate spacing between ducts

Observed lack of adequate spacing or clearance between ducts which are in contact with each other. This may lead to possible condensation leading to water damage to finished ceiling below. Highly recommend proper correction to this defect. See pictures in other comment in this section.

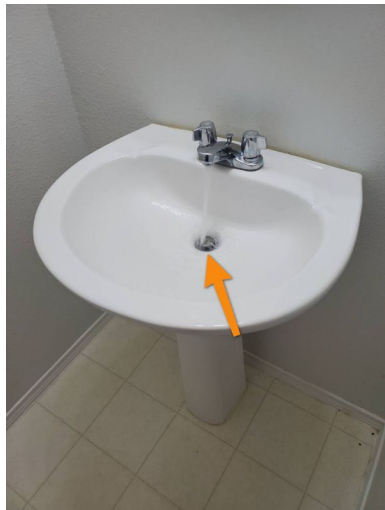
Common toilet

Observed drain pop up inoperable.

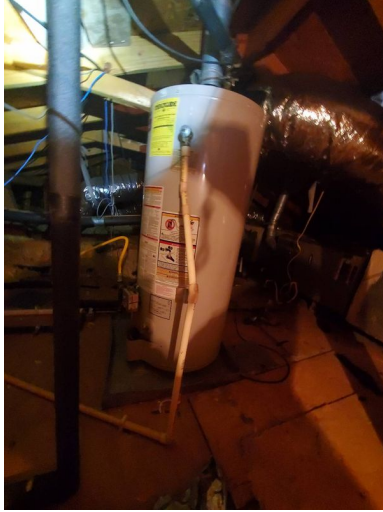
1: Gas flu/vent loose, damaged

Gas flue/vent is loose, damaged, improperly installed or poorly connected at water heating equipment and was observed to be a SAFETY HAZARD. Loose, damaged, improperly installed or poorly connected gas exhaust flu should be corrected. Loose, damaged, improperly installed or poorly connected gas exhaust flues are a SAFETY HAZARD and should be repaired prior to operation of the water heating equipment.

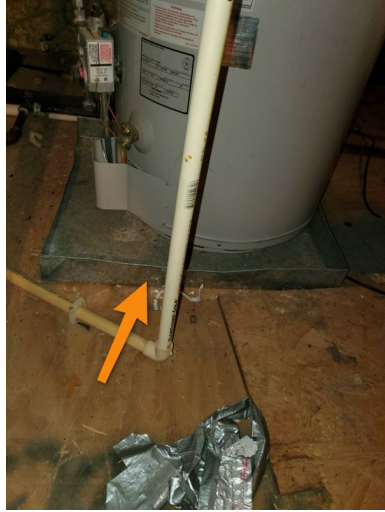
5: Water Heater - Passed average life expectancy
