## DOMESTIC/CAUSE & ORIGIN LEAK INVESTIGATION

Homeowner's Name	Mariann Porter
Work Order #	32062
Testing Address	119 Dover Grace, New Braunfels, Tx 78130
Date of Service	Sep 7, 2022
Homeowner's Phone #	(830) 708-1075
Work Performed by:	Sonny Osborne By JT
Payment Type	Check
Pictures of Home

## POOL LEAK DETECTION

Homeowner's Name	Mariann Porter
Work Order #	33383
Date of Testing	Nov 2, 2022
Testing Address	119 Dover Grace, New Braunfels, Tx 78130
Homeowner's Phone Number	830-708-1075
Payment Type	Credit Card
Technician's Name	Carlos Gutierrez By JT

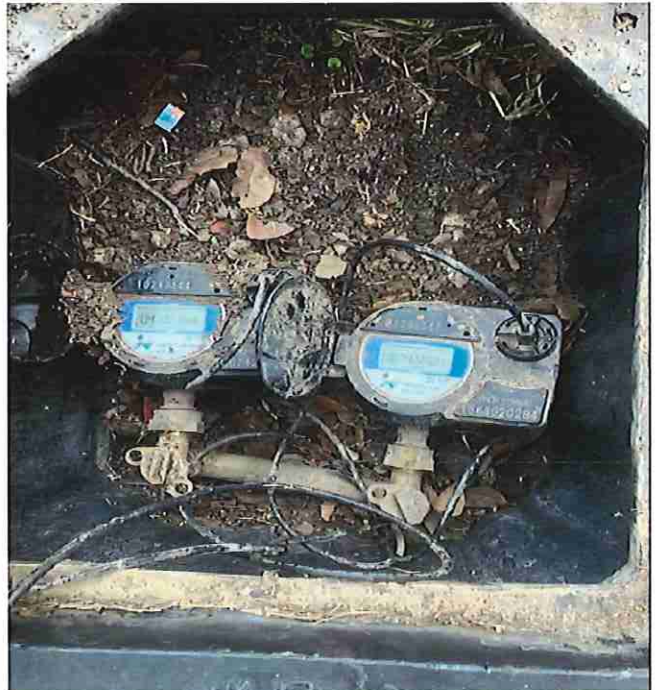
Additional Pictures

The only thing we found is that the water meter has very unusual meter movement, the meter seems to be bouncing backwards and forwards causing the water meter to show constant movement.

- ◆ The incoming pressure is too high and needs to be reduced.

We recommend keeping the incoming pressure between 60 – 80 PSI. Installing a PRV (pressure reducing valve) is recommended to avoid future damage and future leaks.

We recommend considering contacting a professional servicing plumbing company to address this issue.

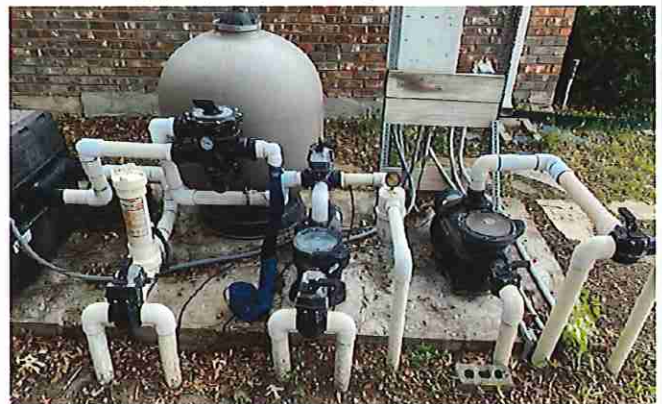
Pictures of the System's Equipment

The pools equipment is clean dry and functioning properly. No signs of leaks.
