18527 Haughland Dr Cypress, TX 77433 April McGee

## PROPERTY INSPECTION REPORT

Prepared For:	April McGee
•	(Name of Client)
Concerning:	18527 Haughland Dr, Cypress, TX 77433 (Address or Other Identification of Inspected Property)
By:	Kelly M Herbert, Lic #TREC21822 06/05/2019 (Name and License Number of Inspector) (Date)
	(Name, License Number of Sponsoring Inspector)

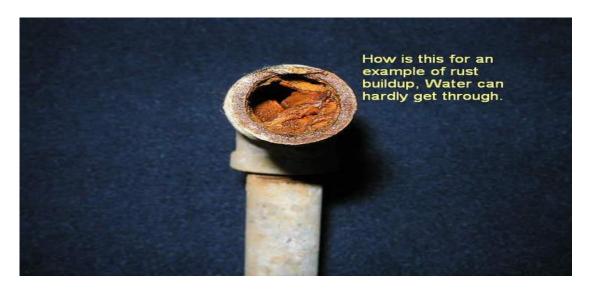
# What Causes Galvanized Steel Pipe to Leak? (pipe failure)

Brown or discolored water and low water flow in galvanized piping systems is a sign of rust and corrosion buildup within the pipe.
