Inspection Report

Property Address:
18527 Haughland Drive
Cypress TX 77433

Sandstone Inspections

PROPERTY INSPECTION REPORT FORM

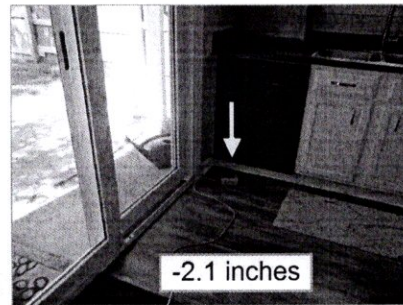
Kitchen area

Significant differential movement / settlement observed: indicated by elevation readings, cracks in brick veneer and/or foundation, cracks in sheetrock over doors and windows, uneven floors, and doors that are not square in jamb.

In my opinion the foundation is not performing its intended function; the distress patterns observed at the time of the inspection are/were severe enough to recommend further evaluation and/or repair by a licensed engineer/foundation company.

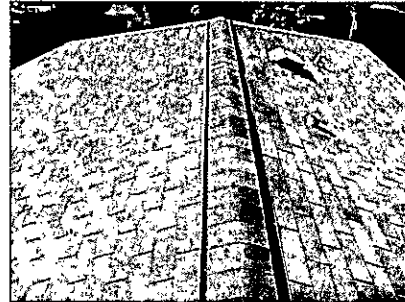
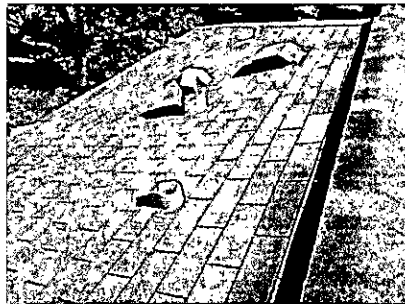
Missing roof shingle and exposed nail heads observed on roof ridge at south side of the house. recommend replacement to prevent water entry.

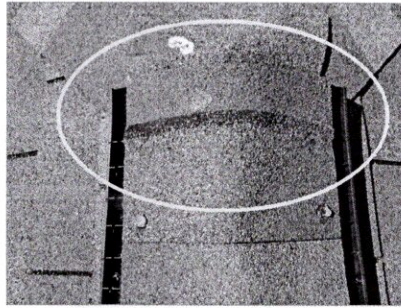
Marks on the roof observed at various locations suggest slight ice impact damage or similar damage.

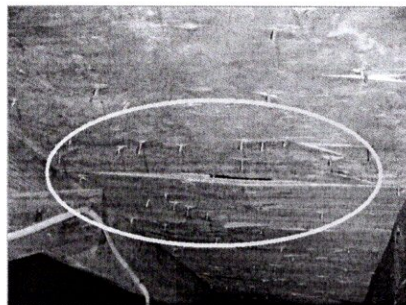
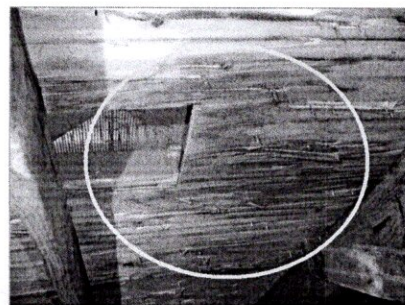
Water damaged roof decking and uneven roof decking observed at various locations in the attic is an indication of previous water penetration.

Uneven roof decking may cause sagging of exterior roof shingles.

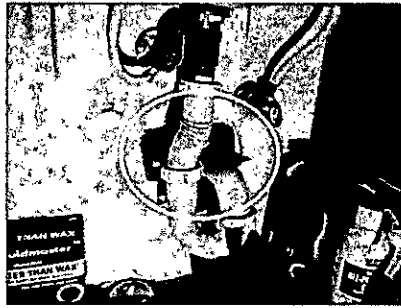
Damage to wall sheetrock observed under the secondary bathroom sink.

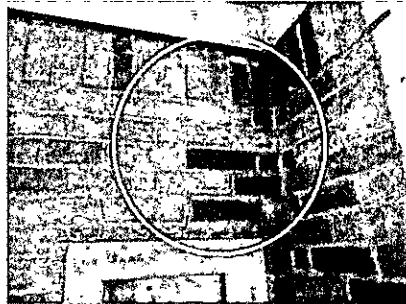
Cracks in brick veneer observed at front of the house. Recommend tracking movement of cracks if any by taking pictures and recording width.

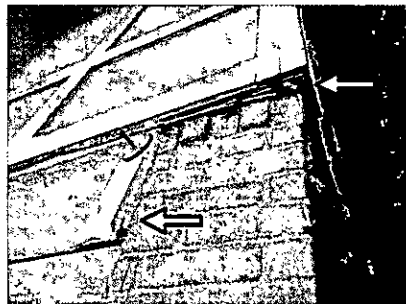
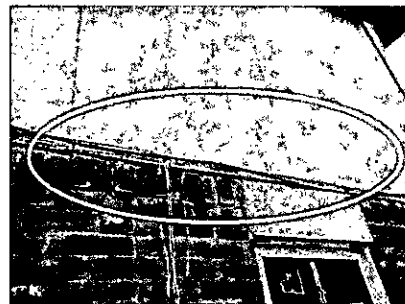
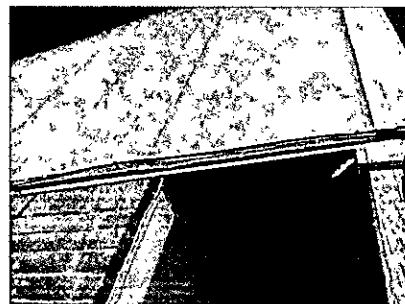
Observed exterior siding material is significantly damaged/deteriorated and will allow water penetration at various locations around the house including around window and/or door frames. The inspector can not determine the condition of wood structural members behind wall covering materials.

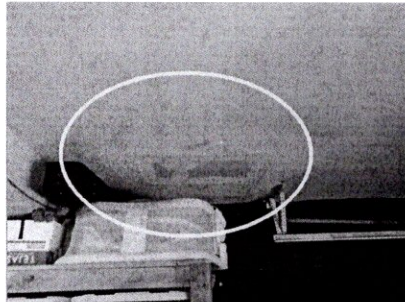
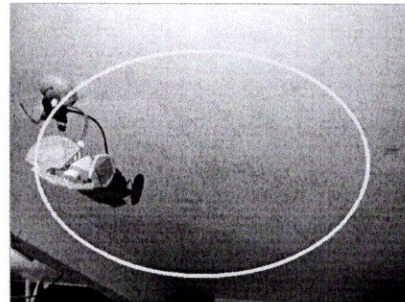
Evidence of previous moisture and/or evidence of previous repairs to the ceiling observed in the garage.
No excessive moisture observed at the time of the inspection

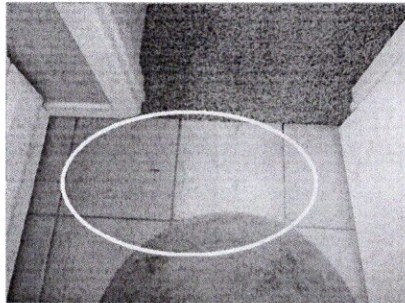
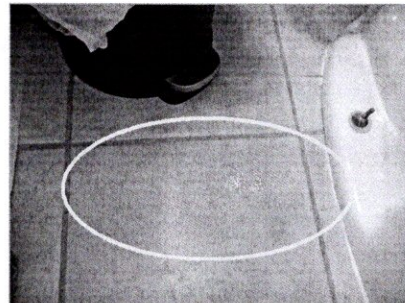
Cracks and/or loose floor tiles observed in the bathrooms.

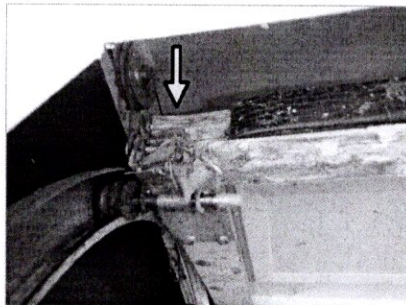
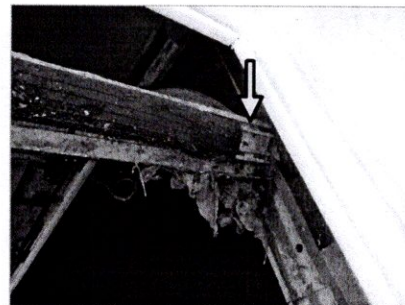
Garage door weather stripping is damaged at both doors. Recommend repair/replacement to prevent water/insect/critter entry.

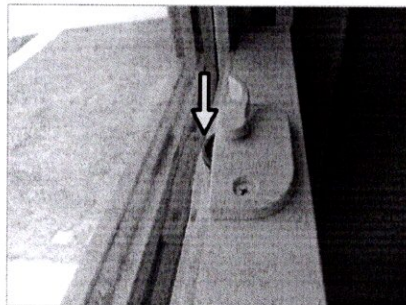
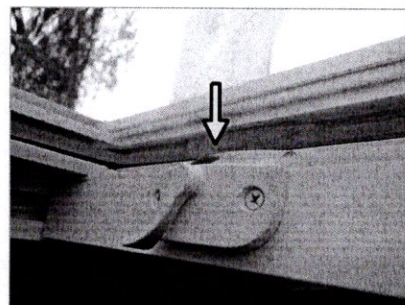
One or more windows, including the primary bedroom, do not latch or latch with difficulty.

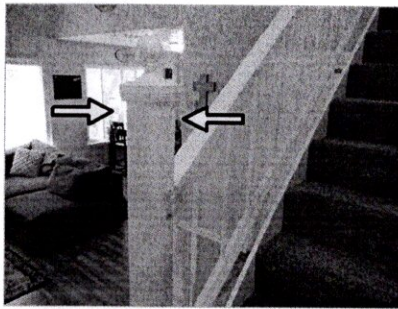
Space between railings does not comply with current industry standard, (code) UBC 421.1.1 & CABO D105.2.1. Requires spacing between intermediate rails do not allow passage of an object four inches in diameter. Recommend covering large openings in stair rails with temporary type nylon netting if small children are present in house to prevent injury.

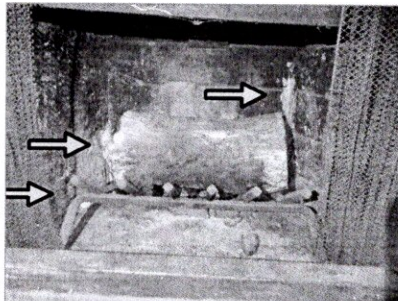
Observed fireplace damper is missing the required bracket/weight to keep the damper from fully closing when the fireplace is equipped with fire logs to prevent combustion gasses from entering the residence.

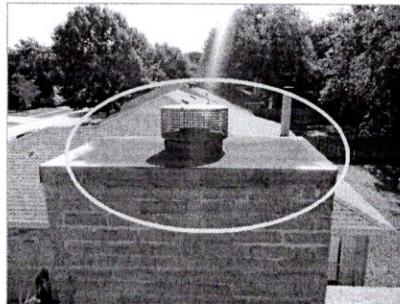
Metal chimney crown is excessively rusted and holding water. Recommend painting with rust protective coating to prevent further damage.

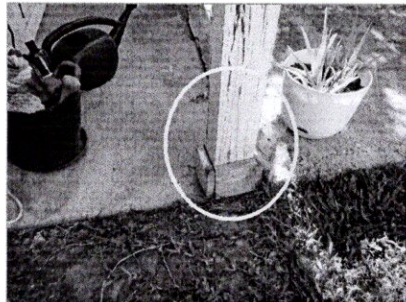
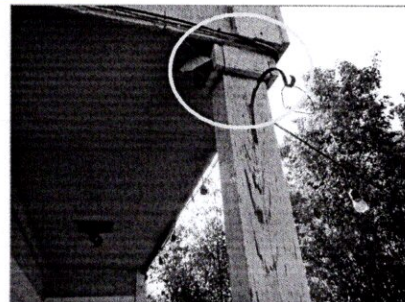
Wood damage/deterioration observed at rear porch wood column.

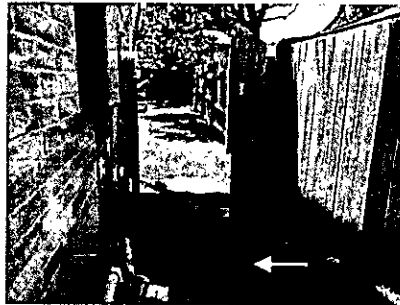
The exterior fence gates rub the ground and can not be closed/latched properly.

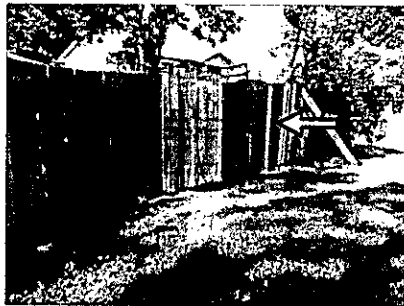
The exterior fence is not properly secured/leaning over at various locations.

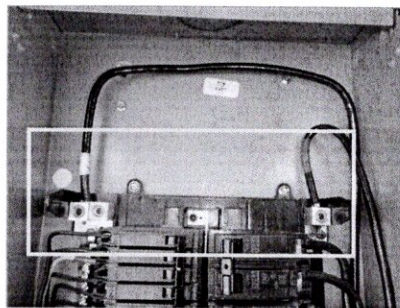
Main disconnect breaker appears to be oversized for feeder wiring used; reference NEC 310-16 note 3. Replace breaker or feeder wiring with proper size. Recommend further evaluation and repair by a licensed electrician.

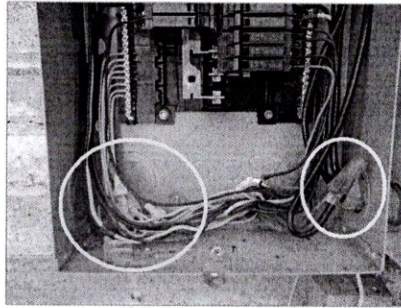
Pig-tail connections observed at the interior of the electrical panel box need to be further evaluated by a licensed electrician.

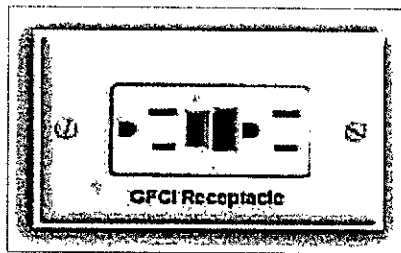
No GFCI protection observed in the exterior and in the garage.

Insufficient GFCI protection observed in the kitchen.

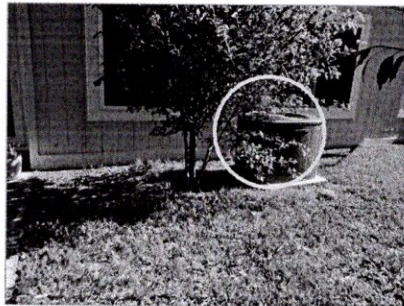
Observed bushes in contact with condensing unit. This condition will block air flow through the coils, and it will bring moisture and damage to the coils/unit.

The condensing unit is too close to the ground. Equipment and appliances supported from the ground shall be level and firmly supported on a concrete slab or other approved material extending not less than three inches above the adjoining ground (CODE M1305.1.4.1).

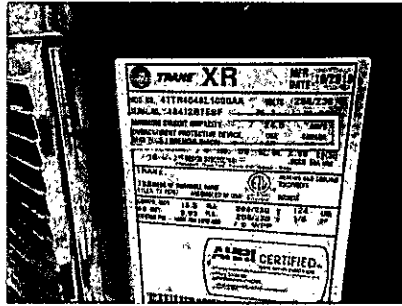
Observed improper sizing of breaker to condensing unit may void manufacture's warranty. Data plate on unit states maximum breaker size to be 40 amps, observed size in service panel is 50 amps.

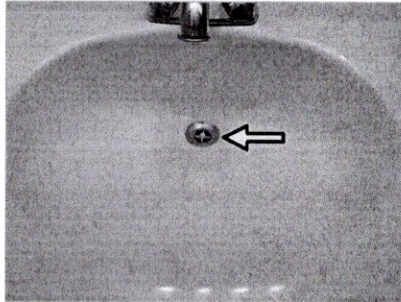
The drain stopper or pop-up lever assembly of secondary bathroom sink is missing.

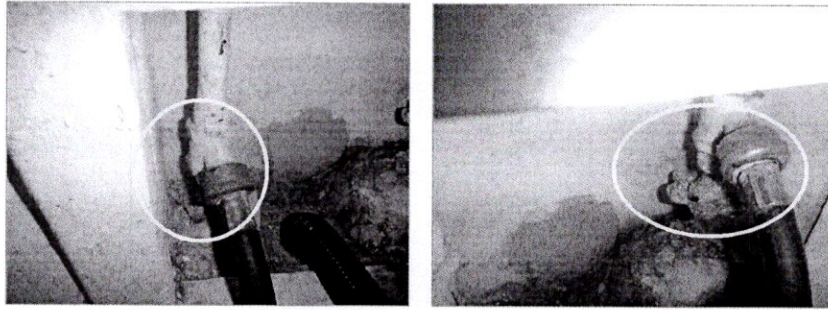
The laundry water supply valves are significantly rusted.

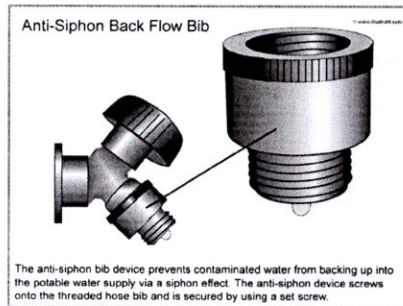
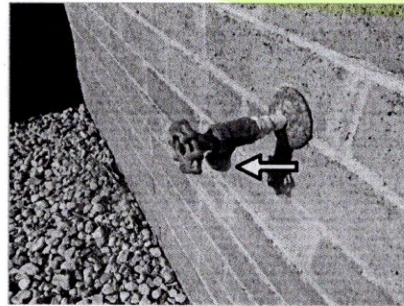
Exterior hose spigot(s) do not have code approved anti-back flow devices installed.

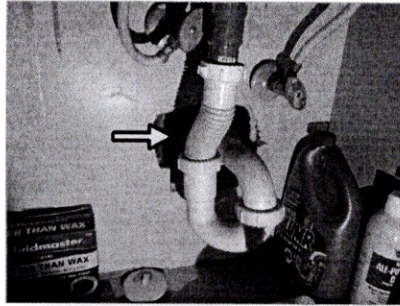
Improper drain material observed at secondary bathroom sink. Flexible material at sink P-traps is not allowed by current plumbing standards.

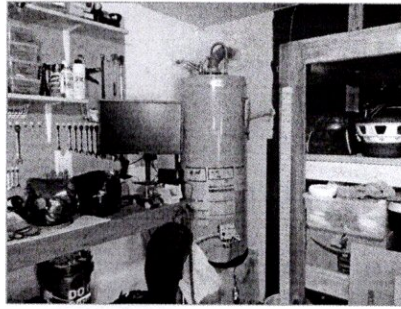
Observed gas line and hot/cold water lines are not properly bonded near water heater. The inspector was unable to verify proper bonding of metal water pipe lines.

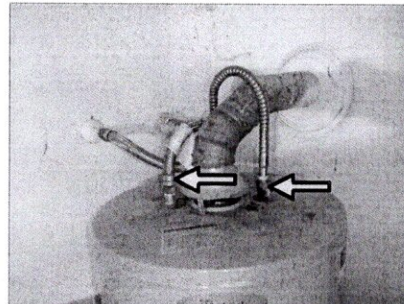
Rust and leakage was observed at water heater tank and plumbing connections.

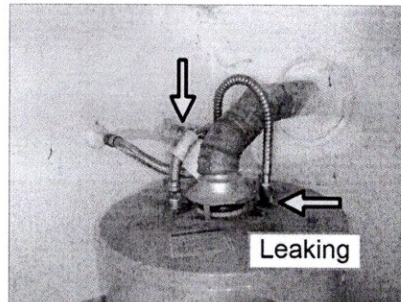
Observed water heater is missing a drain pan. Where a storage tank type water heater is installed in a location where water leakage from the tank will cause damage, the tank shall be installed in a galvanized steel pan (CODE IRC P2801.6). Recommend installing drain pan to prevent damage to wall, floor, and/or objects around the water heater should there be a leak.

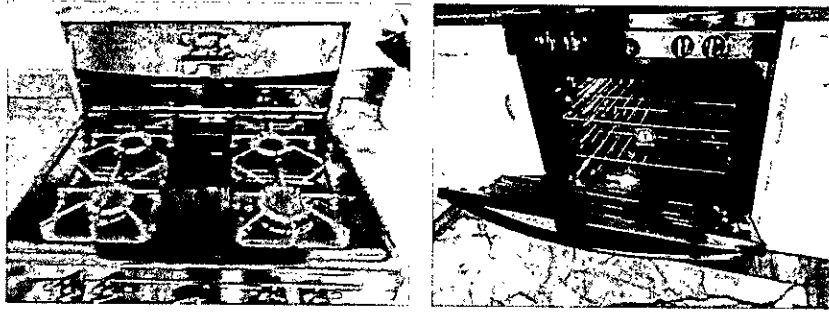
The oven door handle is loose.

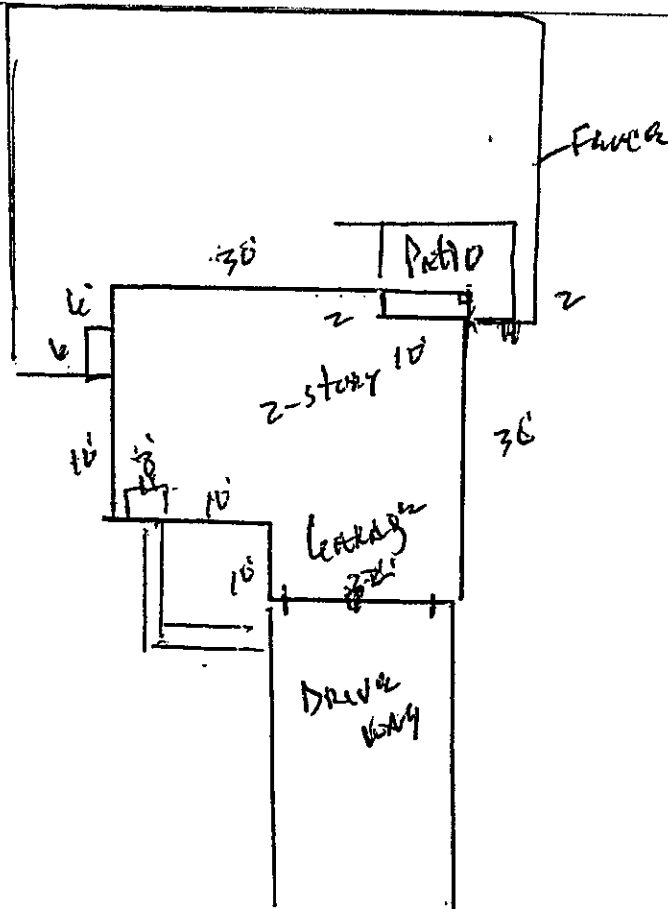
Diagram of Structure(s) Inspected

No visible evidence of wood-destroying insects this date, past or present
