PROPERTY INSPECTION REPORT

Age of Home: 2013 Size: 1,643
Structure Type: Structure is a wood framed structure on a concrete slab foundation.

| Matt Messer Name of Client 5626 That Way, Kingwood, Texas 77339 | 5/3/2023 Date of Inspection | |

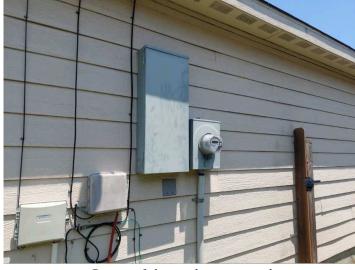
- Service entrance wiring is underground
- The aluminum wiring in the service panel noted to be missing anti-oxidant grease.

Picture of electrical service panel

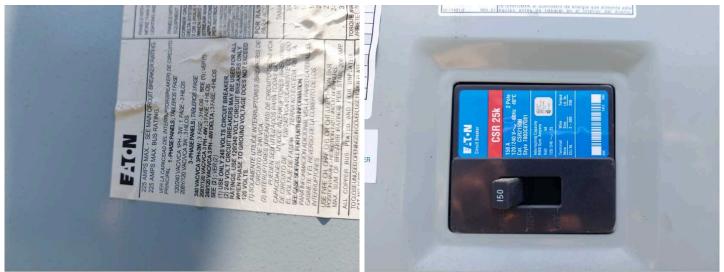
Panel manufacturer

Aluminum service conductors missing anti-oxidant grease

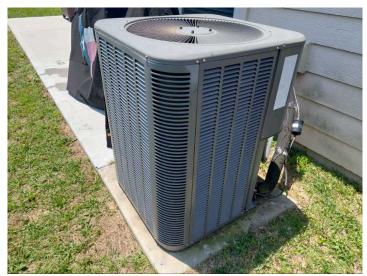
- The temperature difference between Return Air and Supply Air is 11.7 deg F.
- The air temperature measurements will be taken at the return air vent and at several supply air vents. The temperature drop / differential is required to be between 15 22 degrees. In the event the air temperature differential measures below 15 degs F, the AC unit will be noted defective and recommended to be evaluated by a reputable HVAC contractor.
- Rust and/or corrosion was noted in the condensate drip pan
- Temperature drop/differential was not observed between 15-22 degrees. (taken between interior return and supply air).

This is considered a defective system and should be serviced by a licensed HVAC contractor.

AC condensing unit

• The HVAC system should be further evaluated by a Qualified Licensed HVAC contractor

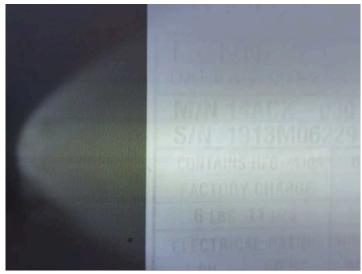
AC condensing unit data tag (s/n 1913M...) (2013)

Evaporator overflow pan has corrosion and should be monitored for further degradation

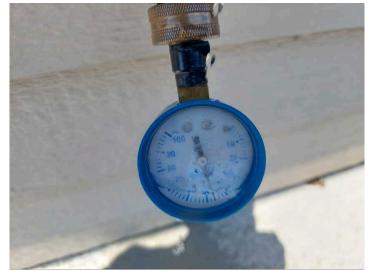
Water pressure (46 psi)
