PROPERTY INSPECTION REPORT

“AROUND THE HOUSE” HOME INSPECTIONS

Concerning: 13106 Sierra National Drive, Atascocita, TX 77346

By: David J. Stiles Inspector Lic. #7308 11/10/2019

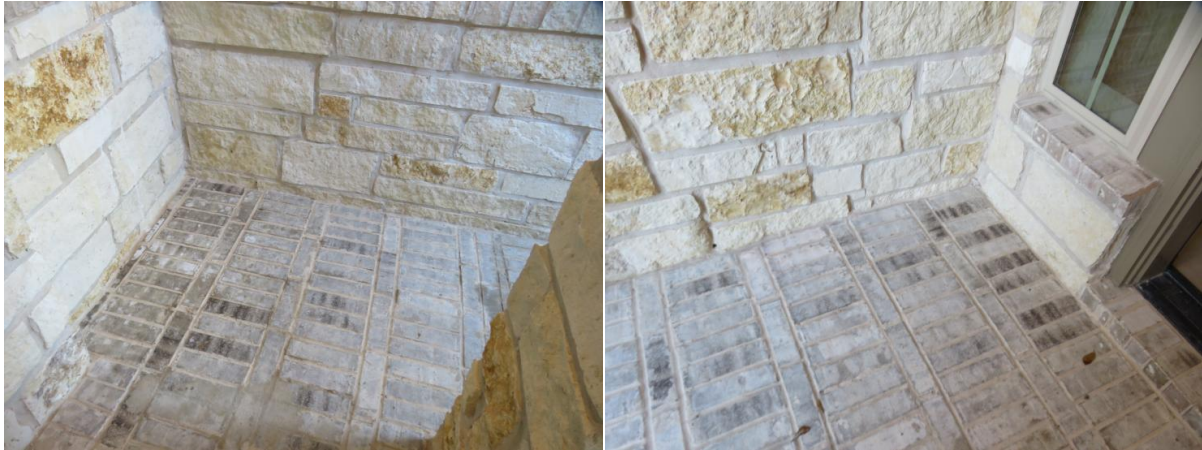
- The front porch wall lacks weep holes necessary to shed condensate that may form behind the exterior wall.

Examples *To Be Repaired 11/20*

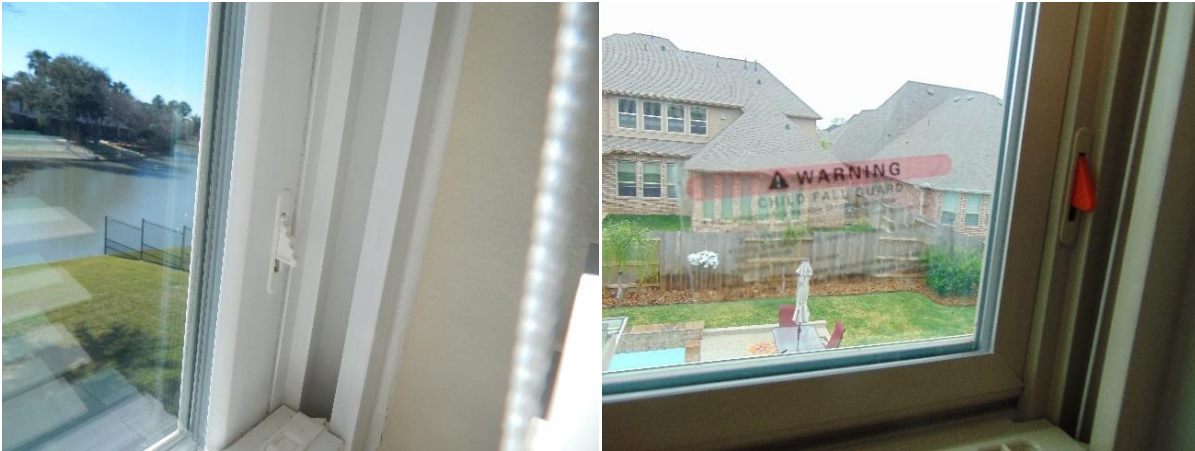
- Windows >72" above the exterior finished grade are required, at sill height, to be a minimum of 24" above the finished floor for child fall safety precautions. IRC {612.2}. The only exceptions include (1) windows that do not open in excess of 4" sphere, (2) windows that are equipped with fall protection devices per ASTM F 2090 and (3) approved window opening limiting devices.

Examples of a safety device

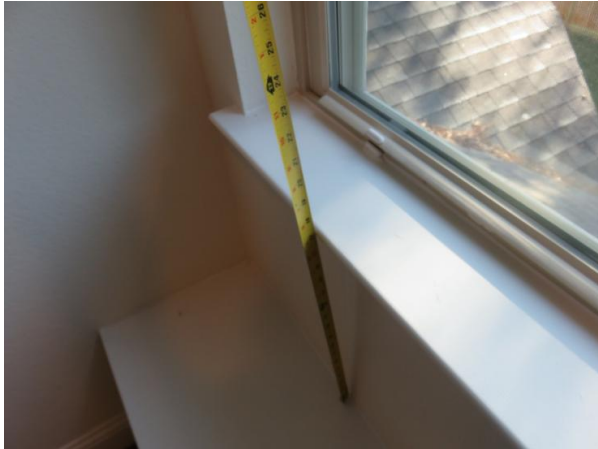
Current installations in the 2nd floor game room. The shelf below the windows makes the window accessible/height above the shelf less than 24".

Installing Angel locks
11/18

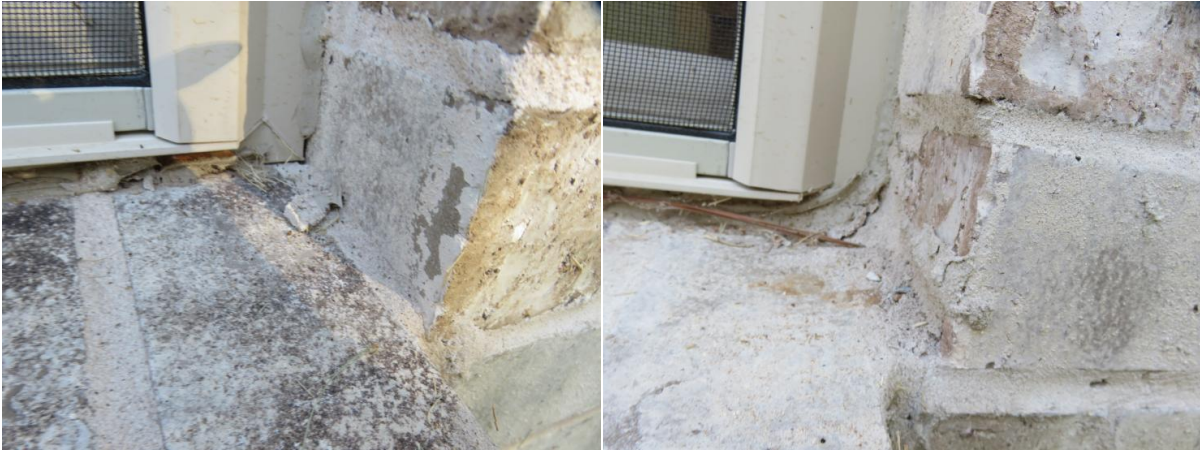
- The builder should inspect all window frames for adequate caulk sealant.

Examples *To be repaired 11/15*

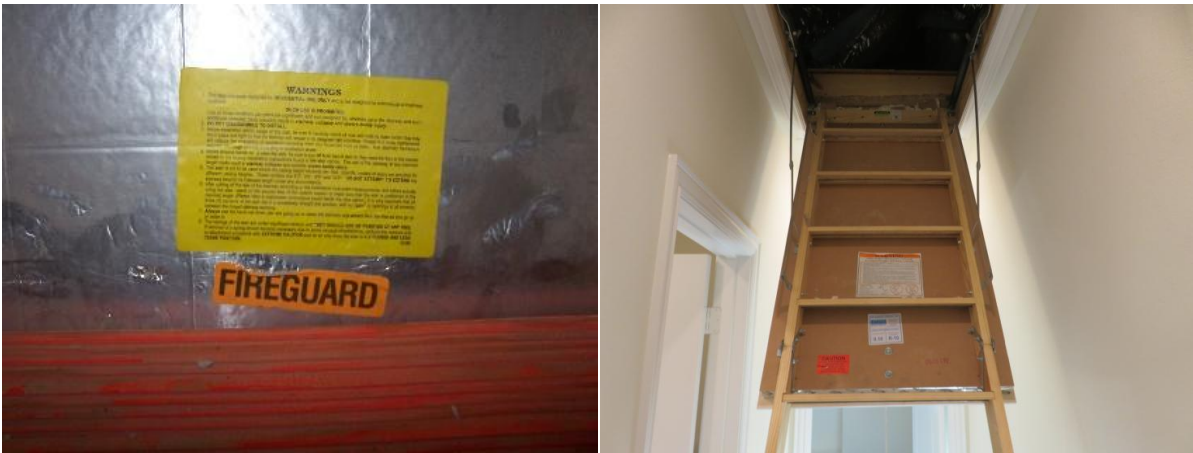
- Pull down attic stairs breach the firewall capacity of the sheetrock ceilings unless they are fire rated. Additionally, the stairs are required to be clad with insulation to form a barrier between the attic and living area of at least R-10. As per the manufacturer, these stairs are insulating accommodations but do not offer a fire rating equal to the wallboard ceilings and walls in the home.

Example of fire rated stairs and current installation

Fireguard door not required when installed inside home.

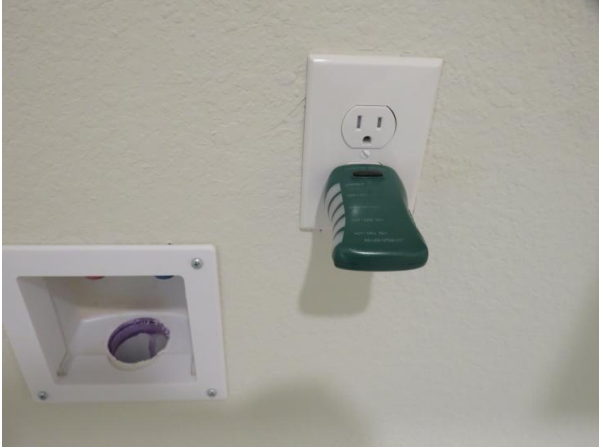
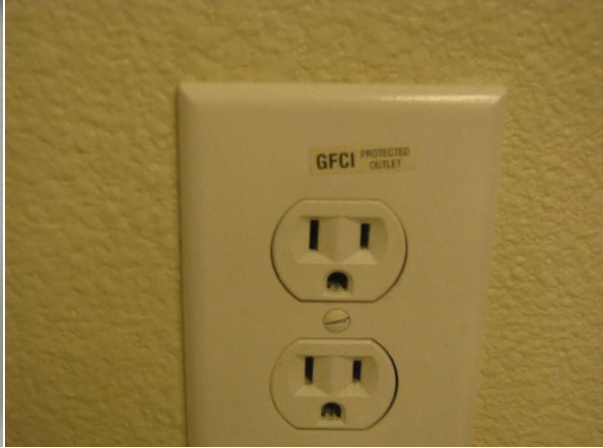
- The outlet(s) on the family room side/dining side of the kitchen sink countertop are required to be GFCI safety rated and no lower than 12" beneath the countertop for safety of crawling toddlers and smaller children. (IRC 3901.4.5X). While not specifically intended for use at the countertop the outlet is GFCI protected and would undoubtedly be used at the countertop and electrical cords may not reach the outlet of an appliance creating a safety hazard.

Required and current installation *Cannot move but is GFCI*

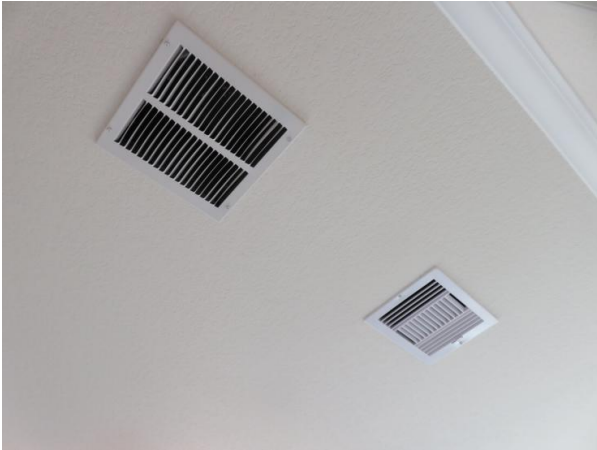
- Supply and return registers should be spaced at least 36"/3' apart.

Example lacking separation in the 1st floor front left bedroom

To be inspected
11/15

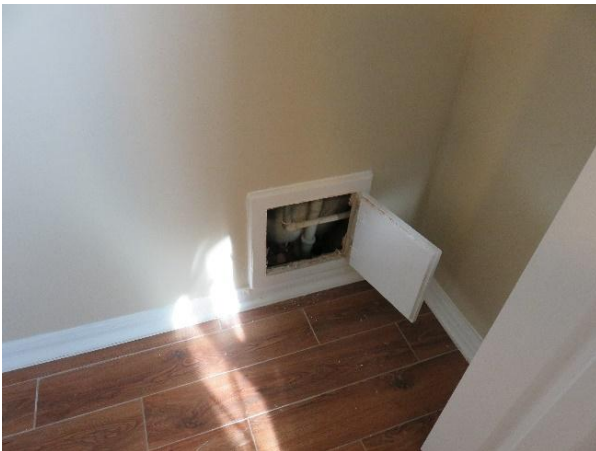
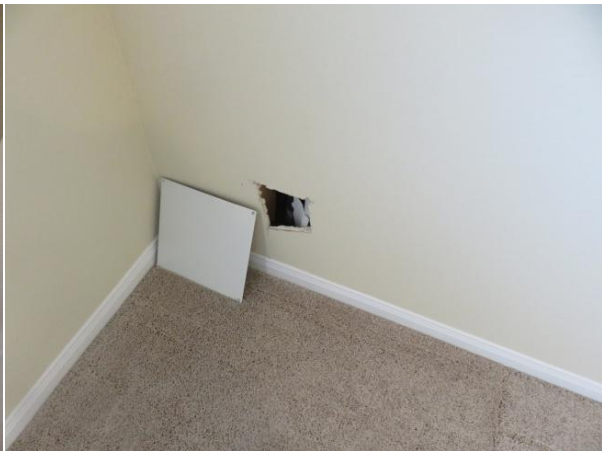
- To readily access plumbing connections in bathrooms for showers and bathtubs it is a required procedure to have access openings installed in walls adjacent to/behind in-wall plumbing fixtures. An access opening at least 12" X 12" is required for repair or replacement of concealed slip joints. The opening can be a ceiling or a wall. {IRC 33201.1} (UPC 404.2)

Examples of opening for drain and plumbing inspection

Only required if a jacuzzi motor is present.

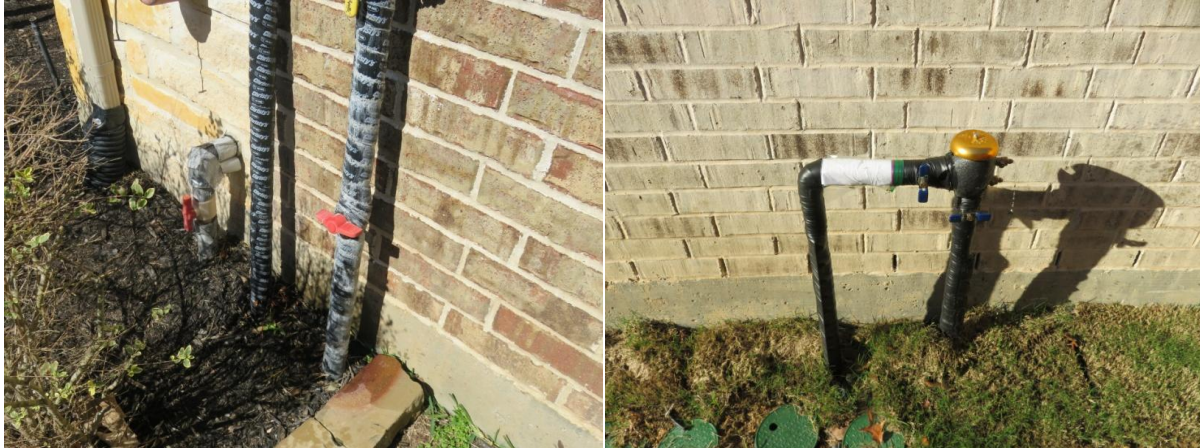
- The backflow preventer should have an intermediate shut off valve on the supply side.

Example and current installation *Show buyer location of ball valve*
