Property Inspection Report

Habib Othman 22007
Bullseye Engineering Inspection, LLC

3615 Windy Drift Ln
Inspection Prepared For: Krishnamoorthy Gopal
Agent: -

Date of Inspection: 6/7/2023
Year Built: 2007 Size: 2973
Weather:

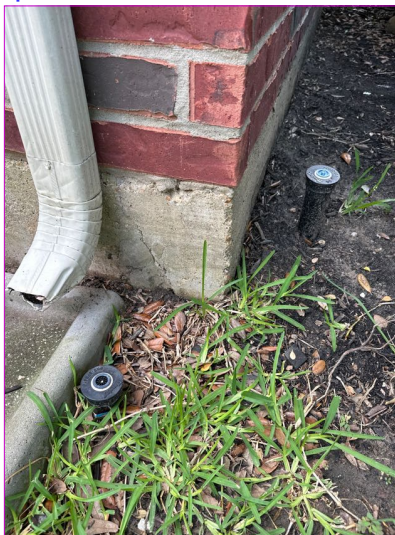
- Cracks noted at the corners of the foundation walls. These are called corner pops and are very common and not a structural issue at this time, but should be properly sealed to prevent further deterioration and termite infestation.

Corner crack (front-left)

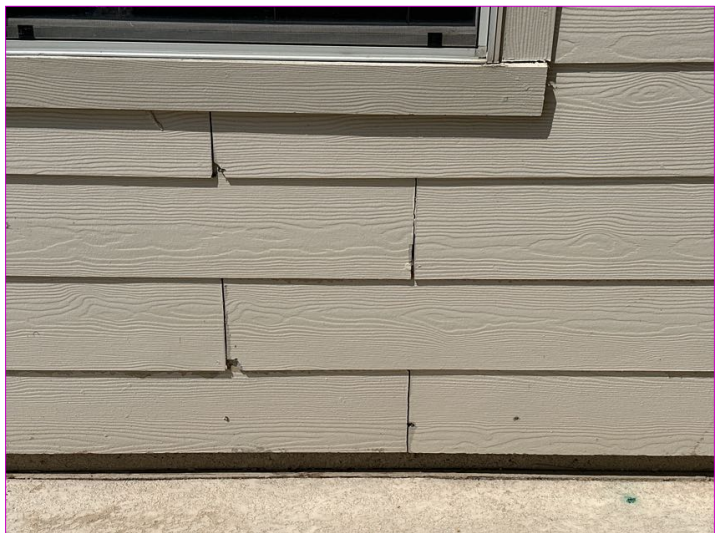
Siding gaps (rear side)

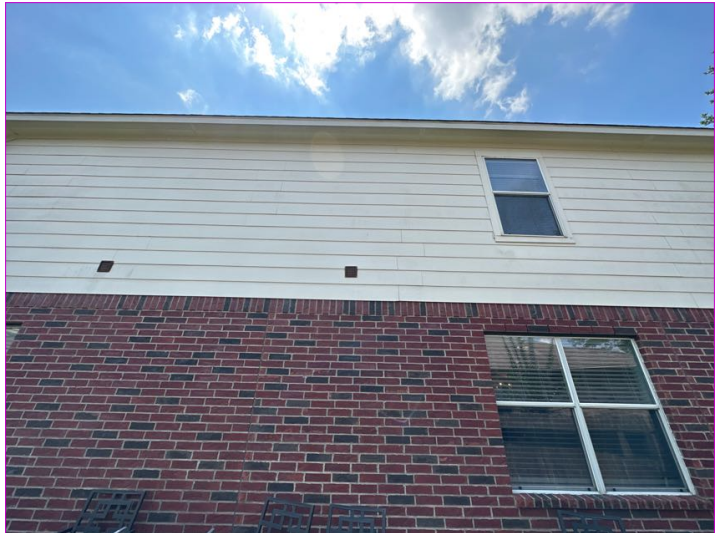
Siding gaps (left side)

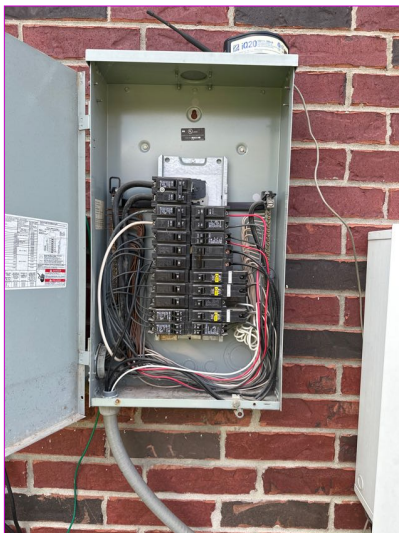
- The aluminum main service wires were missing anti-oxidant gel. Aluminum service wires can become very hot and also corrode over time. It is crucial to apply an anti-oxidant gel to the wires where they meet the main lugs of the service panel.

Electric panel interior

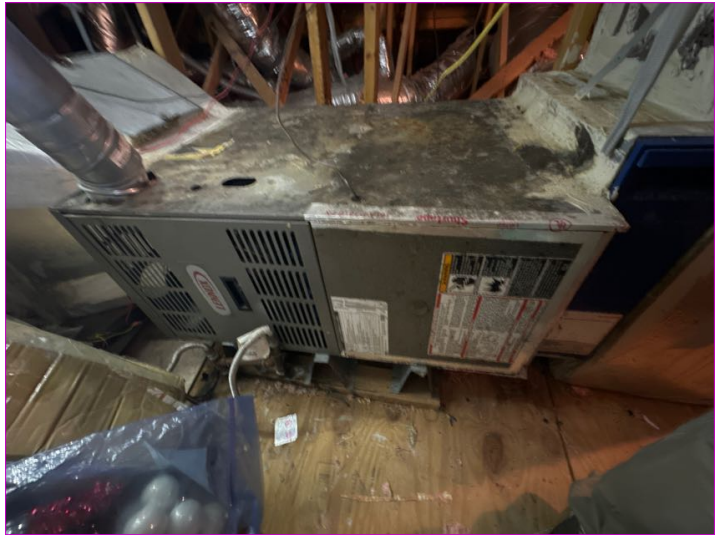
Lennox gas furnace

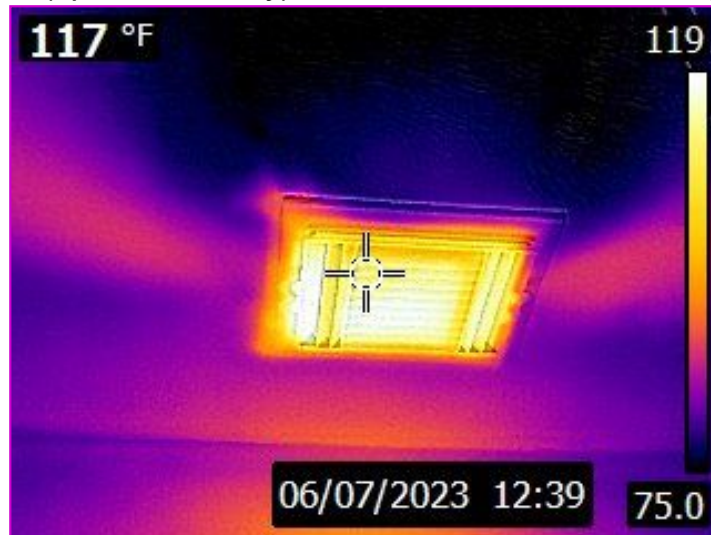
Furnace hot air temperature

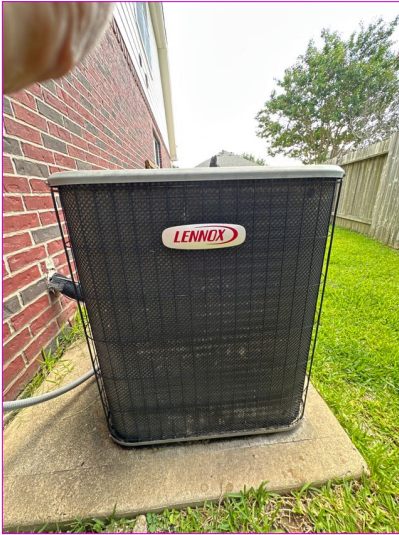
2007 Lennox AC condenser (right side)

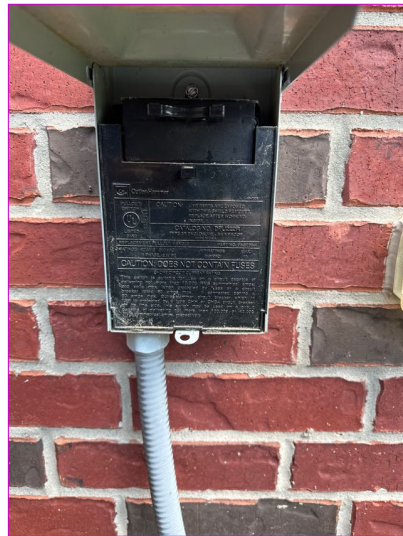
AC main disconnect OK

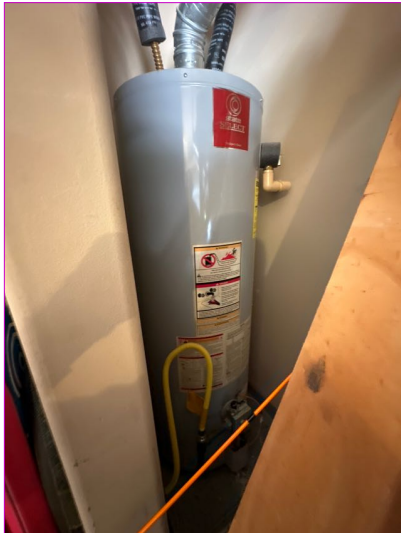
2007 State gas water heater

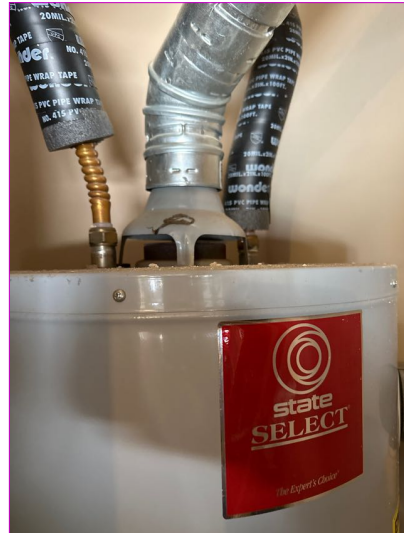
Pipe fittings OK

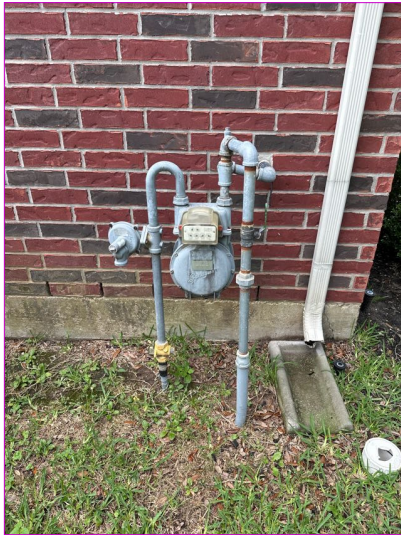
Gas meter (left side)

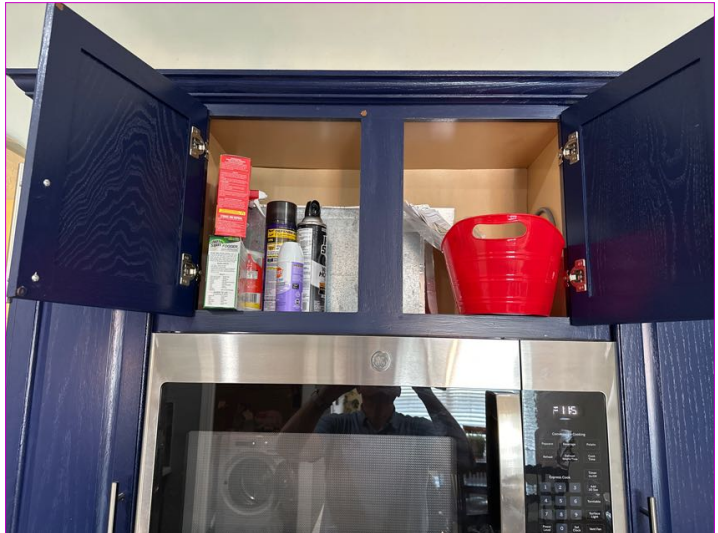
Outdoor exhaust duct OK

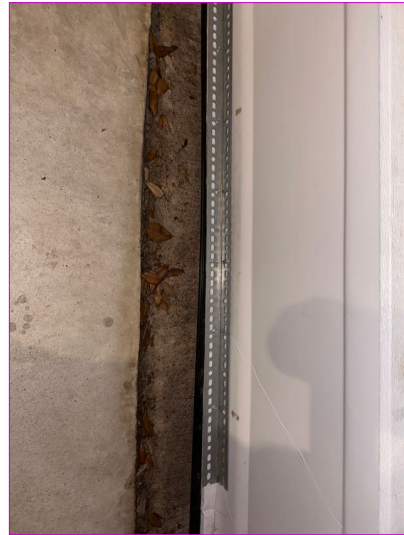
Repaired garage door

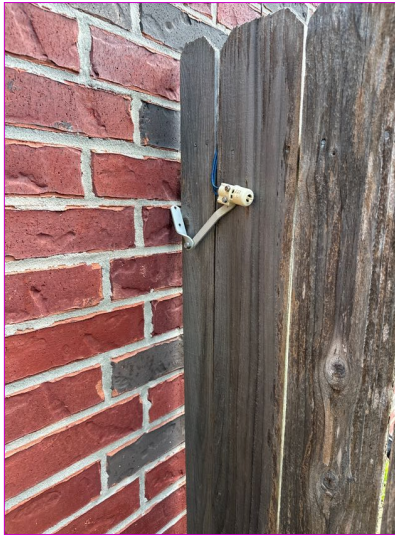
- Loose rain sensor

Loose rain sensor

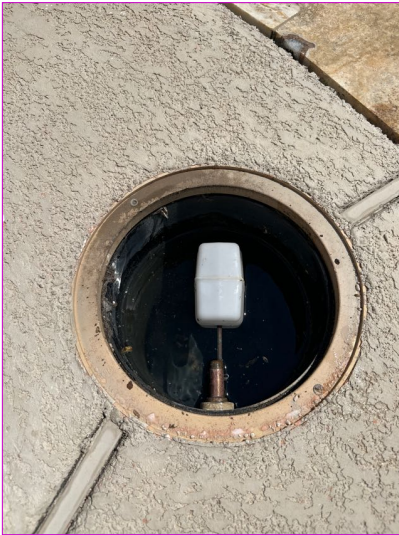
Automatic water filler OK

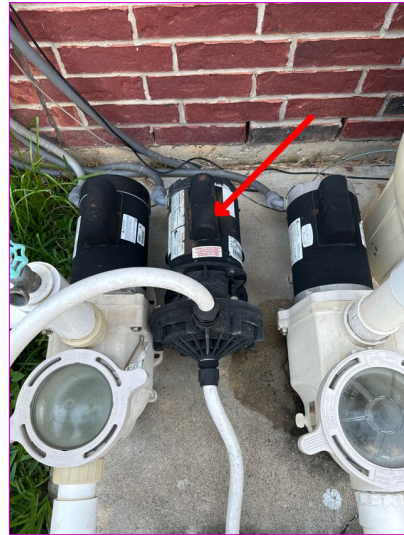
Cleaner pump OK

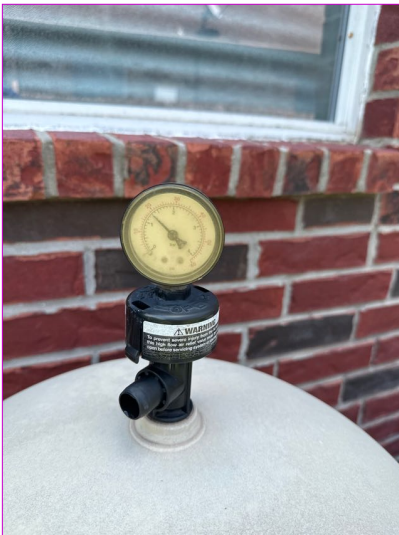
Pressure gauge OK

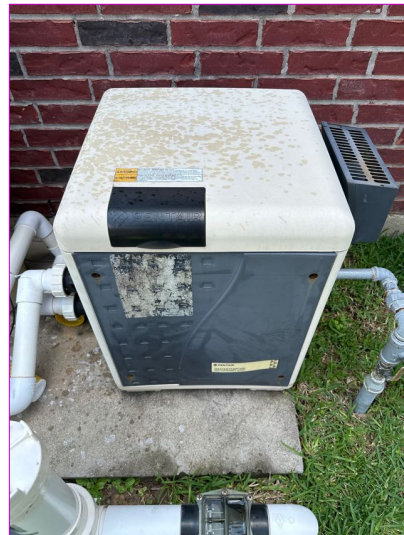
Gas furnace OK
