BPG Inspection, LLC

**21839 Hannover Village Drive
Spring TX 77388**

Client(s): White
Inspection Date: 6/1/2020
Inspector: Murray Campbell , TREC #22455

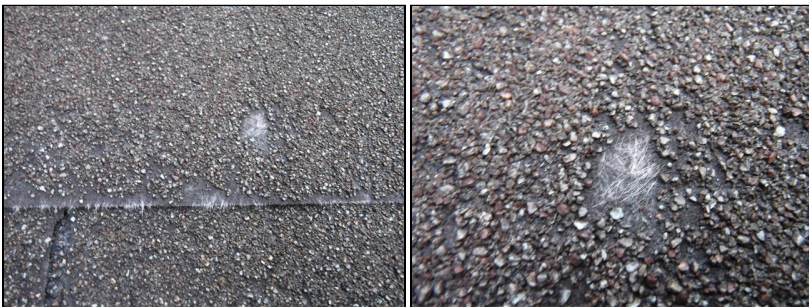
- 1. The shingles are worn with some granular loss on the ridge areas. A roofer should perform a maintenance check on the covering for needed repairs, patching or replacement of worn shingles.
- 2. There are signs of previous hail strikes.

There are signs of previous hail strikes.

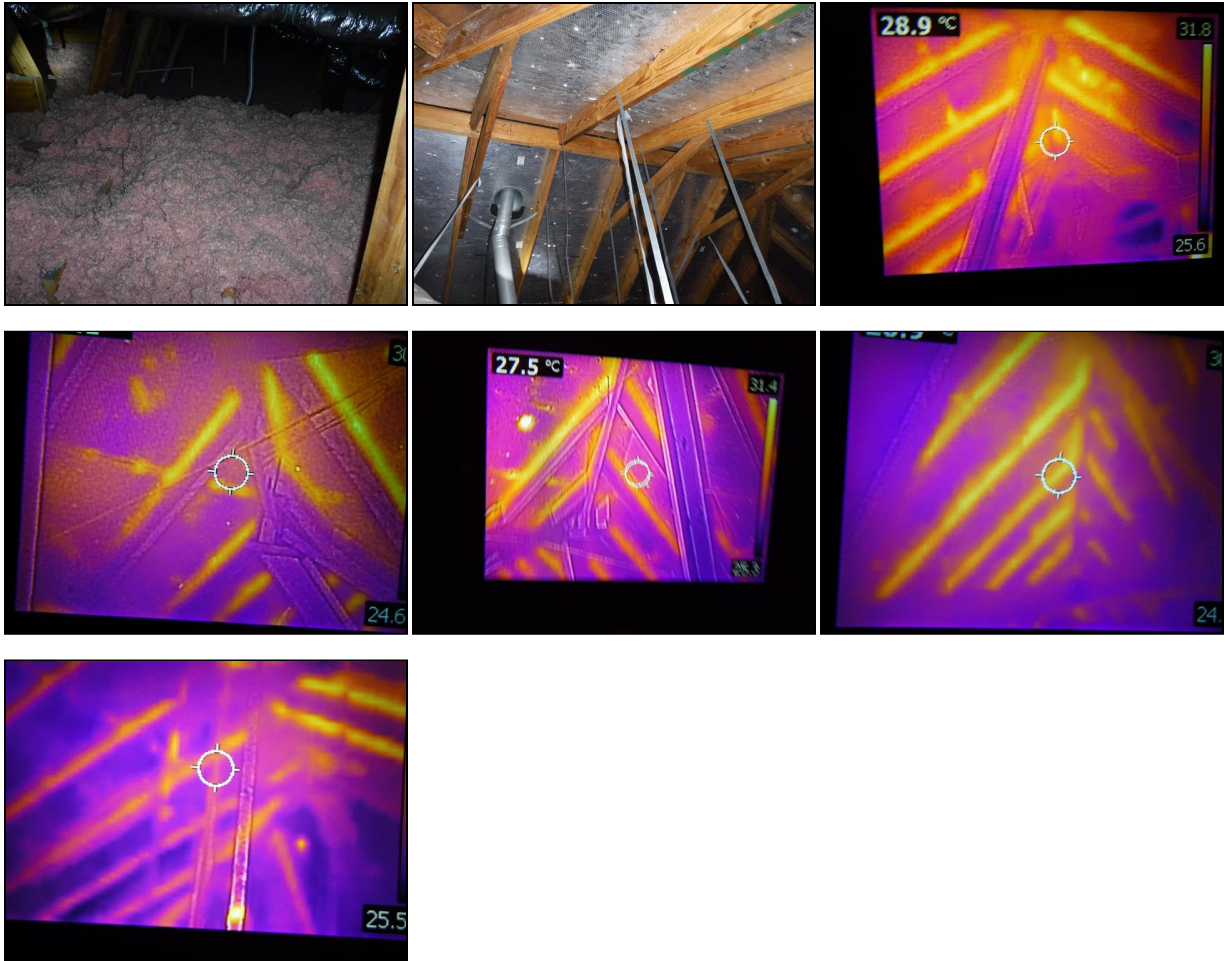
The structure was in good condition. No leaks were active or apparent at time of inspection. Insulation determined to be at acceptable levels/depths. At accessible areas inspected.

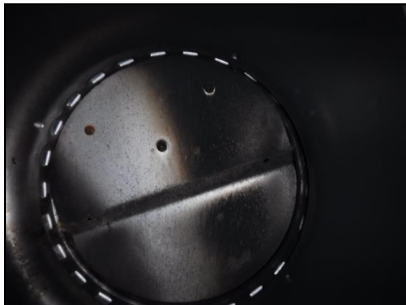
Fireplace does not have a damper blocking device installed as called for by today's standards in fireplaces with gas log systems. <http://damperclamp.com/installation.php>

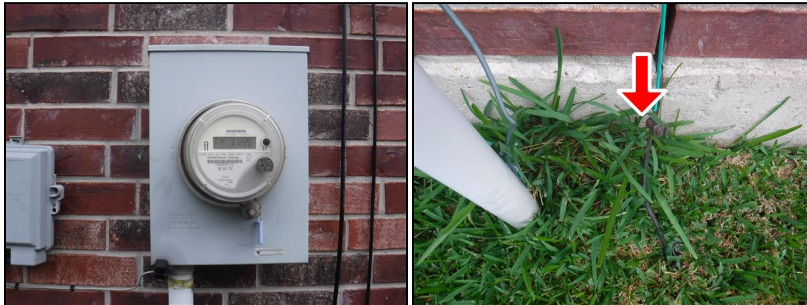
The main panel box is located in/at the Garage.

System panels installed correctly, grounded and bonded.

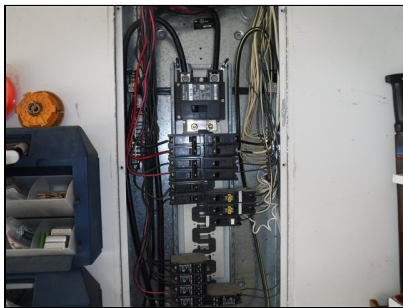
Neutral wires are not individually lugged to the panel neutral bus bar as called for by today's standards.

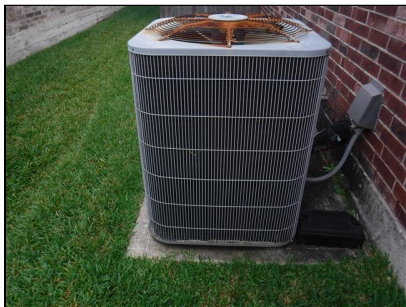
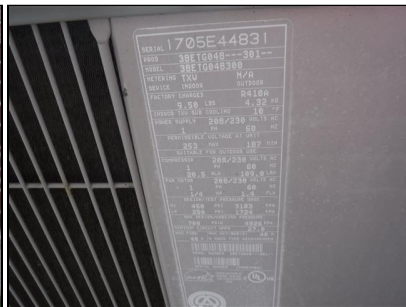
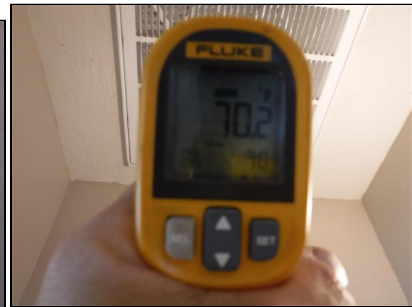
The main unit functioned at time of inspection. Target temperature drops between 14-22 degrees were obtained.

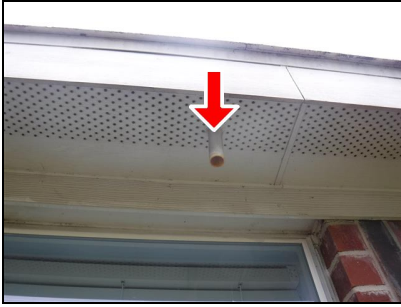
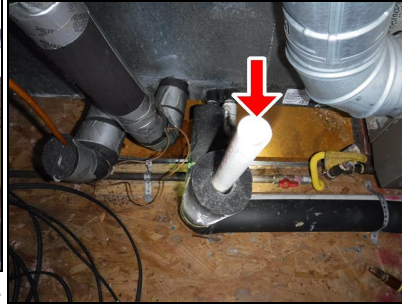
A/C secondary drain located right side of residence.

- 9. Rust noted in the secondary drain pan. The rust may extend to the bottom of the pan, which may result in water leaking onto the surrounding area. This is typically from excess condensation, most times produced from a soiled evaporator coil. I recommend replacing or repairing pan as needed. I also recommend that the system be serviced by a licensed HVAC technician to address the cause of excess condensate before closing.

Rust noted in the secondary drain pan. The rust may extend to the bottom of the pan, which may result in water leaking onto the surrounding area. This is typically from excess condensation, most times produced from a soiled evaporator coil. I recommend replacing or repairing pan as needed. I also recommend that the system be serviced by a licensed HVAC technician to address the cause of excess condensate before closing.

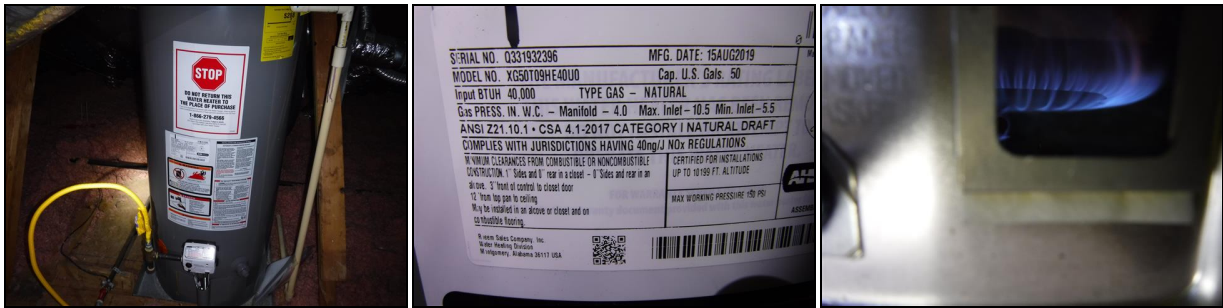
Temperature readings at sinks were measured at a higher than suggested setting. The U.S. Consumer Product Safety Commission (CPSC) urges all users to lower their water heaters to 120 degrees Fahrenheit. In addition to preventing accidents, this decrease in temperature will conserve energy and save money. Most adults will suffer third-degree burns if exposed to 150 degree water for two seconds. Burns will also occur with a six-second exposure to 140 degree water or with a thirty second exposure to 130 degree water. Even if the temperature is 120 degrees, a five minute exposure could result in third-degree burns. Consumers should consider lowering the thermostat to the lowest settings that will satisfy hot water needs for all clothing and dish washing machines.
