## INVASIVE STUCCO INSPECTION

1301 Milford St  
Houston, TX 77006

MARCH 7, 2022

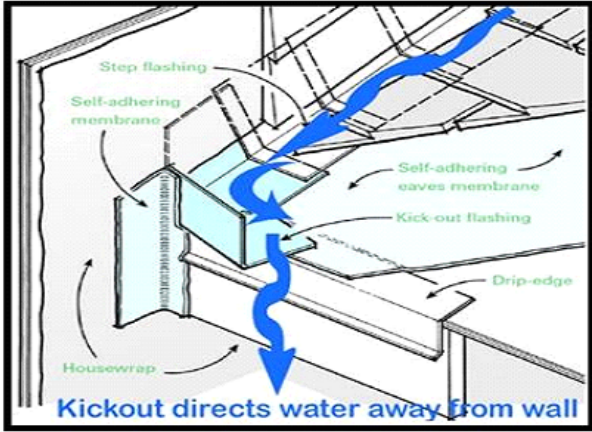
**KICKOUT FLASHING MISSING - NO DAMAGE OBSERVED**

Kickout flashing was not present at the roof to wall intersection. A lack of kickout flashing can possibly allow water run off from the roof to be routed into the wall cavity. This condition is known to lead to wood rot, mold, and other moisture related problems. When the area was probed no damage or elevated moisture was observed. Consideration should be given to having a water proofing specialist install this flashing detail or at a minimum the sealants for this area be routinely maintained.

Schematic of kickout flashing

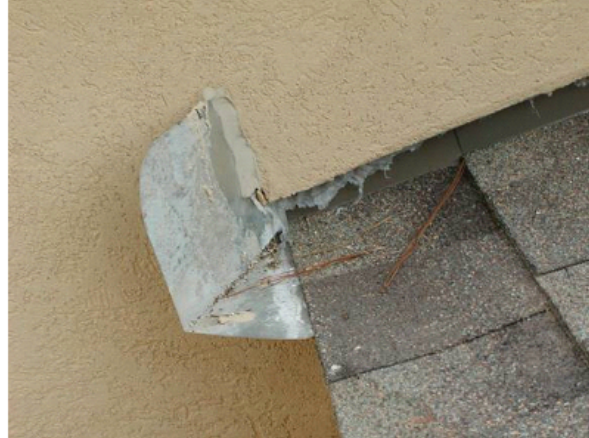
HS file photo illustrating kickout flashing
