## STRUCTURAL INSPECTION

1301 Milford St  
Houston, TX 77006

KRAUSE MANAGEMENT TRUST c/o Greg Krause

MARCH 7, 2022

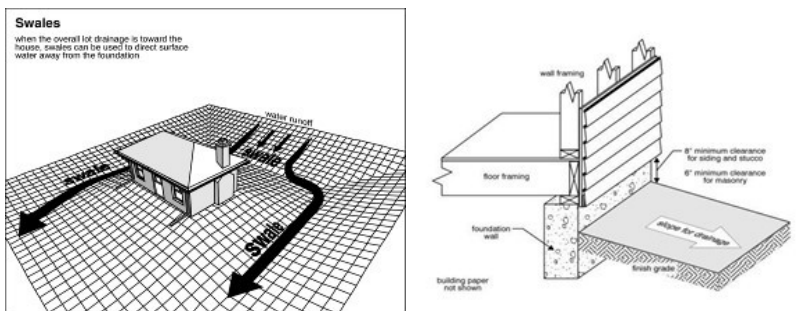
**Perimeter Grading/Drainage: Appeared Adequate**

The perimeter drainage around the property appeared to generally be adequate. It could not be determined with certainty if water would pool at any localized low areas around the property. Further investigation with the homeowner is recommended to determine if there are any drainage problems or water that ponds on the property after a rain.

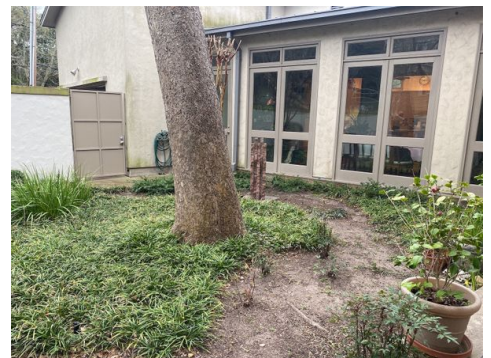
Trees and/or foliage were observed in the vicinity of the house which can contribute significantly to differential movement of the house foundation. Care should be taken to prevent the trees and foliage from removing an excessive amount of water from near the foundation of the house.

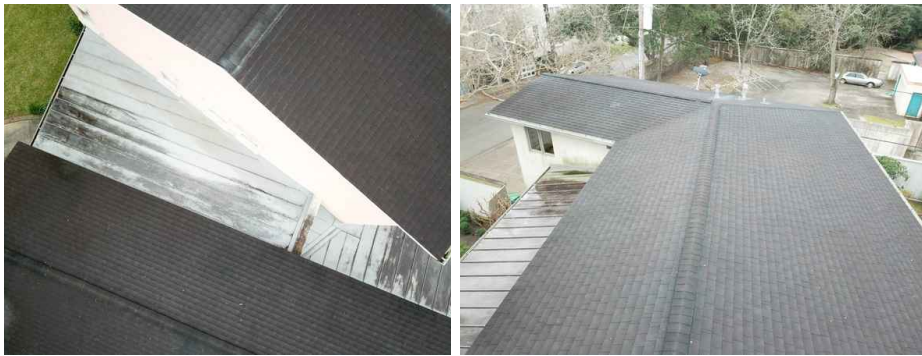
The roof surface was constructed of a standing seam metal roof. The life expectancy of the roof is considered to be the life of the structure.

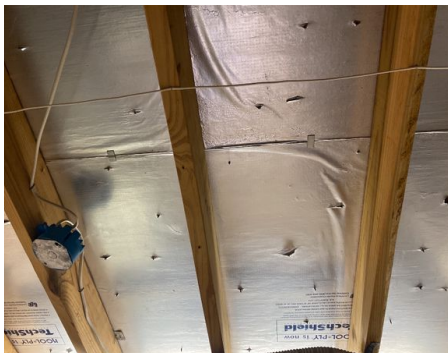
Radiant Barrier, Spacer Clips Present

The roof decking was observed from the attic space to be as described above.

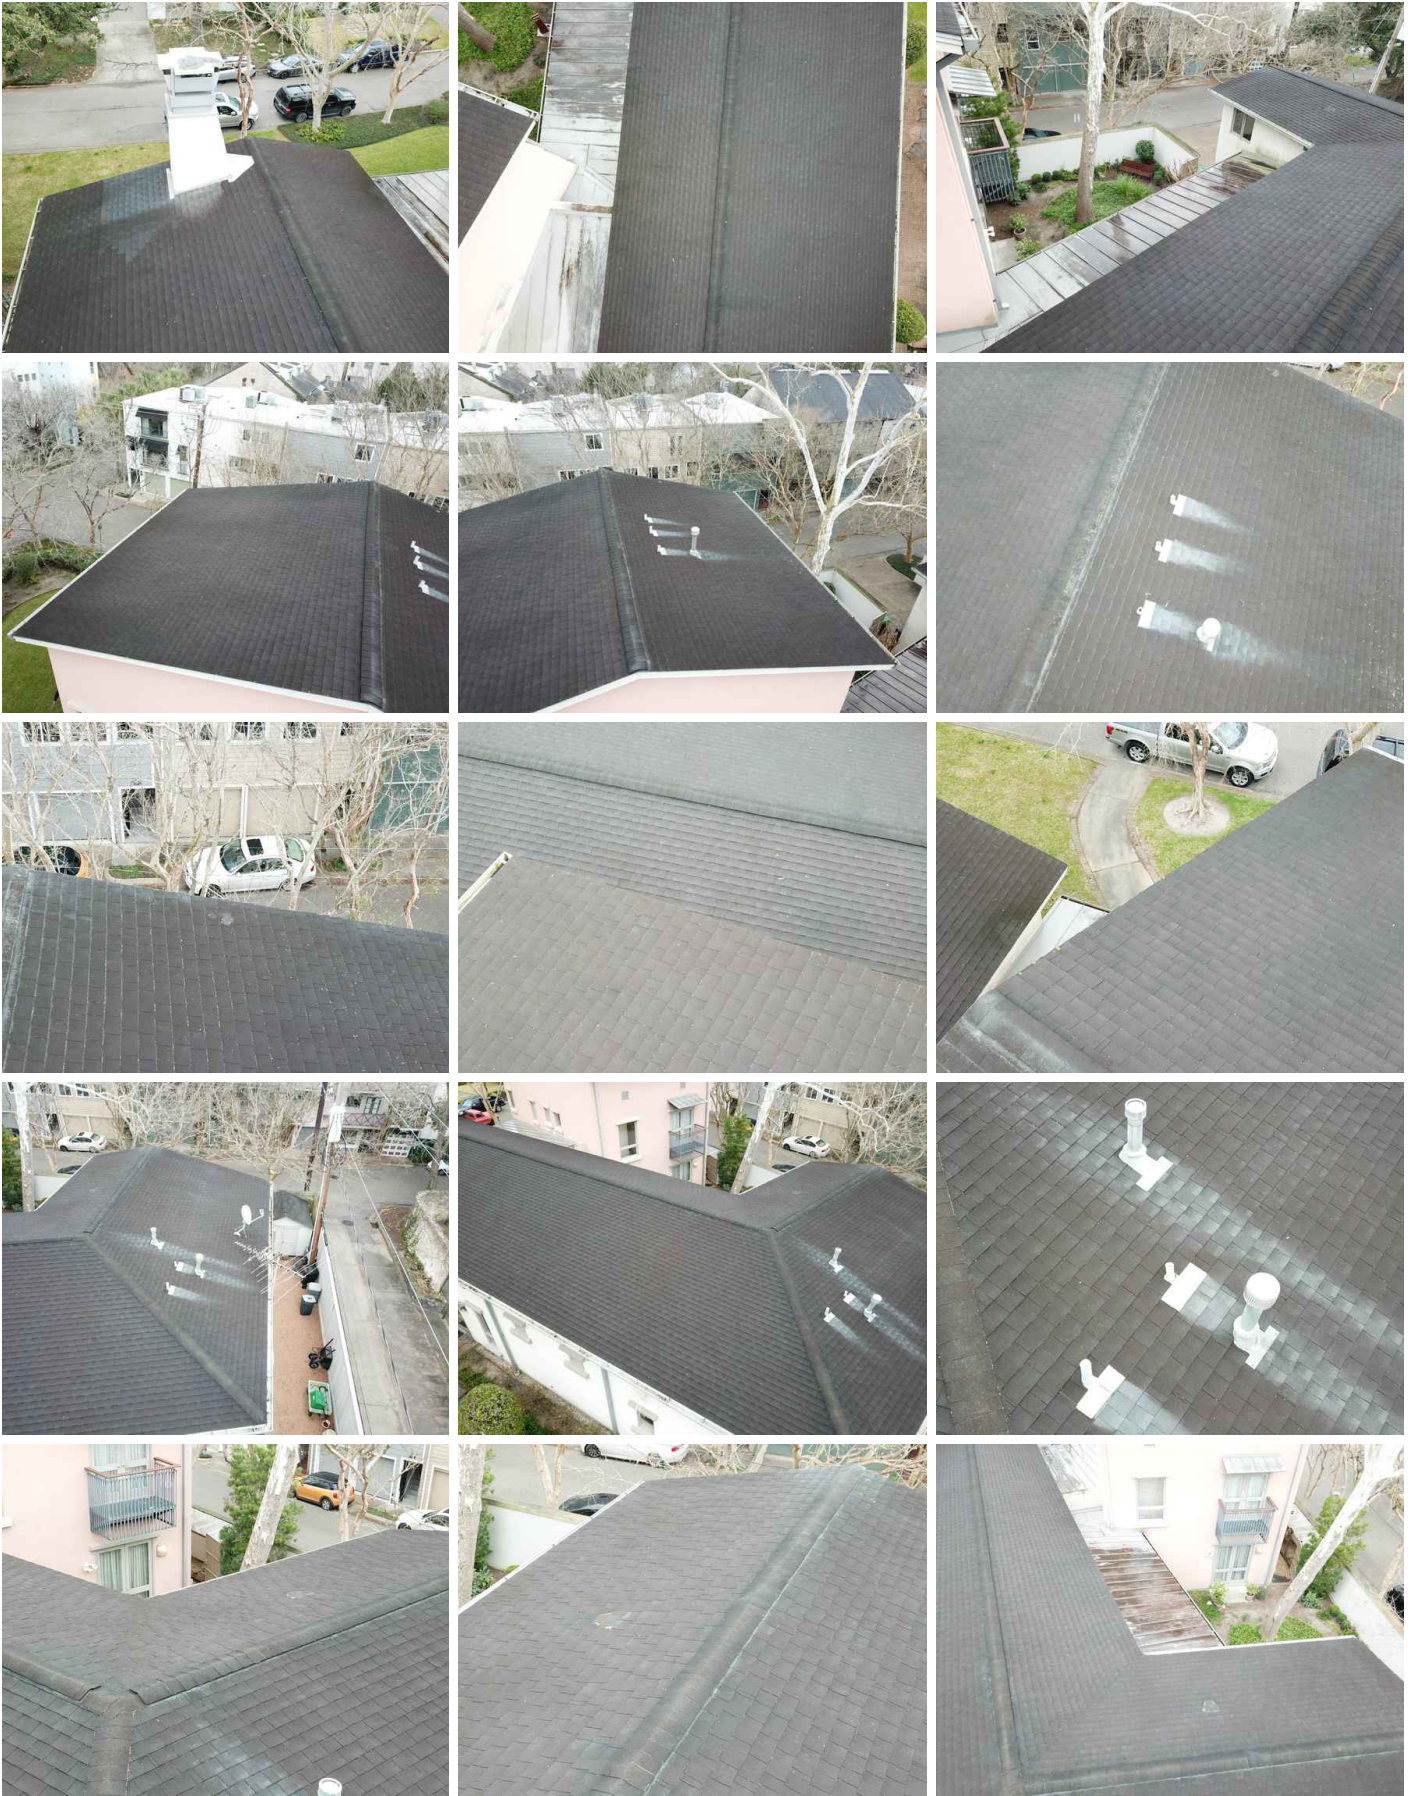
Due to the height and/or steep pitch on the roof, the roof was not viewed from its surface due to safety concerns, but was viewed from photographs taken by a drone.

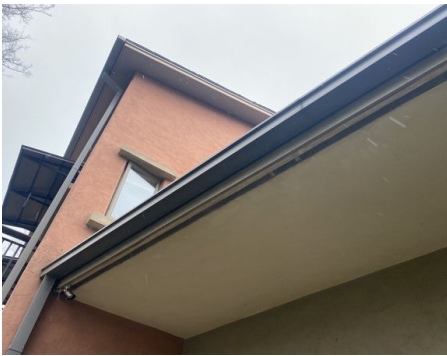
Continuous Ridge Vent, Continuous Soffit Vents

The ventilation for the attic space was observed to include the following vents listed above.

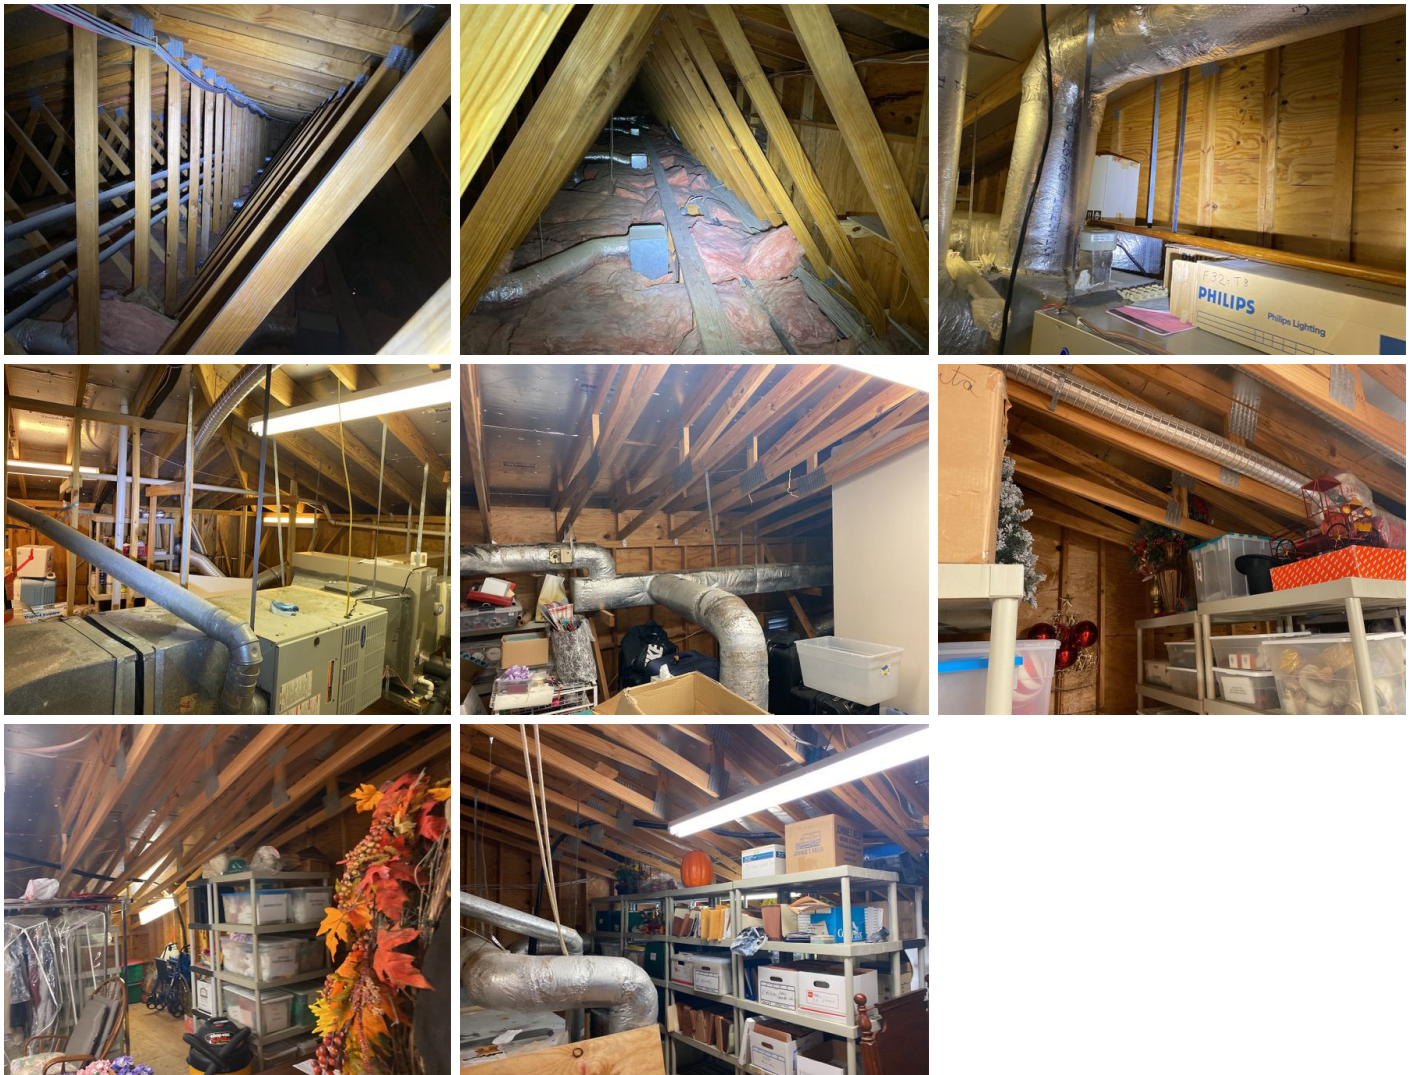
The attic space was viewed only from the areas determined by the inspector to be safely accessible from the access walkway.

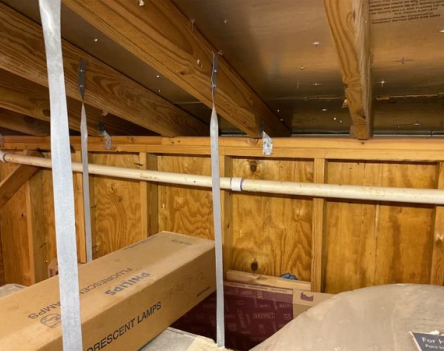
Wind uplift or hurricane clips were observed to be installed at the bottom of the roof framing, connecting the roof rafters to the top of the wall framing. This provides a stronger structure and will be more resistant to wind uplift from hurricane and tornadoes.

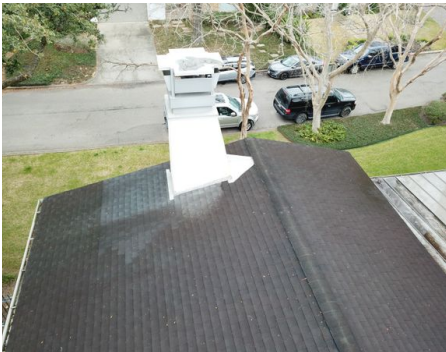
Metal Chimney Flue Through Roof, Ceramic gas log, Gas log lighter

The fireplace was a prefabricated metal fireplace that vented by a metal flue pipe to the outside of the house.

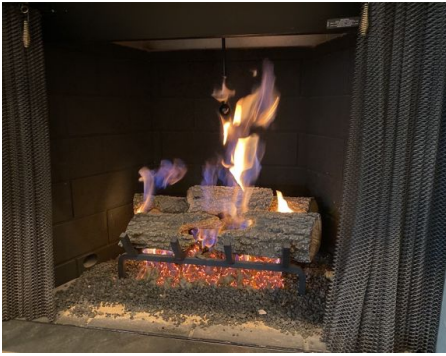
The gas log lighter was operationally checked, and was functional at the time of the inspection.

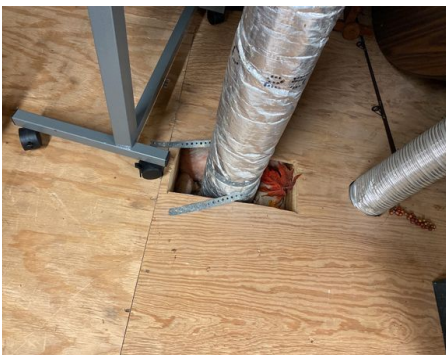
The insulation in the attic was average by the standard for the age of the house. The insulation appeared to be approximately 9-10" thick, which would be an R30 energy rating. It is pointed out that the insulation requirements according to the latest standard for new houses in this area is an R38 energy rating.

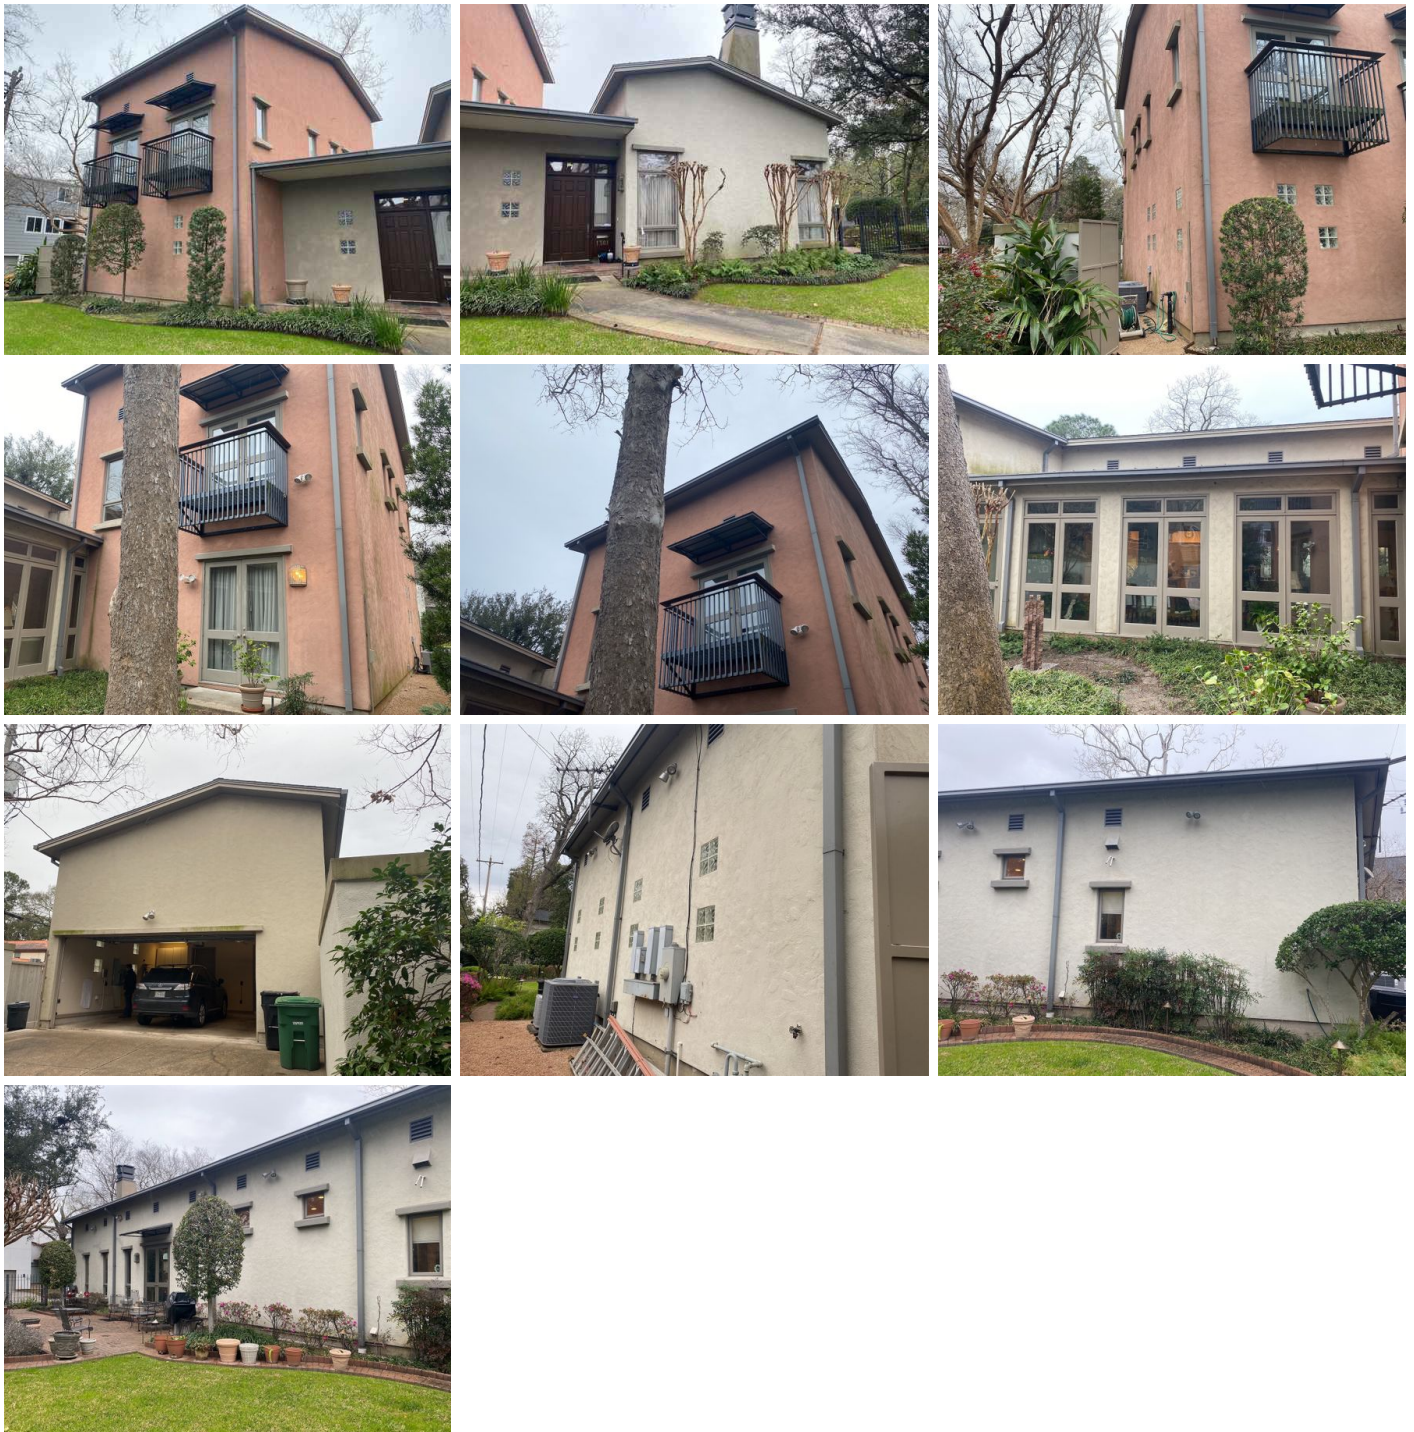
Cement Siding

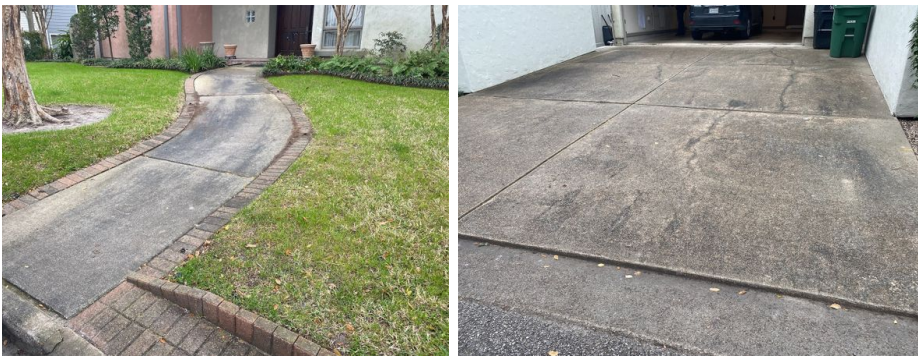
The flatwork concrete listed above was in generally good condition at the time of the inspection with no significant repairs needed. Note that there may be some small cracks in the concrete, but in the opinion of the inspector, the concrete is still functional.
