Home Inspection Report

Property Address:
502 Pearl View Ln
Pinehurst TX 77362

PROPERTY INSPECTION REPORT

By: Jonathan Dooley TREC # 22163 / Dooley Inspections LLC 9/2/2020
(Name and License Number of Inspector) (Date)

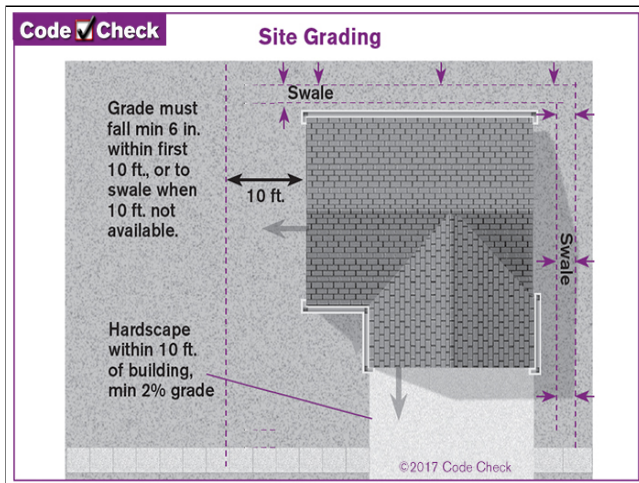
Muddy Area

Storm water didn't appear to drain well at right side (near front). A rut has formed creating muddy areas in yard. Consider back filling low areas to promote drainage to french drain and prevent ponding of water in yard.

Maintenance Advice: Proper grading and drainage is important to maintaining long term foundation performance, preventing water penetration, avoiding wood rot and preventing insect intrusion. It is recommended that grade be at a minimum of 6" from exterior siding and sloped away from structure 6" in first 10' to promote proper drainage.

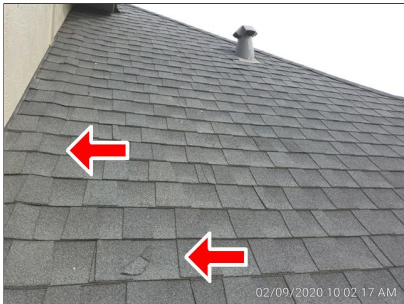
Left Side

Left Side: Nail Sticking Up

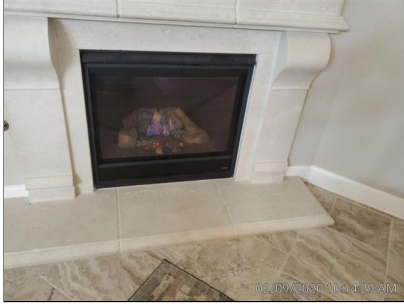
The gas burning fireplace in the living room functioned as intended.

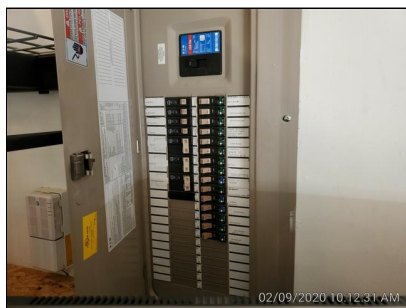
Main Panel Install-OK

I found no deficiencies in the wiring of the Main Panel. However, full inspection of electrical systems requires Master electrician-level experience. For this reason, I recommend contacting a qualified electrical contractor to inspect further.

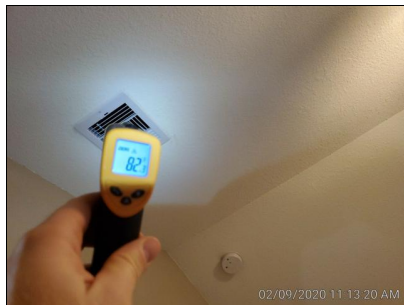
Heating equipment functioned properly at time of inspection. Recommend following the manufacture care and maintenance instructions.

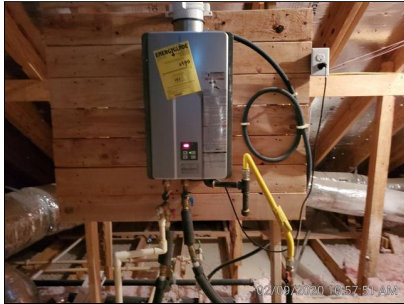
Attic

Water Heater was functioning satisfactorily at time of inspection.

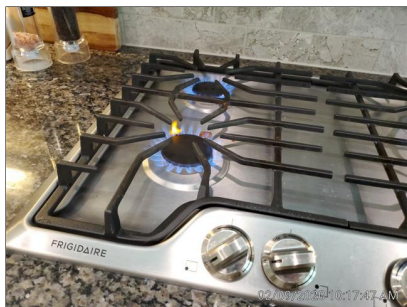
The range and oven were functioning as intended.

The oven was tested at setting of 350 degrees. Each burner on stove top was turned on and observed for 15 seconds to check functionality.
