Property Inspection Report

Texas Premium Inspections

1213 55th St

Date of Inspection: 6/17/2023

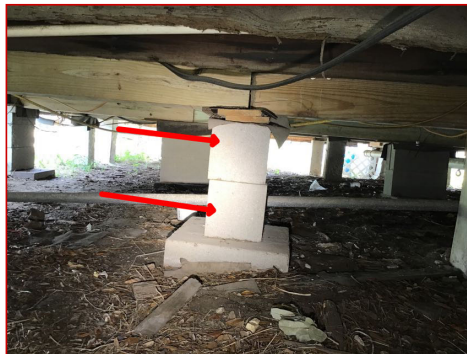
Leaning support column

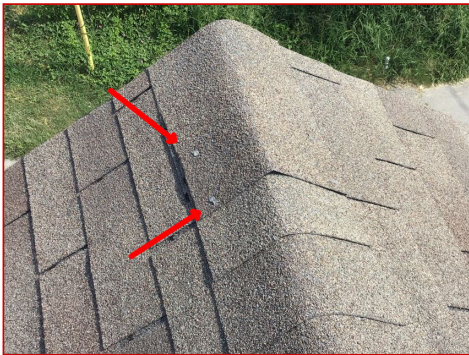
- **Exposed nail heads are evident and should be sealed to avoid water penetration.**
- **A Tree is touching the roof and should be trimmed back to eliminate premature wear on the roof covering.**

Example of exposed nail heads

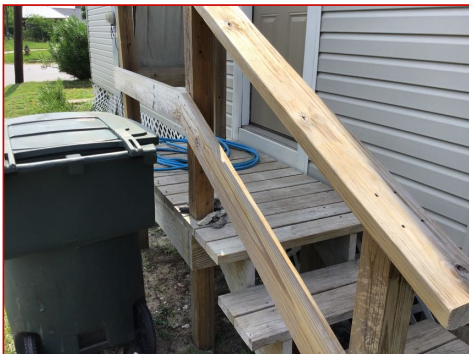
Climbable guardrail and handrail

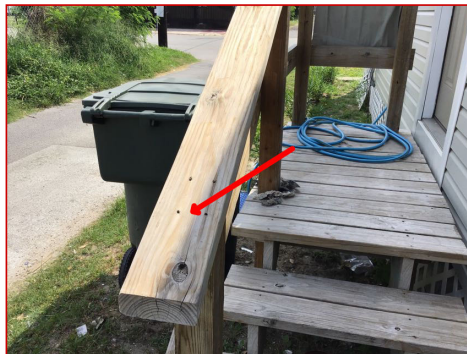
Non graspable handrail

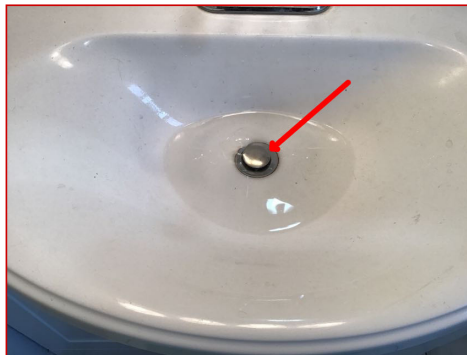
Slow to drain, hall bath sink

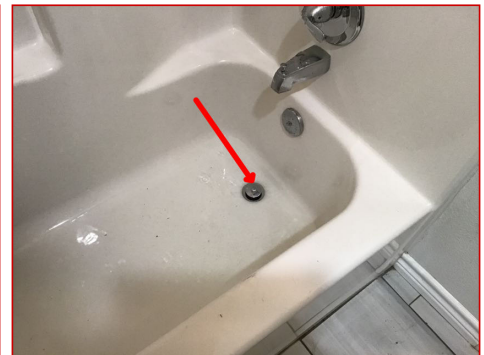
Slow to drain, hall bath tub
