# NEW CONSTRUCTION FINAL INSPECTION REPORT

# 24607 Charlton Green Lane Spring Tx 77389

Heather Nava & Justin Nava NOVEMBER 22, 2020

# PROPERTY INSPECTION REPORT

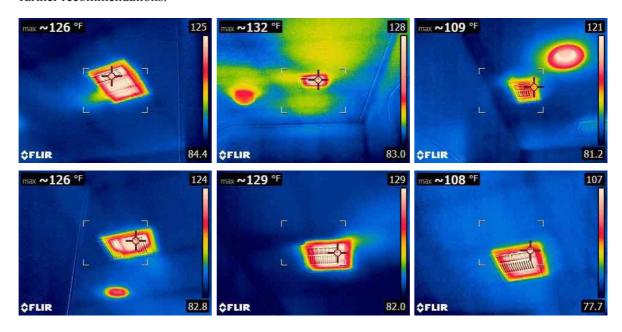
Heating System was Functioning:

The heating system was functioning at the time of inspection. Refer to the inspection report for any further recommendations.

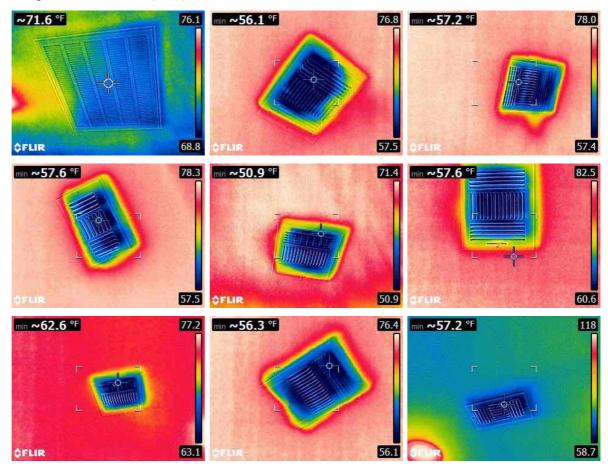
Temperature difference (delta) - First Floor: 14°
