PREMIUM INSPECTIONS

2707 Mapleglade Dr, Humble, TX 77339

Date of Inspection: 3/23/2020 Time: 9:00 AM

Property Inspection Report

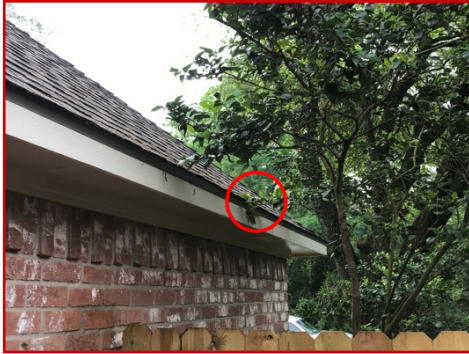
Tree touching structure

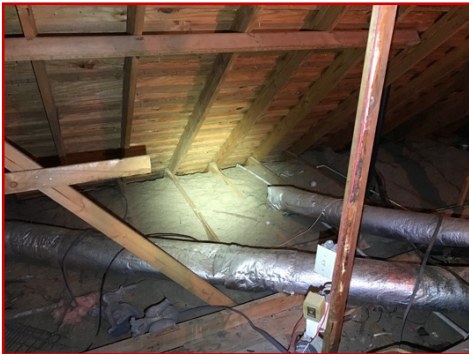
No visible termination for bath fan in hallway bathroom

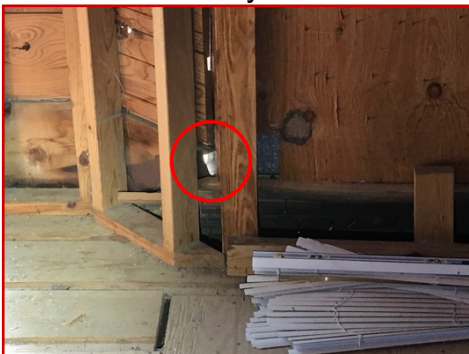
Gaps in flashing

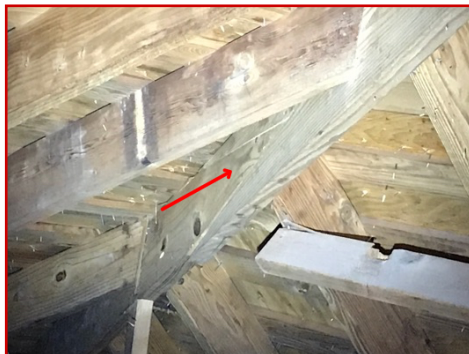
Joint is poorly secured

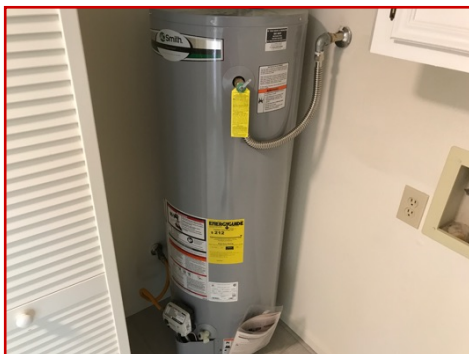
- The pipe serving the TPR Valve as a drain pipe is not approved material. This material, flexible style, is most likely not well suited to this application, and should be a smooth interior material, so for safety reasons, it may need to be replaced.

- No safety catch pan and drain was found for the water heater. This should be repaired by the installation of a pan with a drain by a qualified professional.

Water heater in laundry room

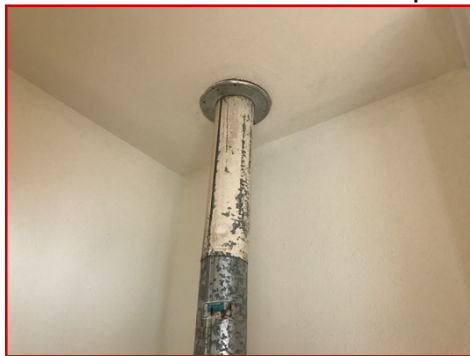
Venting appears ok

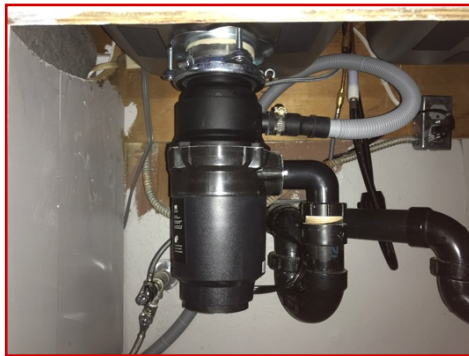
Disposal appears ok

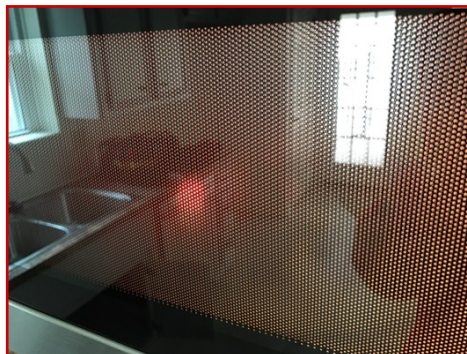
Microwave detector showing unit functioning properly

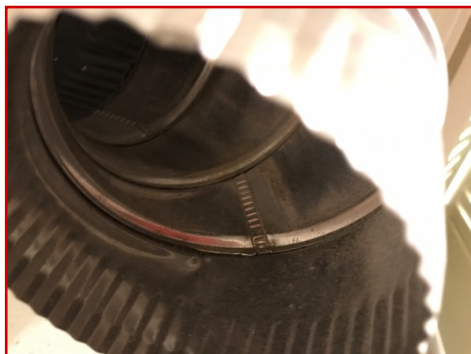
- The Inspector observed few deficiencies during inspection of the dryer vent cover and dryer tube. Notable exceptions will be listed in this report.
- The dryer vent outlet has a screen installed. Recommend removal of the screen or replacing the cover with an open louvered vent as it poses a potential fire hazard by trapping lint. FIRE HAZARD!

Dryer vent appears ok
