PROPERTY INSPECTION REPORT FORM

Address of Inspected Property: 224 Calvit Hempstead, TX. 77445

Date of Inspection: October 19, 2022

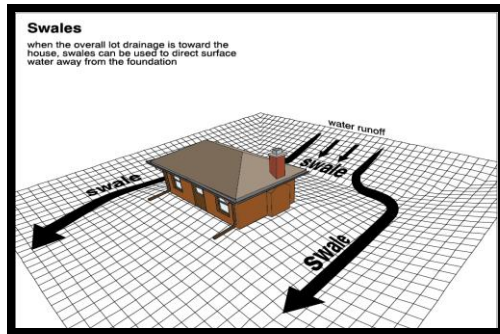
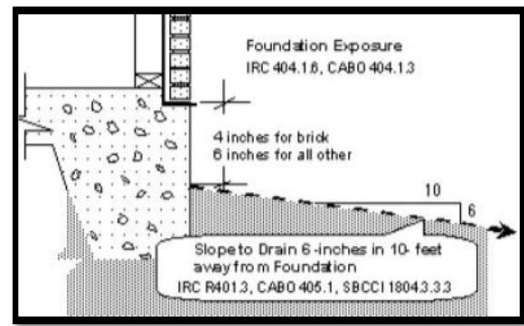
Grading and drainage around the structure does is not functioning as intended. Signs of erosion/damage & flat/improperly sloped areas were observed on all sides of the structure. These conditions may be conducive to ponding which may have an adverse effect on the foundation. It's recommended that the drainage improvements be made in these areas or that sub-surface/French drainage be installed to allow the water to flow freely away from the structure & to the street as required. After the drainage improvements have been made it is recommended that the drainage around the structure should be monitored during/after heavy rains & if ponding water is observed then additional drainage improvements should be performed.

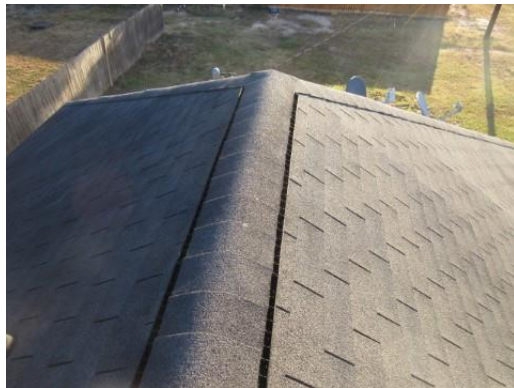
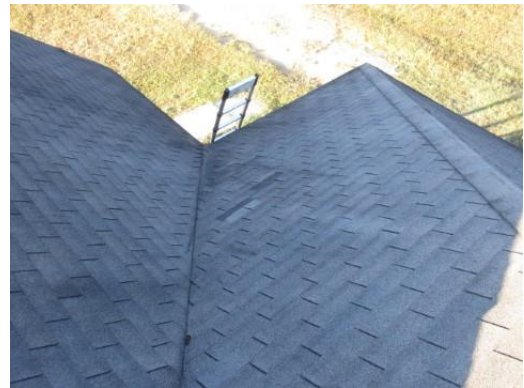
Roof covering/materials appeared to be functioning as intended however there were deficiencies as described below. It’s recommended due to the deficiencies below that the roof be further evaluated/inspected by a qualified roofer prior to closing. It’s also recommended that the budgeting for roof replacement in the future be considered & that the roof be monitored during times of rain to determine if any leaks are present.

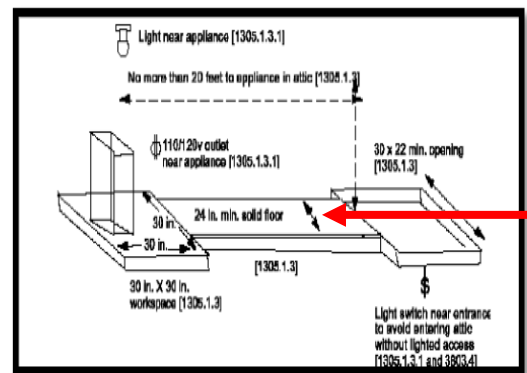
The attic does not solid flooring at least 24" wide for access to the appliances where access is required & does not have a 30" wide by 30" deep work area along all sides of the appliances where access is required.

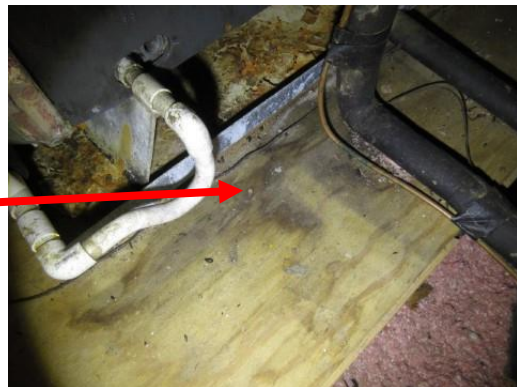
Existing/previous moisture penetration/staining was observed in the attic decking by the HVAC equipment. A moisture reading was performed in the accessible area & no moisture was detected at the time of the inspection.

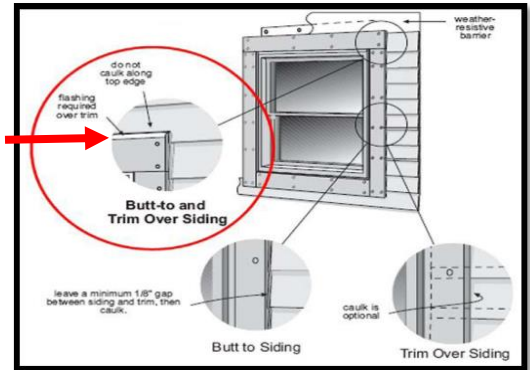
☒ Flashing is not installed above the horizontal trim board on the front side of the structure. Flashing is required above all continuously projected trim.

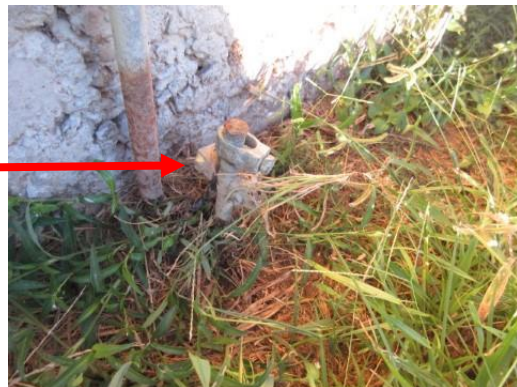
The grounding electrode is not flush with the ground. Since grounding electrodes are typically 8' long and are required to be driven 8' feet into the ground, it is recommended that the grounding electrode be driven flush with the ground or properly protected from damage/impact.

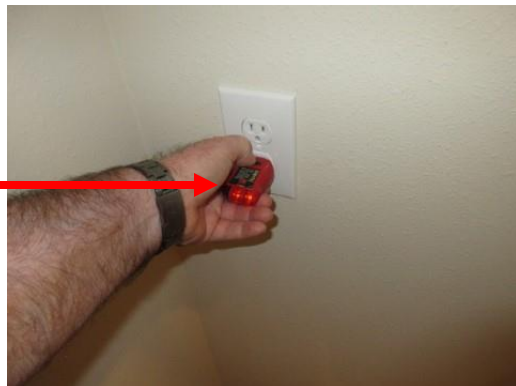
Laundry Room/Closet: No

This is a safety issue as required by today's standards. It is recommended that GFCI protection be added.

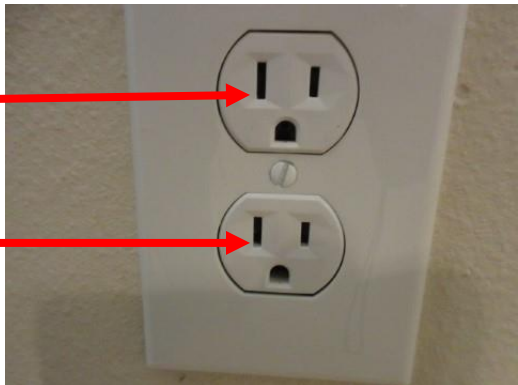
The outlets less than five and a half feet above the floor are not tamper resistant as required by today's standards.

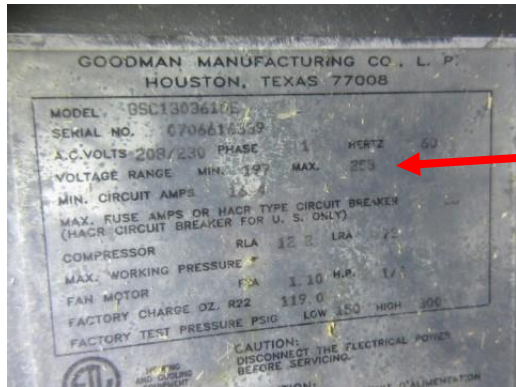
Condensing unit rated for a maximum 25 Amp. breaker however the panel is labeled with a 30 Amp. breaker. Recommend repair.

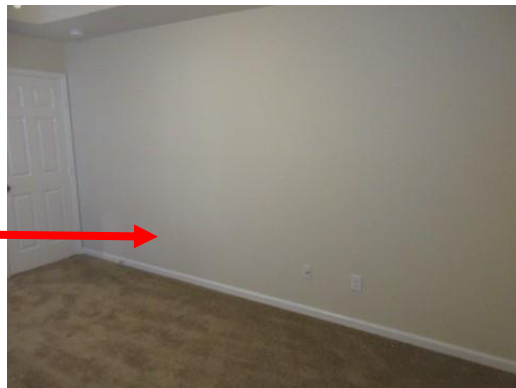
Insufficient number of outlets installed in the primary bedroom as required by today's standards. Outlets should be provided every 12' on a wall, 6' max. distance between outlets, in hallways 10' or longer and is required if the wall is greater than 2' wide.

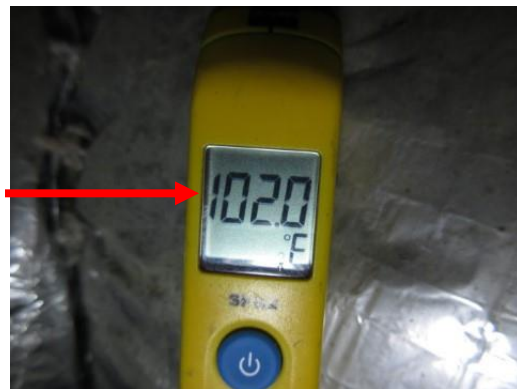
Supply air temp: 102.0° (as measured at the heat exchanger in the attic)

The heater is potentially nearing the end of it's life cycle. Recommend budgeting for replacement in the future.

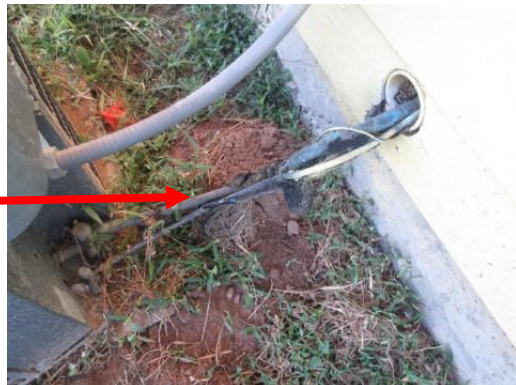
Rust was observed in the secondary drip pan. This is an indication of previous/existing condensation leaking from the primary drain pan. Due to not knowing the extent of the rust damage it is recommended that the pan be replaced.

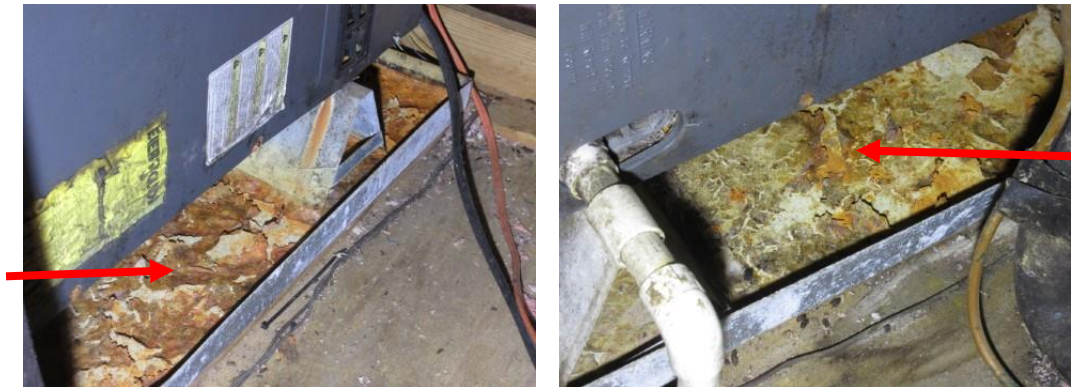
FYI The refrigerant used for the condensing unit is the older R-22 which is being phased out, recharging of a R22 system may not be possible in the future which may required that the system be replaced.

FYI The drip pan does not have a float switch installed. Float switch installation is recommended (not required) to shut the system down in the event of a leak into the secondary drip pan to prevent possible moisture damage.

FYI The condensing unit/coil are potentially nearing the end of it's life cycle. Recommend budgeting for replacement in the near future.

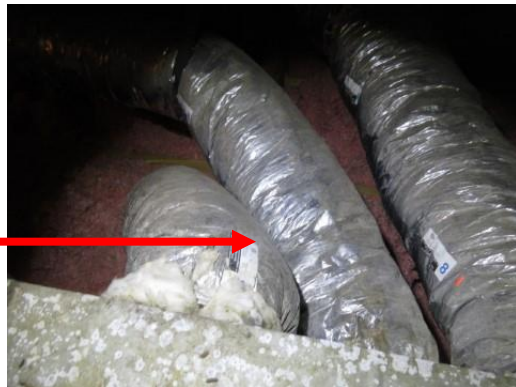
The flex duct was observed to be in direct contact with other pieces of duct in some areas of the attic. Recommend adding insulation between the ducts or rerouting ducts should be considered to prevent condensation between the ducts.

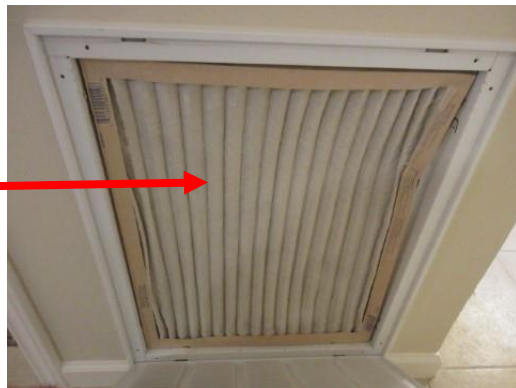
Return air chase is not properly sealed and has conductors running through it.

Return air filter is dirty, recommend replacing.

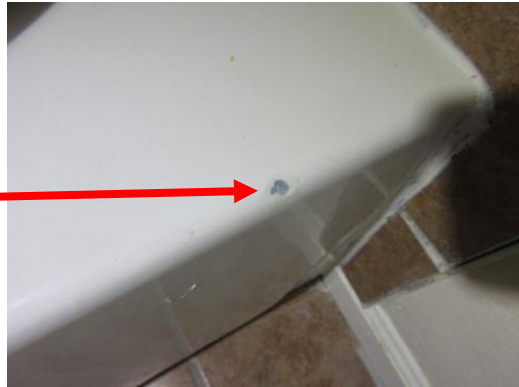
The primary bathtub surface is chipped, recommend repair to prevent rusting.

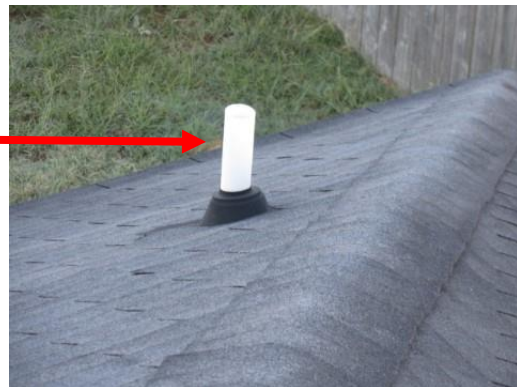
The drain waste vent pipes at the roof line have not been painted. Recommend painting to prevent deterioration of the plastic piping exposed to the elements.

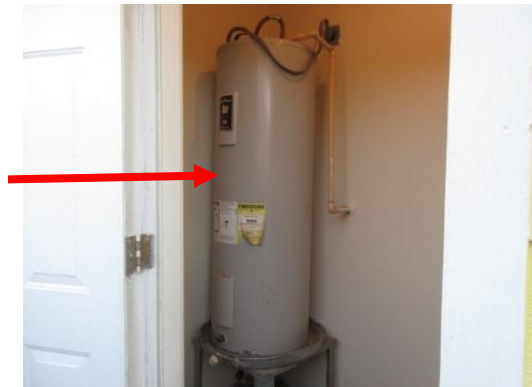
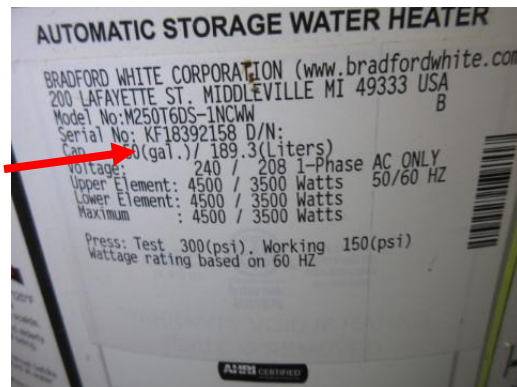
Mfg: Bradford White

Mfg. Date/Dates: 2013 (According to the Manufacturer Label/Labels on the equipment at the time of the inspection):

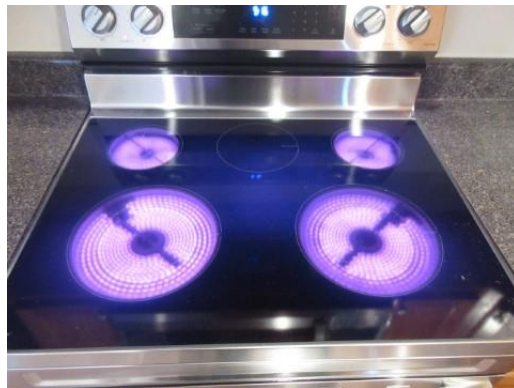
No anti-tip device is provided for the range. Recommend the installation of an anti-tip device as required.

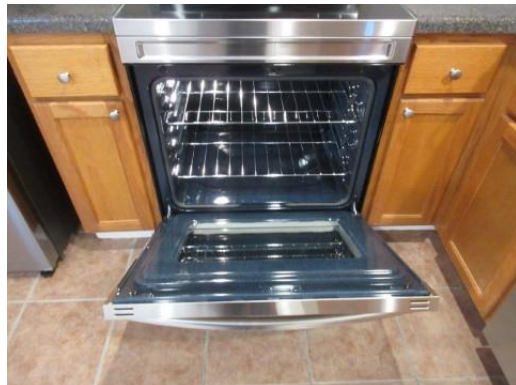
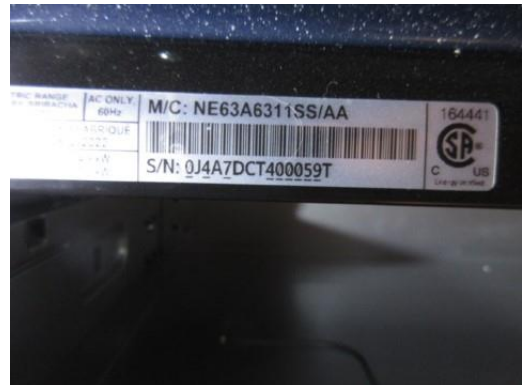
The oven was turned on to 350 degrees and allowed to cycle through the preheat function, a temperature reading was performed and read 350 degrees, a variance of 25 degrees is considered acceptable.

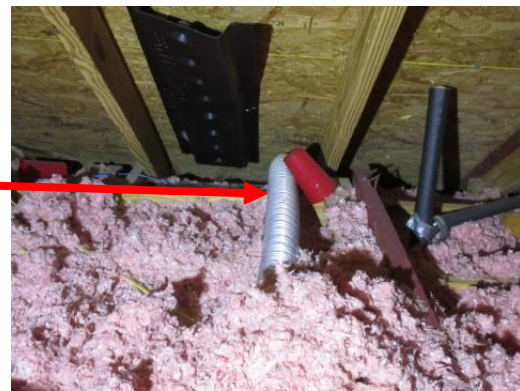
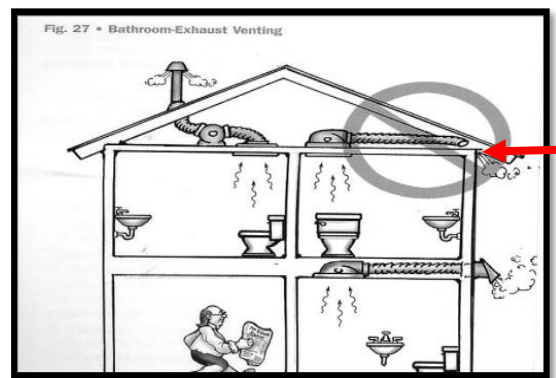
Bathroom exhaust vents are vented to the soffit and not through the roof deck or exterior wall as required.
