Home Inspection Report

9002 Hemlock St.
Richmond, TX 77469

PROPERTY INSPECTION REPORT

Inspection Date: 03/14/2020

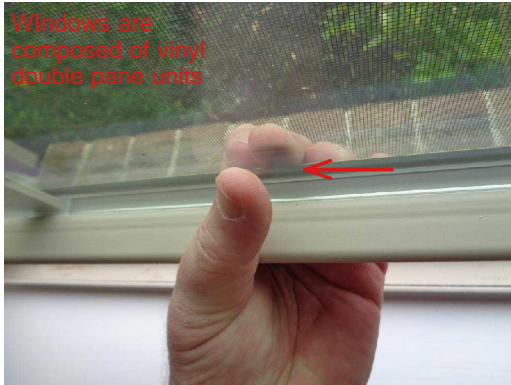
H. Windows - Comments: - Vinyl double pane

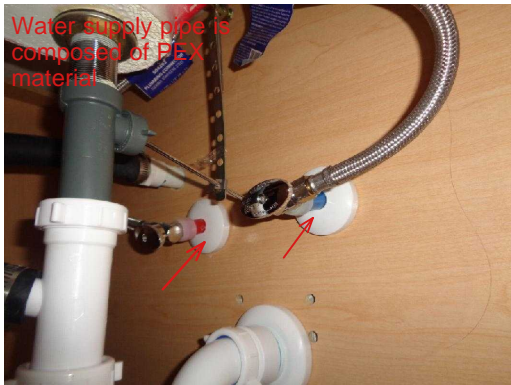
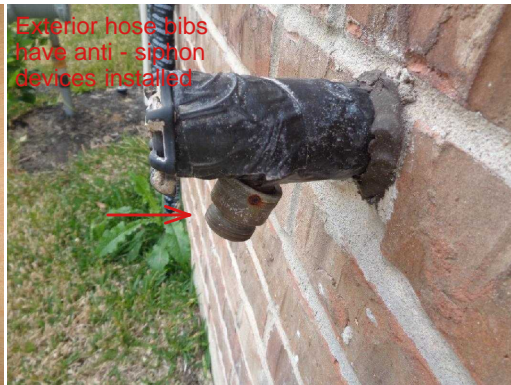
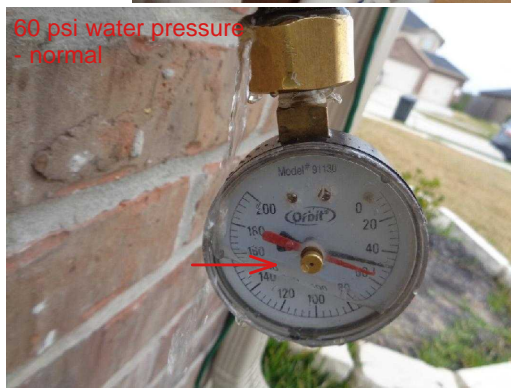
Static water pressure reading: - 40-80 psi (normal range)

Comments: - PEX - Anti - siphon devices appear to have been installed on exterior hose bibs

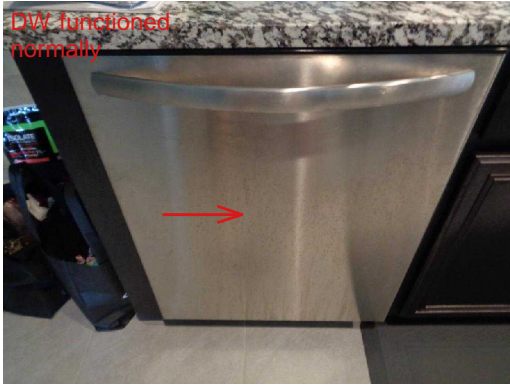
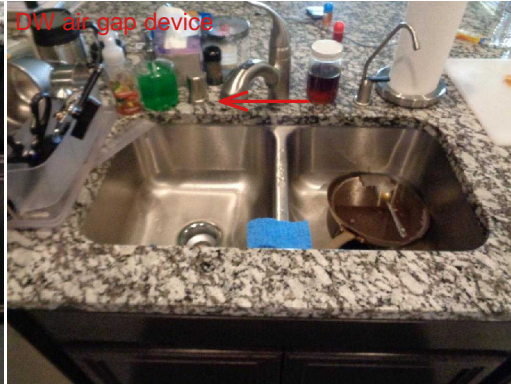
A. Dishwashers - Comments: - Frigidaire, - Dishwasher appears to have proper air gap or high loop device to prevent cross contamination condition.

- Dishwasher was turned on full normal cycle and appeared to function properly at the time of the inspection.

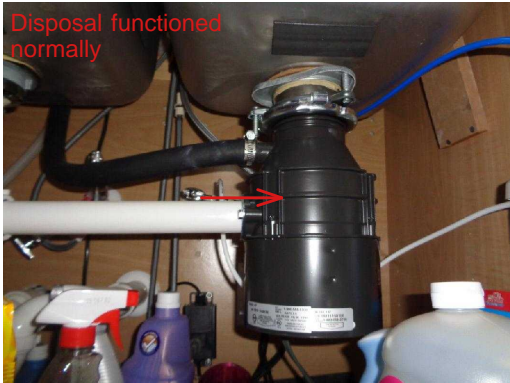
B. Food Waste Disposers - Comments: - In-Sinkerator, - Disposal was engaged and appeared to function properly at the time of the inspection.

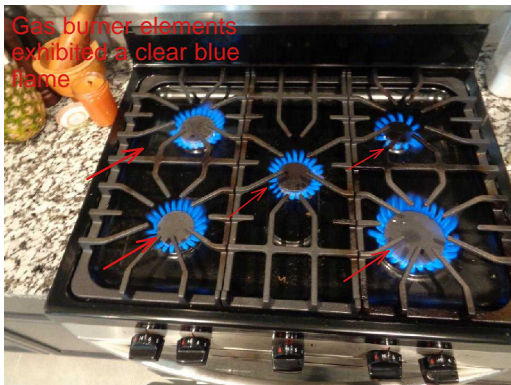
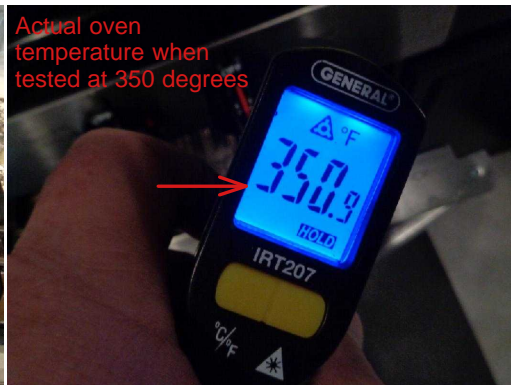
☒☐☐☐ D. Ranges, Cooktops, and Ovens - Comments: - Frigidaire, - Gas burner elements exhibited a clear blue flame.

- Oven was tested at 350 degrees and had 0 degree variance at the time of the inspection.

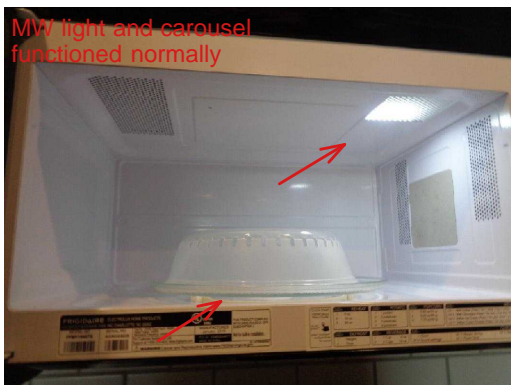
☒☐☐☐ E. Microwave Ovens - Comments: - Frigidaire, - Unit was engaged and appeared to function properly at the time of the inspection.

- Carousel and light functioned properly at the time of the inspection.

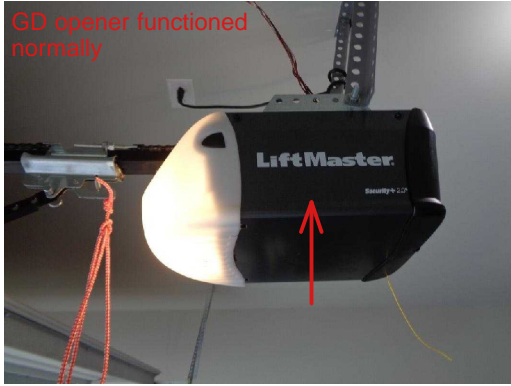
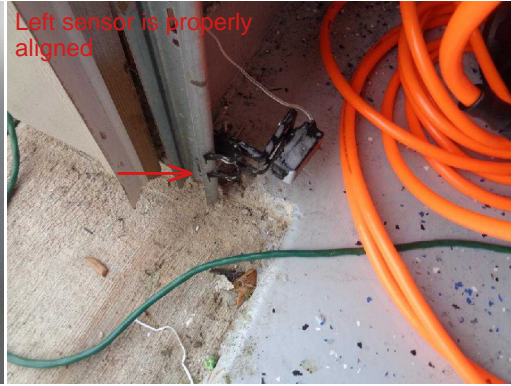
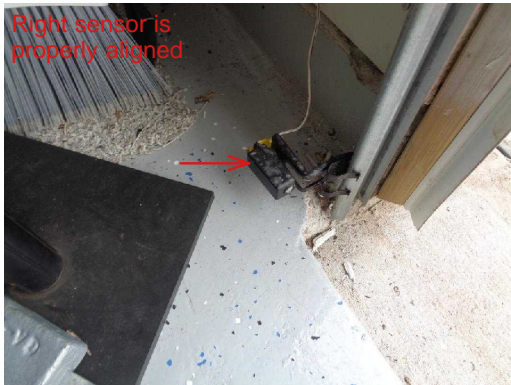
- The garage door reverse operating system was engaged and appeared to be functioning properly at the time of the inspection.

- The sensors appear to be properly aligned.

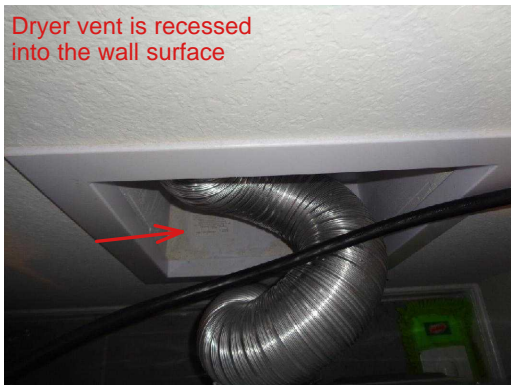
H. Dryer Exhaust Systems - Comments: - Metal flex, - Dryer vent assembly is recessed into the wall surface.
