## PROPERTY INSPECTION REPORT

Prepared For: Justin & Lesley Miller  
(Name of Client)

Concerning: 1513 Nagle Street, Houston, TX 77003  
(Address of Inspected Property)

By: Jared Owen, TREC: PI 21225 06/01/2020  
(Name and License Number of Inspector) (Date)

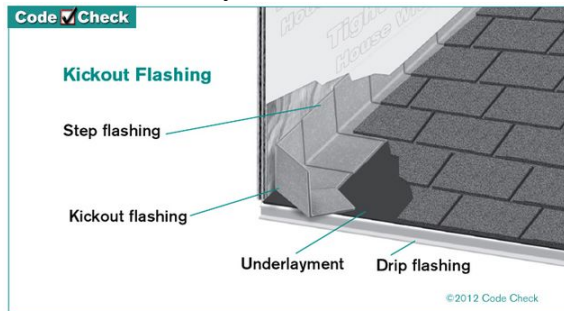
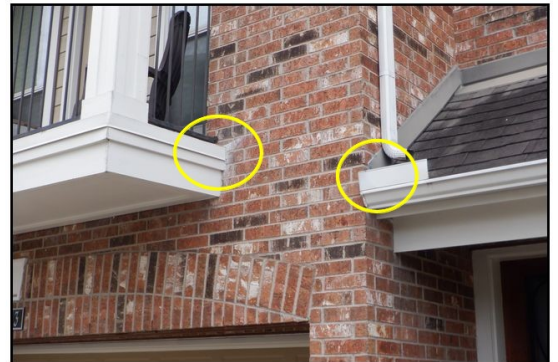
Did not observe "kick out" / end dam flashing where roof / balcony terminates along a wall. This flashing encourages rain water running down the roof / balcony to be diverted / "kicked out" away from wall and reduce chance of water penetration behind wall.

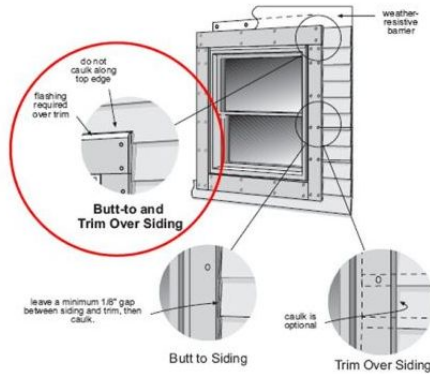
Head flashing missing over window/door trim pieces. Without head flashing over window trim, sealing must be maintained as a defense against water penetration.

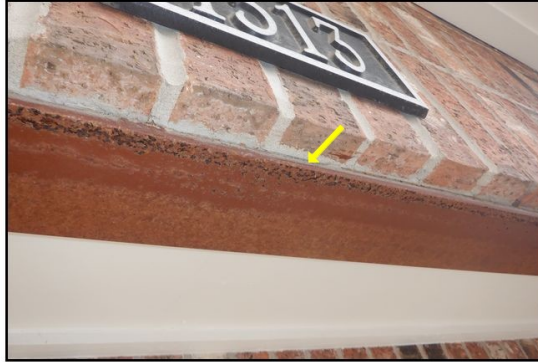
Metal lintel(s) over window/door openings need paint.

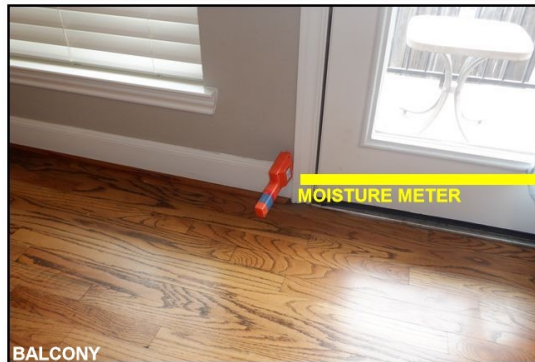
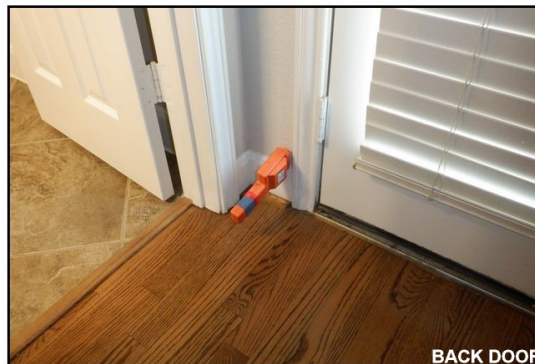
**Water penetration detected at balcony and back doors. Did not observe door pan flashing at door thresholds (see Exterior Doors section below). Recommend further investigation / repair by a qualified professional.**

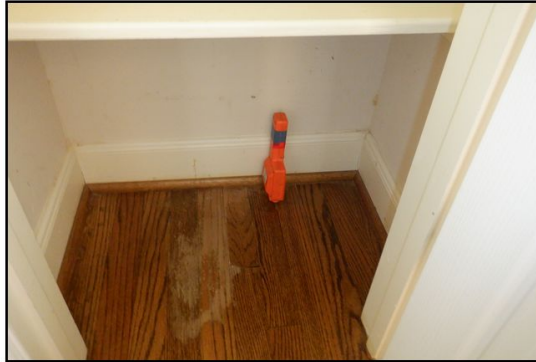
**Moisture meter registers water stains as active (wet); first floor bedroom closet (near bath). Source of moisture is unknown, no visible leaks observed from nearby sink. Recommend further investigation to determine root cause.**

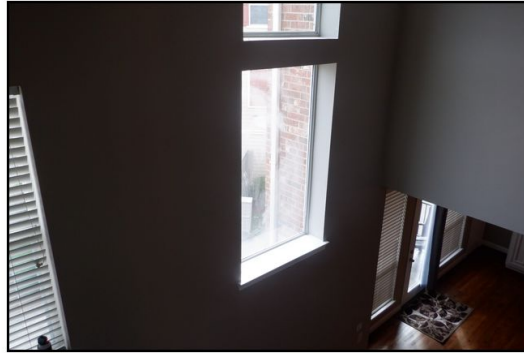
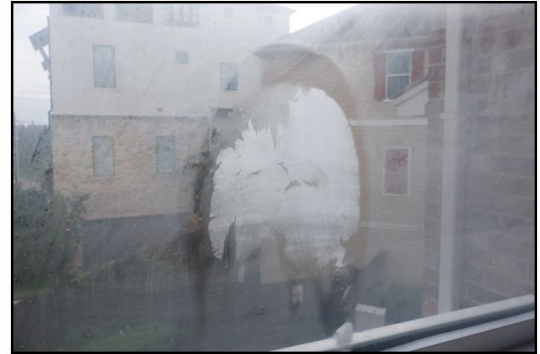
One or more of the thermal pane windows observed to have lost their seals. This has resulted in condensation and/or fog like film to develop between the panes of glass. The thermal pane windows no longer function as designed when they lose their seals. The windows that have noticeably lost their seals are listed but may not be limited to the following: third floor stariwell.

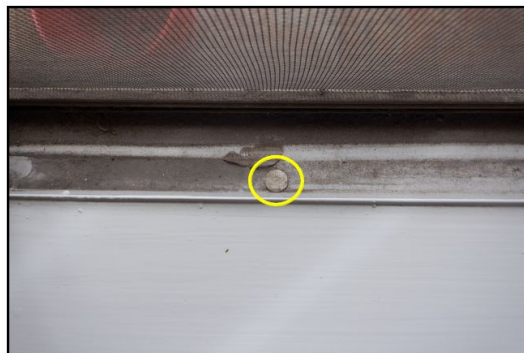
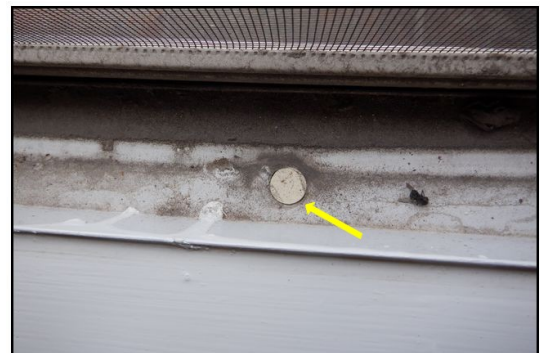
Some window sills have been drilled for alarm sensors, possibly against the advice of the window manufacturer. Window jamb alarm sensors need to be sealed with silicone seal to prevent water entry.

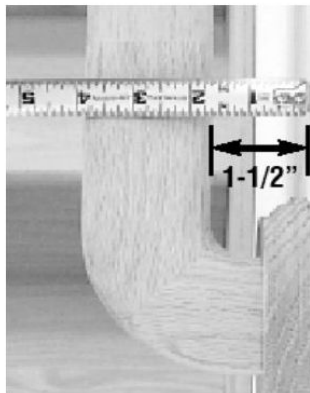
Stairway handrail does not comply with code, a section of the handrail does not have required clearance from the wall, It is a "hand/finger/knuckle grabber" (handrails adjacent to a wall shall have a space of not less than 1-1/2 inches (38mm) between the wall and the handrail) Per UBC 1006.2, IRC 311.5.6.2.

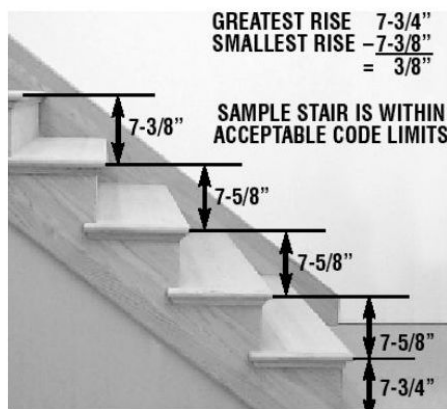
The stairway has a tripping hazard, Risers are not the same height along the entire height of the steps. Stairway does not comply with the current industry standard, Per IRC 311.5.3.1 & UBC 1006.3 requires "The greatest riser height within any flight of stairs shall not exceed the smallest by more than 3/8 inch."

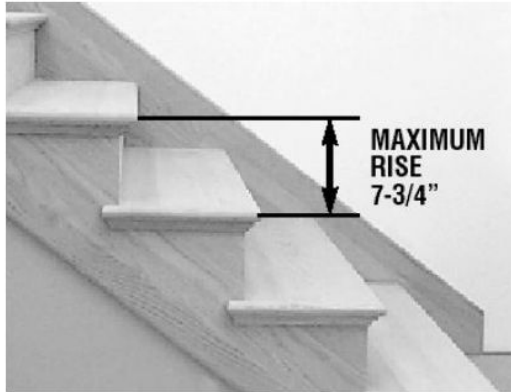
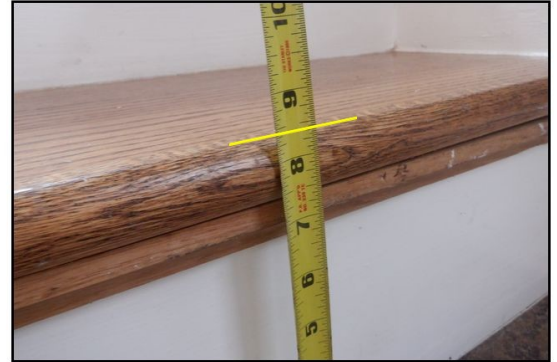
Stairway does not comply with the current industry standard, Per IRC 311.4.3.1. requires “The maximum riser height shall be 7-3/4 inches.”

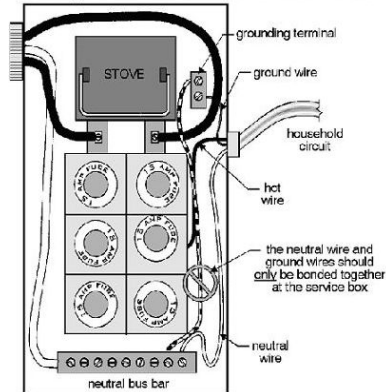
150 AMP ELECTRICAL SUB PANEL LOCATED AT SOUTH EXTERIOR WALL  
Improper wiring to sub-panel, there is no floating neutral. It does not comply with NEC 250-61b National Electric Code.

Don't bond neutral and ground wires downstream of service box

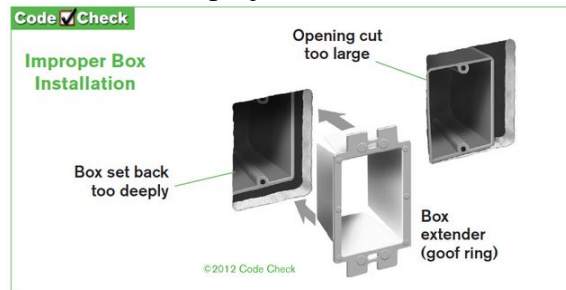
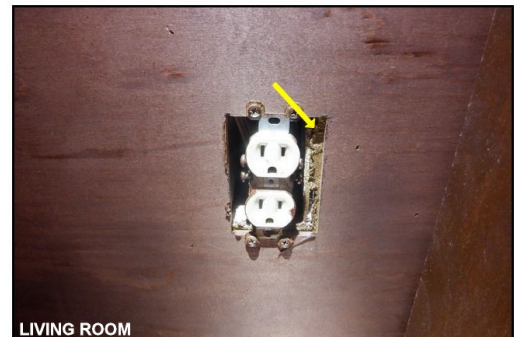
One or more outlets/switches/devices installed in/through combustible material were not flush-mounted as required by code, space exists between the faceplate and the edge of the electrical junction box. Per IRC E3806.7. In walls constructed of wood or other combustibile material, cabinets (outlet & switch boxes) shall be flush with the finished surface or shall project there-from.

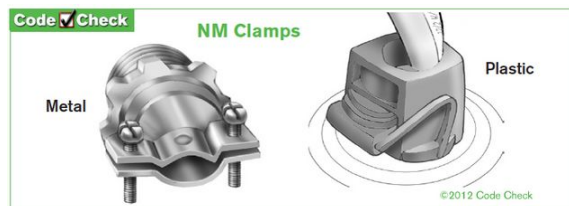
Thermostat wiring not secured to attic unit(s), missing small fitting that secures wiring to the cabinet to prevent pulling loose by service personnel or homeowner.

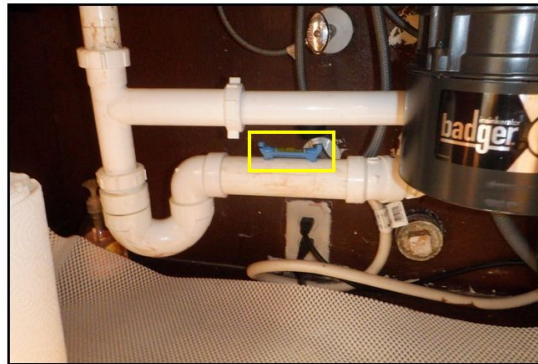
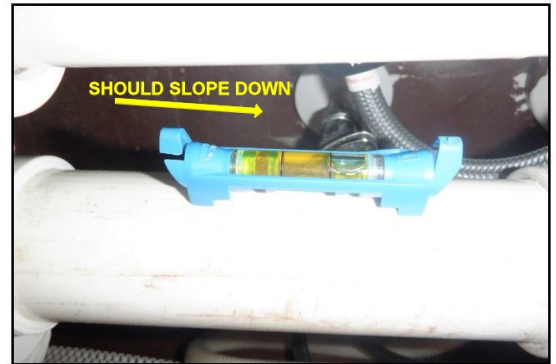
Reverse slope of drain line, does not tilt towards downhill for proper drainage; kitchen.

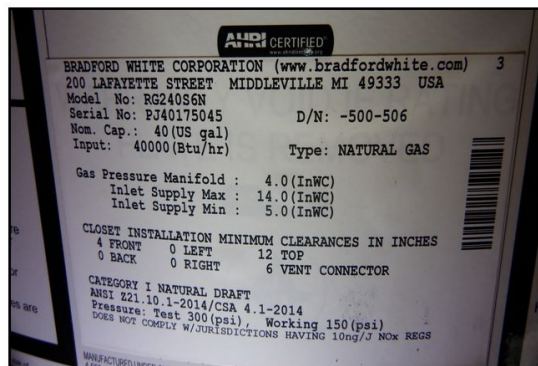
WATER HEATING UNIT(S): (2017) BRADFORD WHITE 40 GALLON

Manufactured in: 2017

Typical life expectancy of a water heater is 6 - 12 years as reported by Nachi-[Click here for more information](#)
