HEDDERMAN SERVICES

STRUCTURAL INSPECTION

1119 Walden Hill Ct
Houston, TX 77077

APRIL 11, 2022

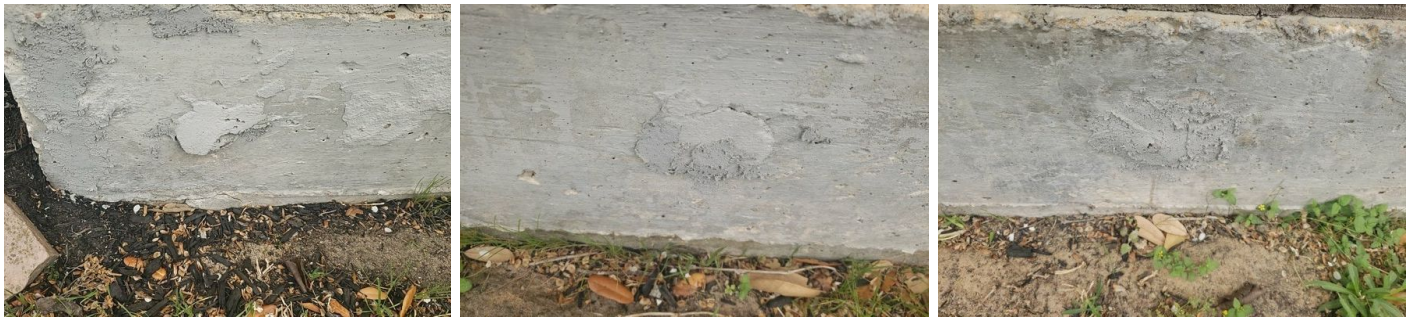
Reference point

See our field sketch below showing the elevation readings for this structure. Note that the "R" on the sketch is our randomly chosen starting reference point, where the elevation is 0, and all other elevation readings are taken relative to the reference point, and are measured in inches to the nearest 1/10 inch. Height adjustments were made for variations in the height or thickness of the various floor coverings. If there is a step up or a step down into an area such as a garage, sunken room, balcony/patio area, or raised rooms, the elevation readings will have larger numbers due to the amount of the step.

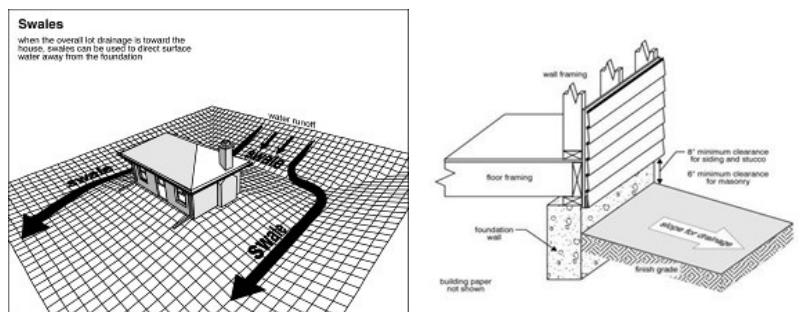
Perimeter Grading/Drainage: Appeared Adequate

The perimeter drainage around the property appeared to generally be adequate. It could not be determined with certainty if water would pool at any localized low areas around the property. Further investigation with the homeowner is recommended to determine if there are any drainage problems or water that ponds on the property after a rain.

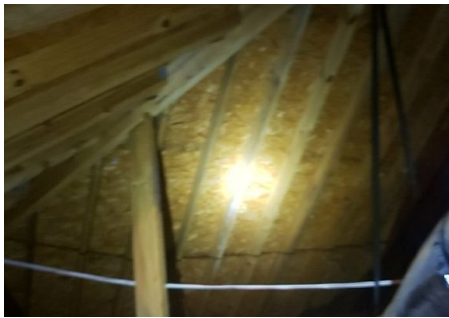
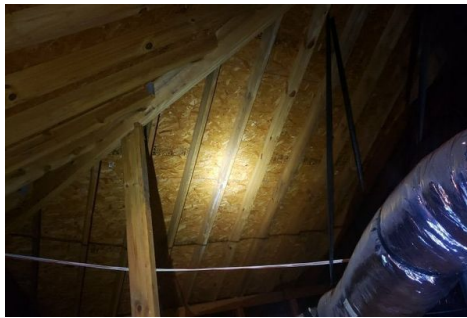
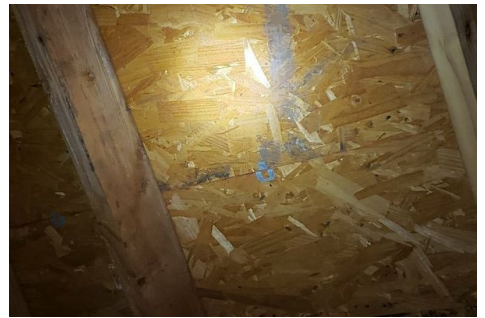
OSB, Spacer Clips Present

The roof decking was observed from the attic space to be as described above.

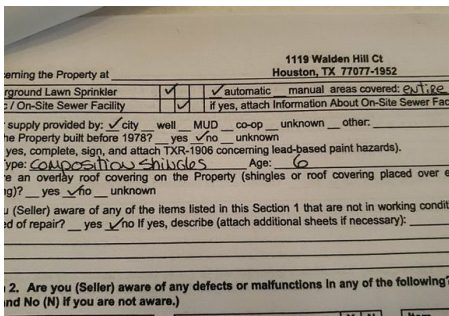
Age of Roof from Sellers Disclosure: Age of Roof: 6 years

The age of the roof, according to the sellers disclosure statement, was six years.

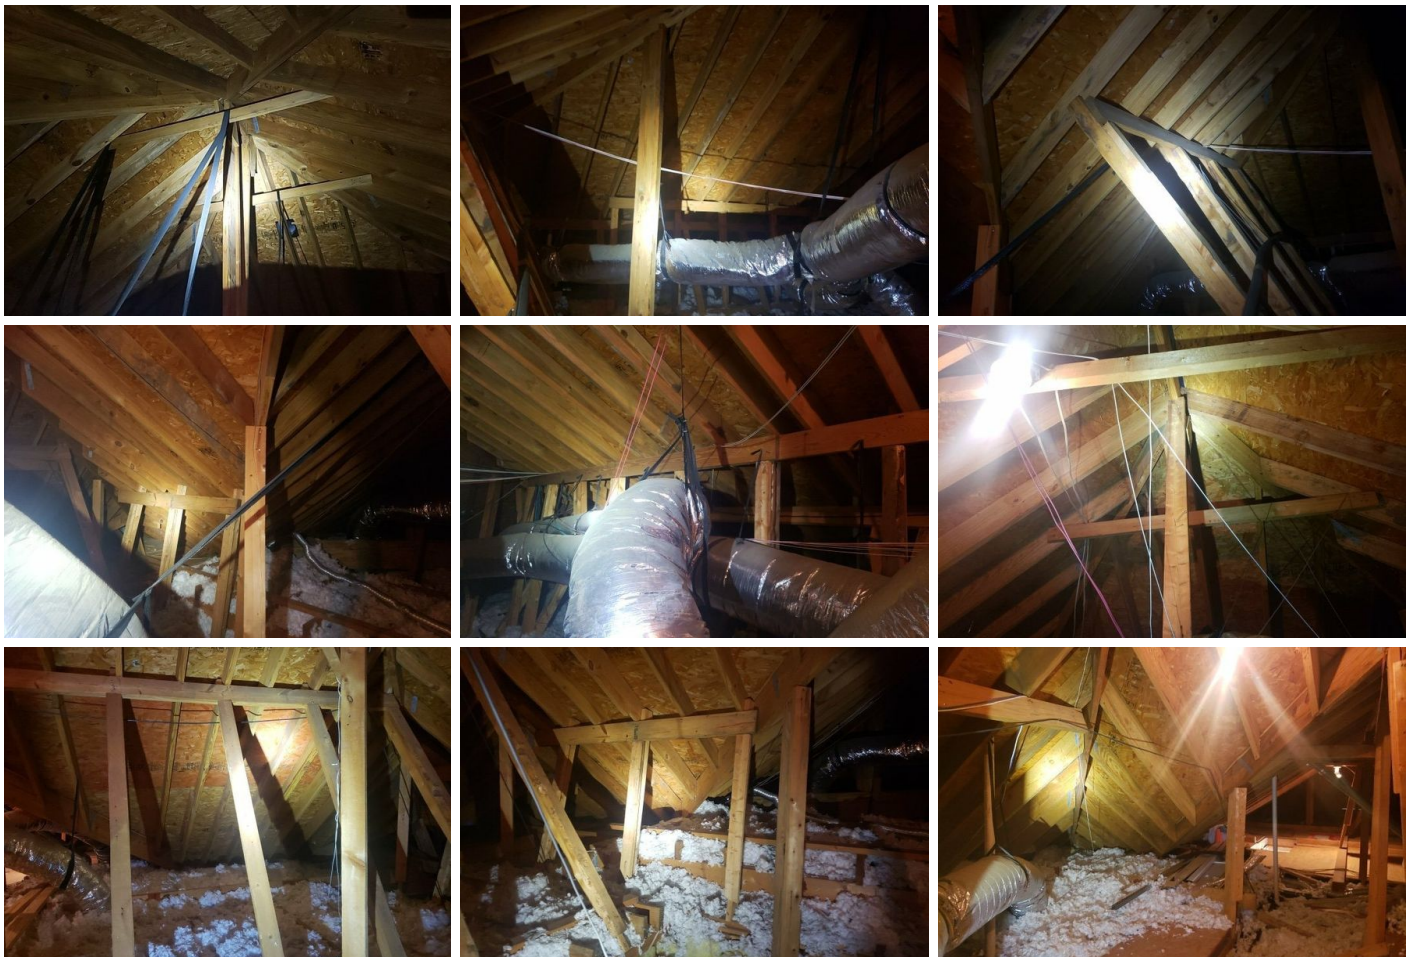
Hurricane Clips/Straps: Hip

Wind uplift or hurricane clips and/or straps were observed to be installed at hip rafters. This provides a stronger structure and will be more resistant to wind uplift from hurricane and tornadoes.

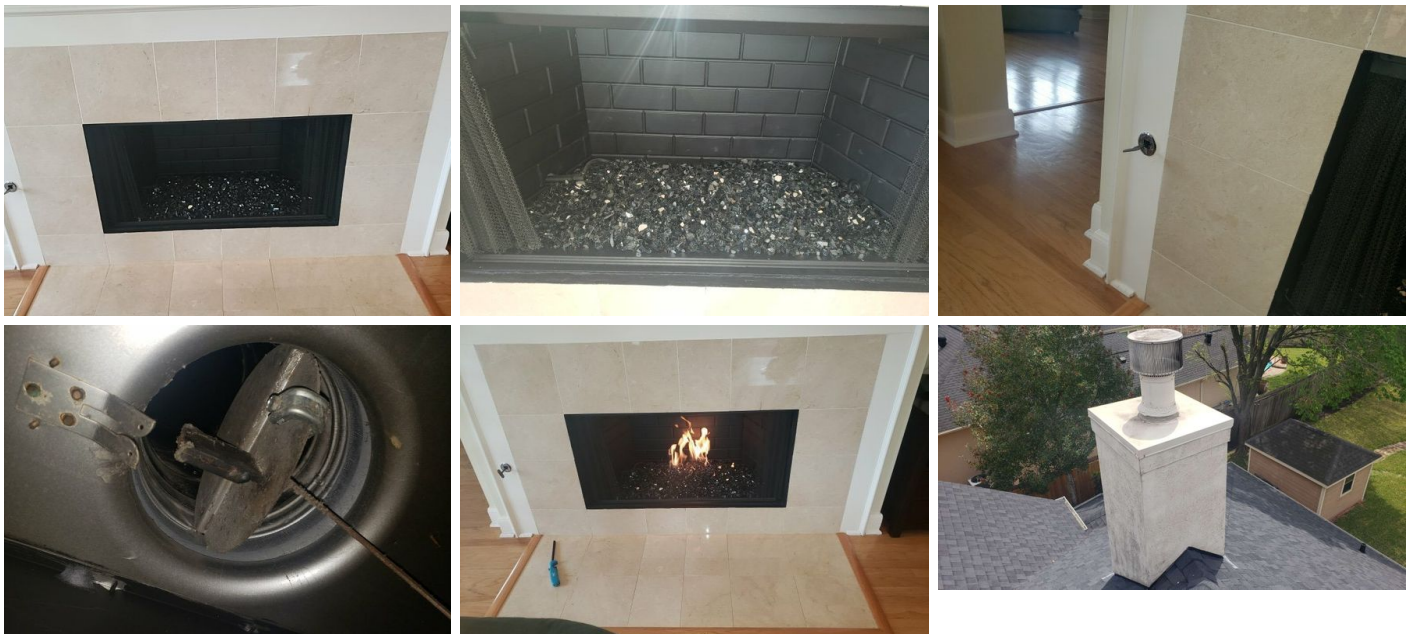
Metal Fireplace: Chimney flue not visible for entire flue

It should be noted that the inside of the chimney flue is not visible due to the construction of the chimney, and was not inspected. The chimney flue extends from just above the fireplace opening inside the house to the top of the chimney. If this a concern to you, we recommend that a fireplace service company be contacted.

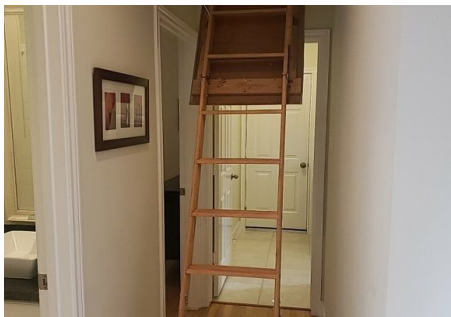
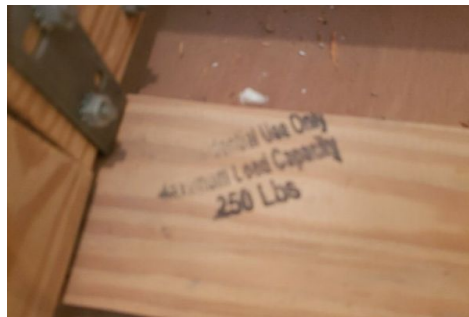
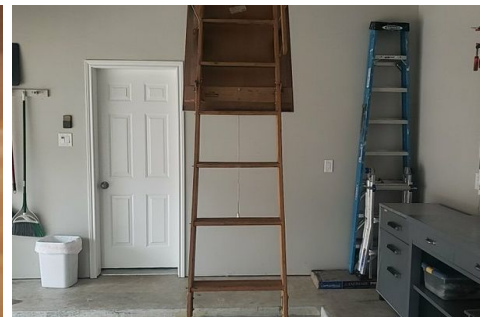
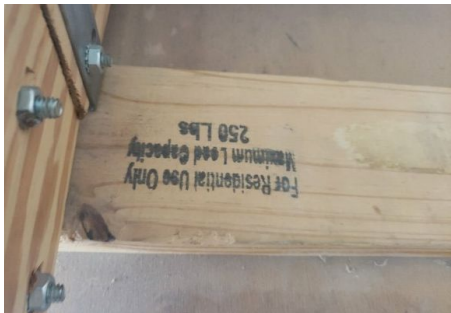
House and garage

The ladder was labeled to indicate the rated capacity of the ladder into the attic is 250 pounds. The ladder does not meet current code requirements for ladders into attics. Consideration should be given to replacing the ladder with a ladder that meets current code requirements.

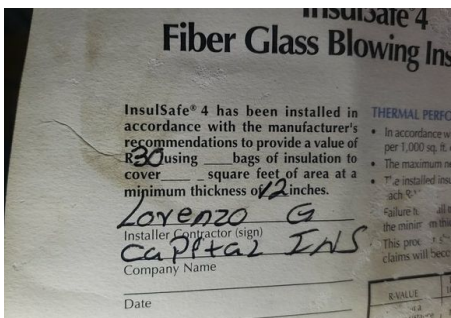
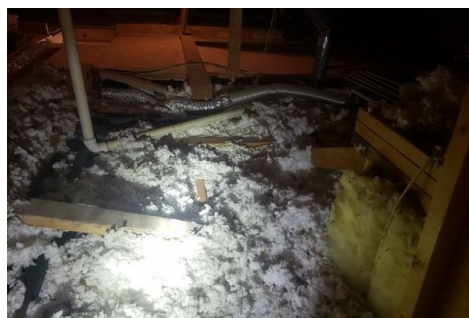
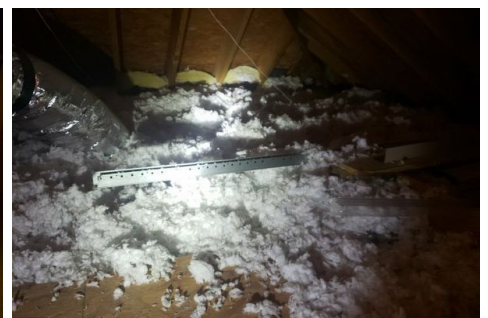
The company who installed the insulation left a tag in the attic stating that the insulation was an R30. It is pointed out that the insulation requirements according to the latest standard for new houses in this area is an R38 energy rating.

Table 1102.1.1

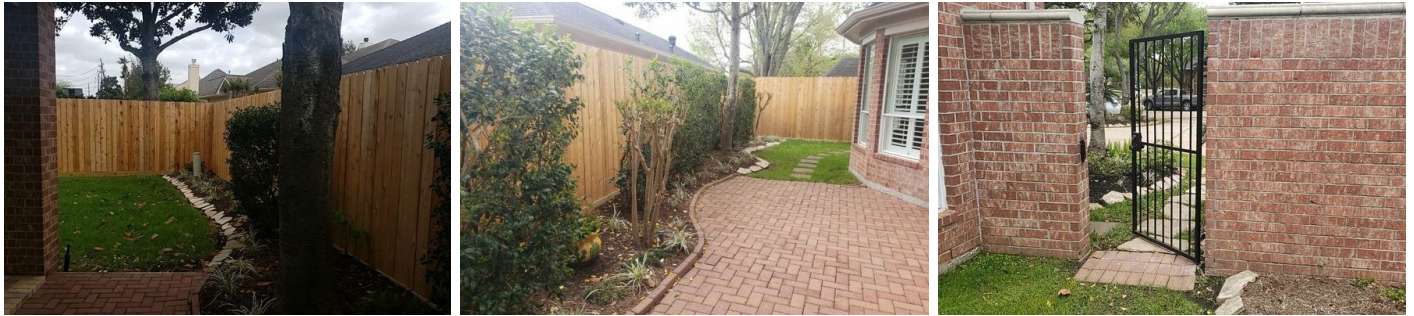
Gates and Fences: Gates and Fences - No Repairs

The gates and fences were in generally good condition at the time of the inspection and no repairs were observed to be needed.
