MECHANICAL INSPECTION

1119 Walden Hill Ct
Houston, TX 77077

PROPERTY INSPECTION REPORT FORM

Marley Vansanten <i>Name of Client</i>	04/11/2022 12:30 pm <i>Date of Inspection</i>
1119 Walden Hill Ct, Houston, TX 77077 <i>Address of Inspected Property</i>	
Daniel Koteles <i>Name of Inspector</i>	TREC #21157 <i>TREC License #</i>
<i>Name of Sponsor (if applicable)</i>	<i>TREC License #</i>

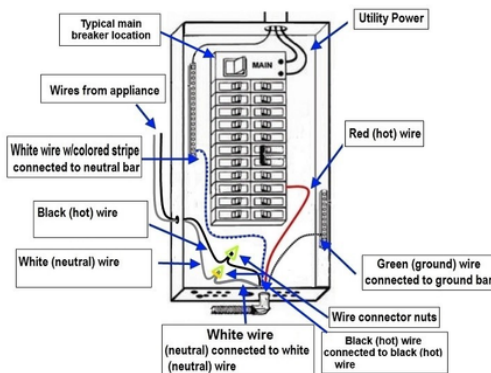
Circuit Breaker Wiring Diagram

The breaker panel(s) did not contain any Arc Fault Circuit Interrupters (AFCI). This is an “as-built” condition, that does not meet current building code standards. AFCI devices are intended to protect against fires caused by electrical arcing in the wiring, by shutting off the power to the circuit when an electrical arc is detected in the circuit. Homes built prior to 2002 were not required by the National Electrical Code (NEC) to be protected by AFCI devices. Since this home was built prior to 2002, the breaker panel is not required to be retrofitted with new AFCI breakers. If adding AFCI breakers is desired, it is recommended that you contact an electrician for further information.

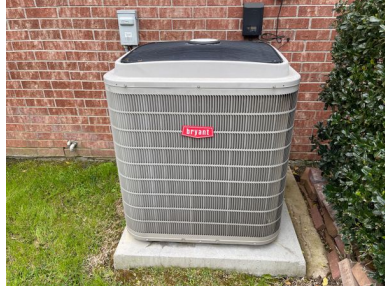
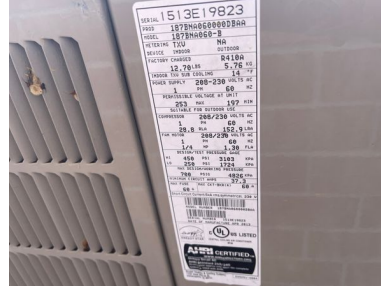
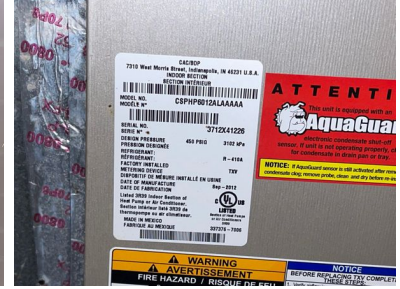
Condensing Unit Equipment - Functional:

The condensing unit equipment was functional at the time of the inspection. The equipment responded to the corresponding thermostat, and the compressor components and fan motor components appeared to be operating as evidenced by the cooling performance of the system.

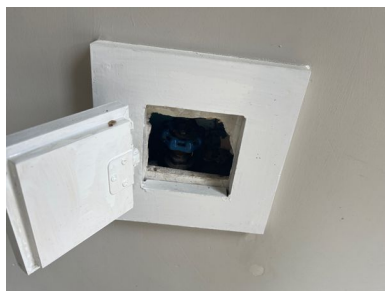
Main Water Shut Off Valve Location: Inside garage -

The main shut-off valve for the water line service piping is intended to provide a means to disconnect the water service to the structure/property.

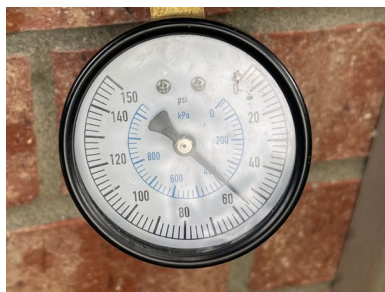
Static Water Pressure: 50-55 PSI -

The static water pressure at the property was measured with a water pressure gauge at the hose bibb nearest to the shut off valve at the time of the inspection.

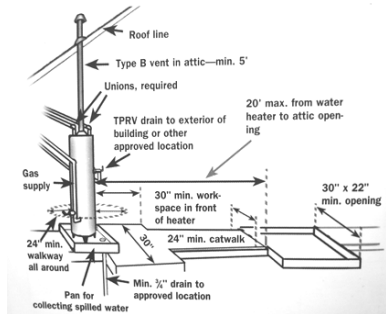
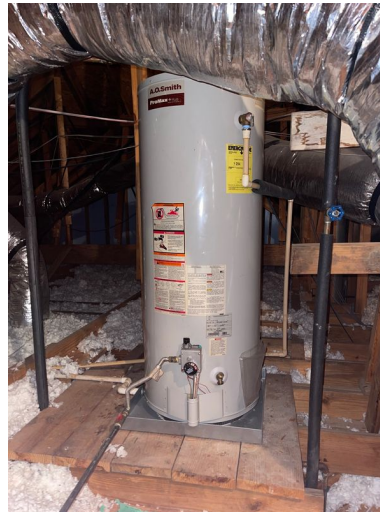
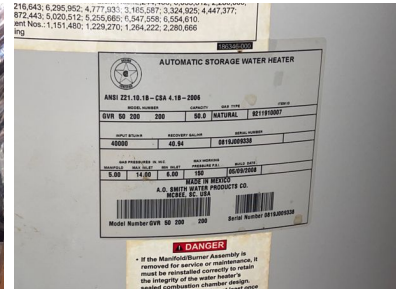
The hot water for the property was provided by the following natural gas fired gas water heater(s):

Location	Brand	Capacity	Age	Energy Type
Attic	A.O.Smith	50	2008	Gas

The water heater equipment was functional at the time of the inspection and providing hot water to the applicable plumbing fixtures.

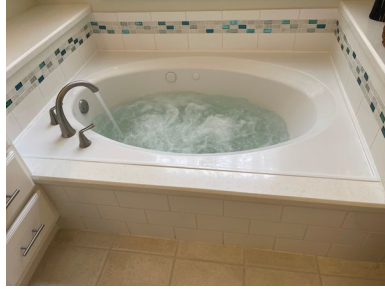
No access to pump/blower:

Access to the pump/blower was not provided at the time of the inspection, therefore the pump/blower, wiring, and plumbing under the tub were not visually checked. If further investigation is desired, it is recommended that access to the underside of the tub be made. It is pointed out, if repairs become necessary, an access opening will need to be installed.

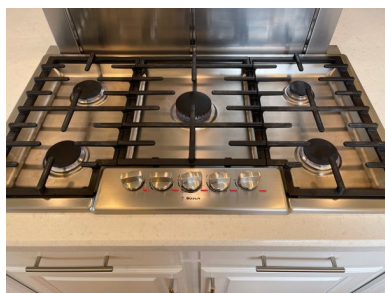
Gas Cooktop - Functional:

The gas cooktop was functioning and responded to the controls when they were operated. All of the burners and controls were operating properly at the time of the inspection.

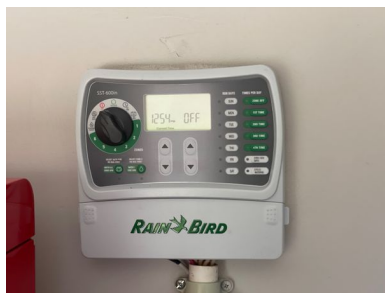
Sprinkler System: Rainbird, Located inside garage, 5 zones -

An automatic sprinkler system was installed. The system included a control panel, one or more solenoid valves, underground water lines and with sprinkler heads.

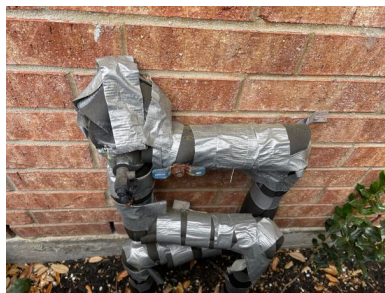
South

Backflow Prevention Device - present:

A backflow prevention device was present and was equipped with the two water shut off valves on the water supply line to the sprinkler system.
