Dukes Home Inspections Property Inspection Report

97 Bird Farm Rd, Huntsville, TX 77320 Inspection prepared for: Michael Hinks Real Estate Agent: Ryan Canada - Keller Williams Realty

> Date of Inspection: 5/25/2022 Time: 1:00 PM Age of Home: 2008 Size: 2390 Weather: Clear and 82 degrees Home faces west Home is furnished. Sellers present.

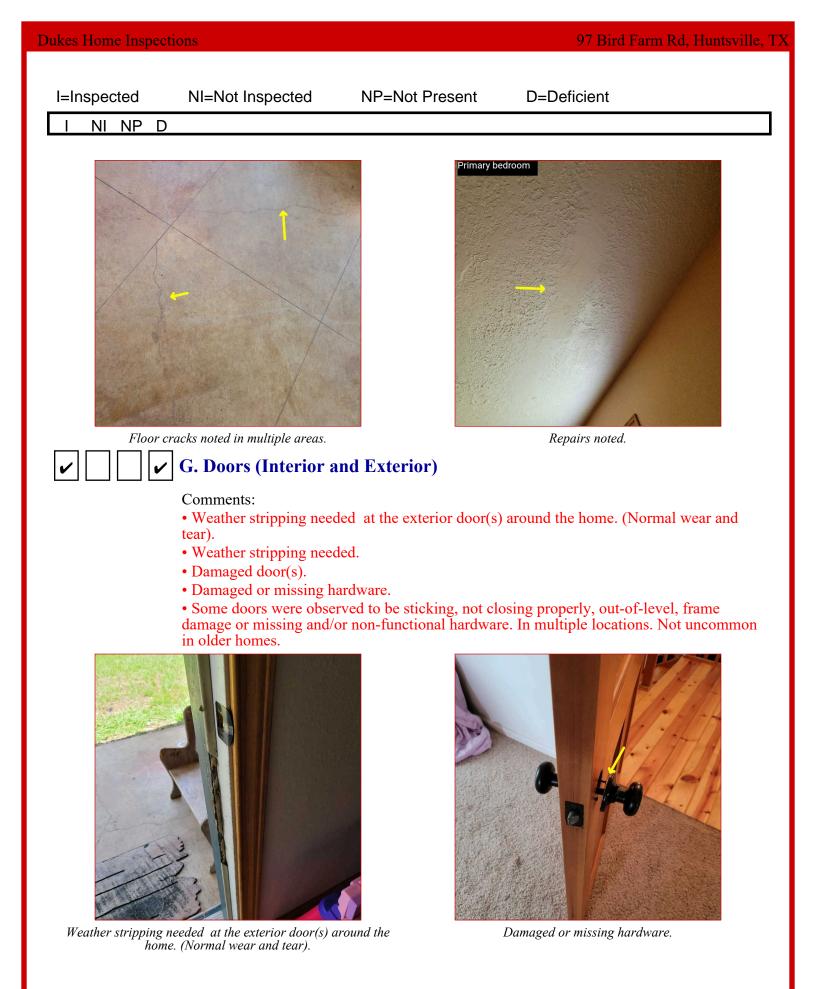
Weather stripping needed.

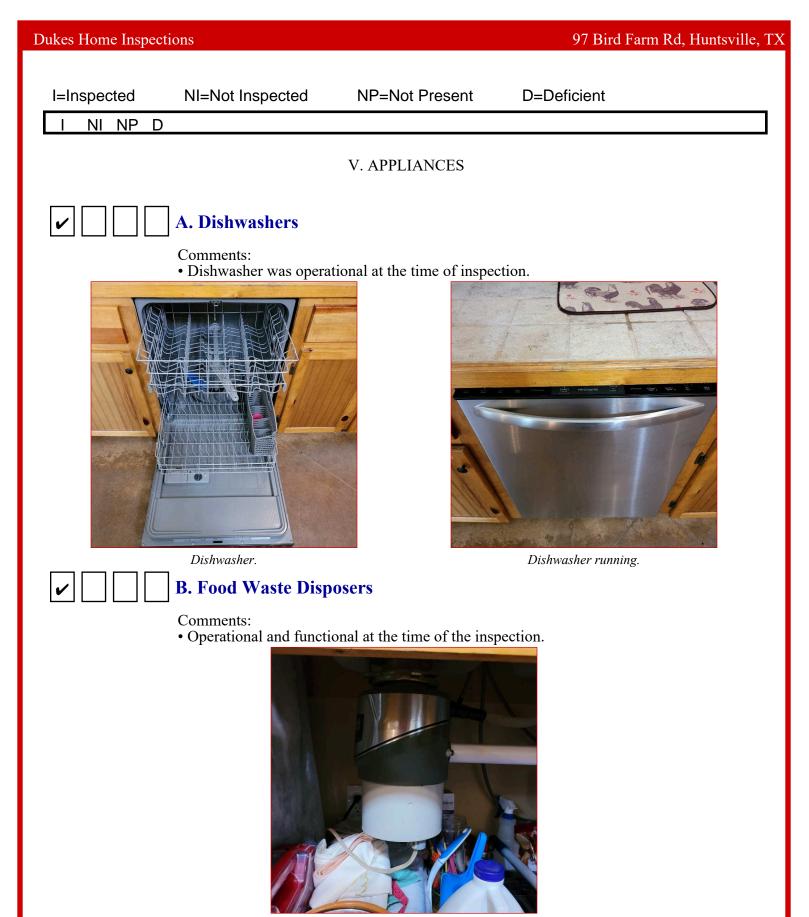
Disposal.
