# HOUSTON INSPECTIONS

**January 27, 2021**

## PROPERTY INSPECTION REPORT

Concerning: 4815 Raven Bluff Ln, Katy, TX 77494  
(Address or Other Identification of Inspected Property)

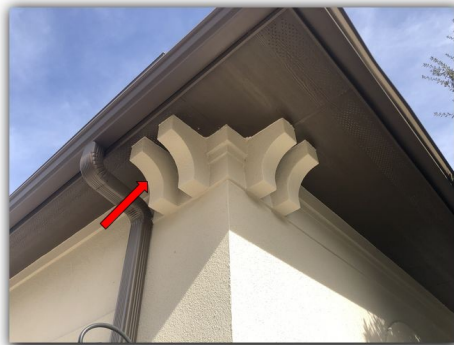
Evidence of previous repairs were found on the exterior of the structure as evident by patching and other signs.
