Property Inspection Report #6/27/20239122 Golden Sunshine Drive
8616 Daffodil St. Houston, TX 77063

PROPERTY INSPECTION REPORT FORM

9122 Golden Sunshine Drive, Houston, TX 77064

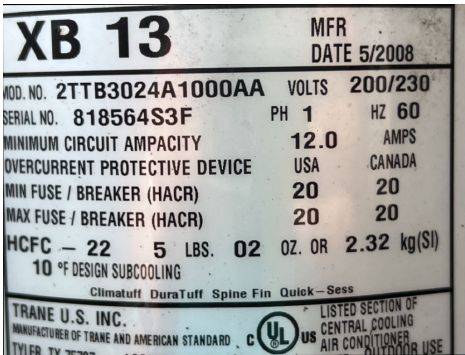
Condensing Unit:
2008 Trane
2 Ton

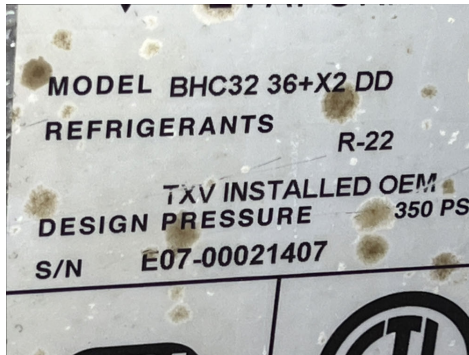
Evaporator Coil:
2007 Aspen
3 Ton

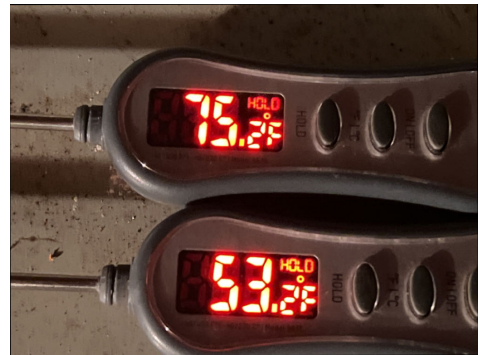
Evaporator coil temperature split:
22.0°

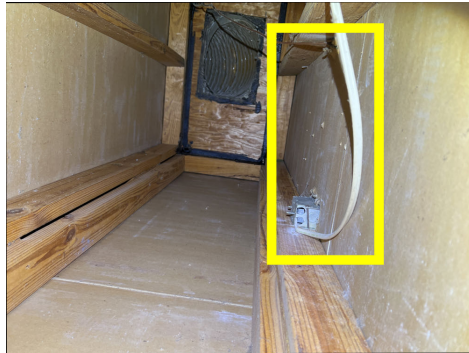
120 V wire located in return air chase

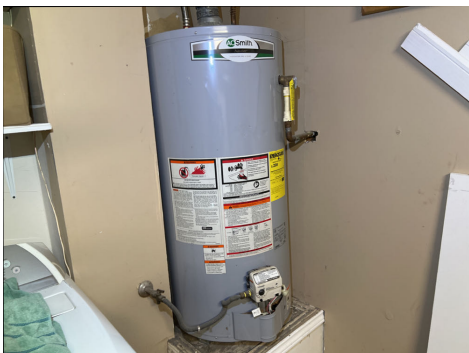
Located near house without benefit of a drain pan. Should water heater leak, interior finishes can be damaged.

Water Heater:
2017 A. O. Smith
40 Gallons
