FIG Services LLC d/b/a FOX INSPECTION GROUP Property Inspection Report #220120CS-2819 Meandering Elm Trail 8616 Daffodil St. Houston, TX 77063

PROPERTY INSPECTION REPORT

Prepared For:	Robert & Armi Harper (Name of Client)	
Concerning:	2819 Meandering Elm Trail, Houston, TX 77045 (Address of Inspected Property)	
By:	Cory Simpson, TREC: PI #25086 (Name and License Number of Inspector)	01/20/2022 (Date)

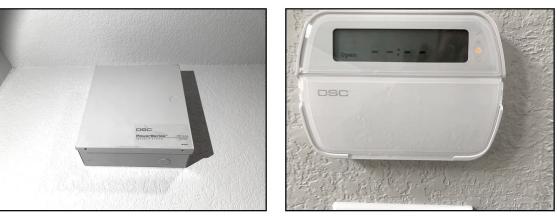
OTHER ELECTRICAL ITEMS:

Not checked/inspected.

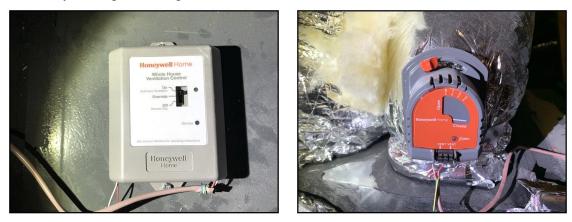
Buyer's Note: Home is equipped with an electronic damper and/or fresh air system. This type of system is out of the scope of a normal TREC home inspection. If buyer has any concerns and or questions about this type of system, and HVAC specialist should be contacted for a separate inspection.

Not checked/inspected.

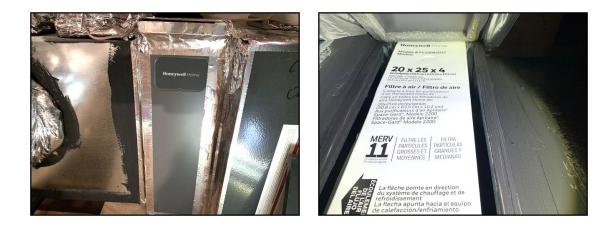
Media air filter(s) located in the attic that requires changing/cleaning every 6 months, recommend checking guide for proper maintenance information.
