Property Inspection Report

3618 Goodhope St, Houston, TX 77021
Inspection prepared for: Alexis Vargas

Date of Inspection: 07/22/2023 Time: 2:30PM
Age of Home: 2006 Size: 3072 sqft

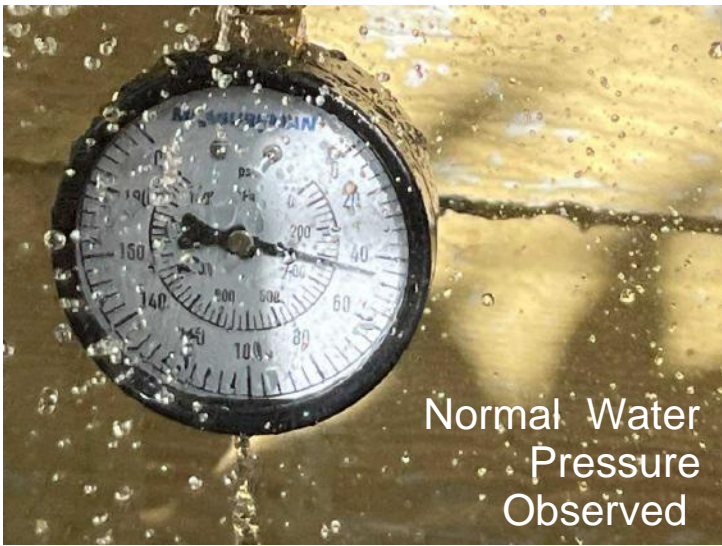
Normal Water Pressure Observed
