## **RESIDENTIAL INSPECTION REPORT**

79 Bradford Cir Sugar Land, TX 77479

# **PROPERTY INSPECTION REPORT FORM**

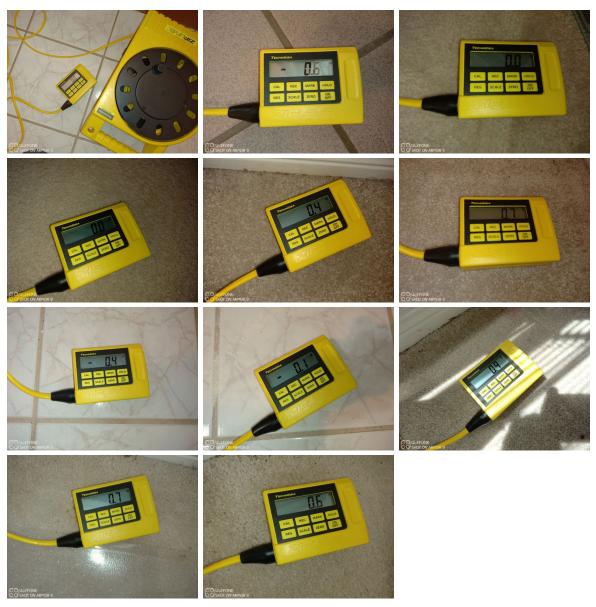
#### Digital Level Pictures:

*Performance Opinion: Functioning as Intended with Some Deficiencies :* Some deficiencies were noted, but they do not appear to be adversely affecting the performance of the foundation at this time.

This foundation was measured with the use of an electronic digital measurement tool. Multiple elevation points were registered on the foundation throughout the property to determine if there were elevation variations that indicated excessive movement of the foundation.

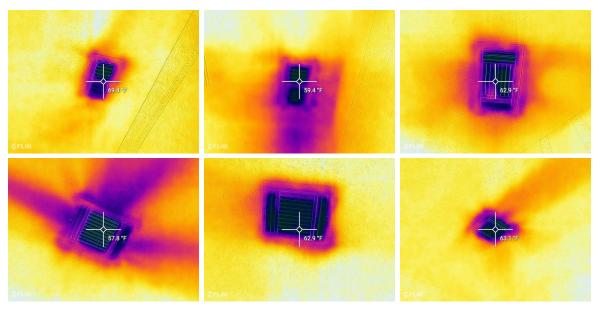
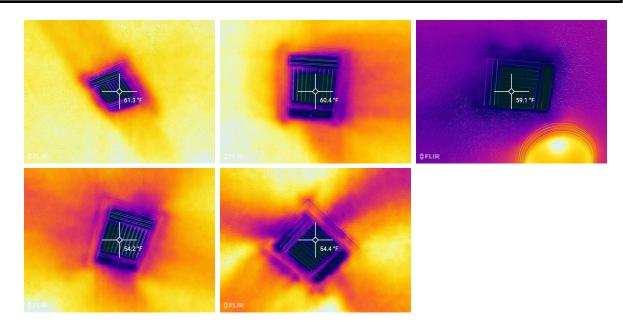
1st Floor

*Type of Refrigerant:* R410A (Puron) *Cooling System Was Functioning:* The cooling system was functioning at the time of inspection. Refer to the inspection report for any further recommendations.

Temperature Difference (Delta) - First Floor: 16° Temperature Difference (Delta) - Second Floor: 14° Comments: No Access to Internal Coils: There were no removable panels/covers to provide viewing access to the internal evaporator coils.
