PROFESSIONAL HOME INSPECTION, LLC

925 S. 6th Street  
La Porte, TX 77571

Report Identification: 20230906-01, 925 S. 6th Street, La Porte, TX

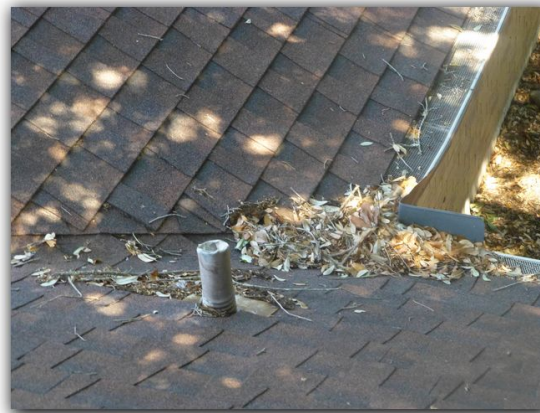
There is excessive debris on the roof. Excessive debris on the roof can hinder drainage and cause multiple issues in that area. I recommend clearing all excessive debris from the roof area.

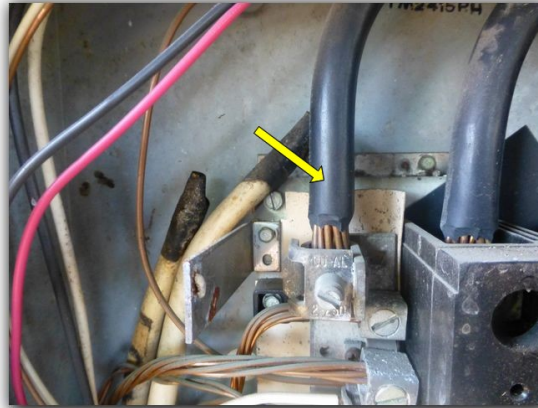
**GROUNDING:**

No deficiencies or anomalies observed at the time of inspection.

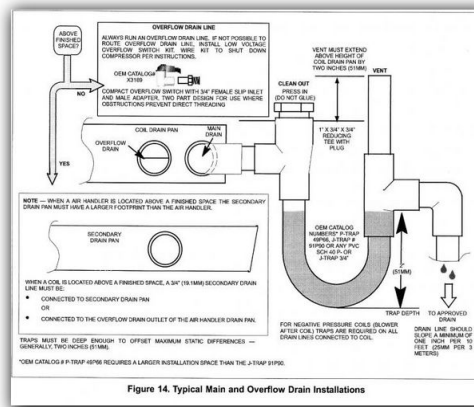
Figure 14. Typical Main and Overflow Drain Installations

The primary condensate drain line is not equipped with a clean-out, p-trap, and/or vent. The condensate drain lines shall be configured to permit the clearing of blockages and performance of maintenance without requiring the drain line to be cut (Ref. IRC M1411.3). In addition, most manufacturer's installation instructions require a p-trap to be installed on the primary condensate discharge to prevent air from moving in or out of the coil box or air handler during operation.
