Residence is a one-story wood frame structure.
For the purpose of this report, residence faces north.
Residence was vacant at the time of the inspection.

PROPERTY INSPECTION REPORT

Concerning: 22135 Kerryblue Dr, Katy, TX 77450
(Address or Other Identification of Inspected Property)

By: David Terry, Lic #10562 06/03/2021
(Name and License Number of Inspector) (Date)

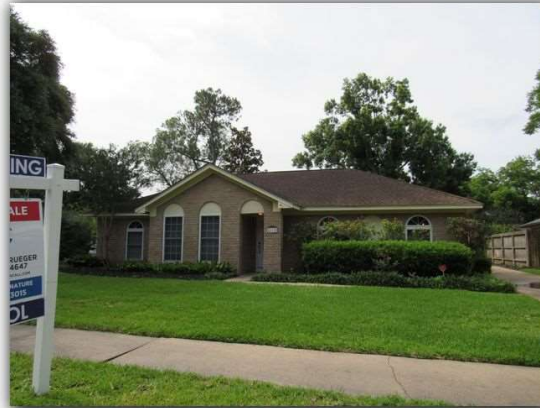
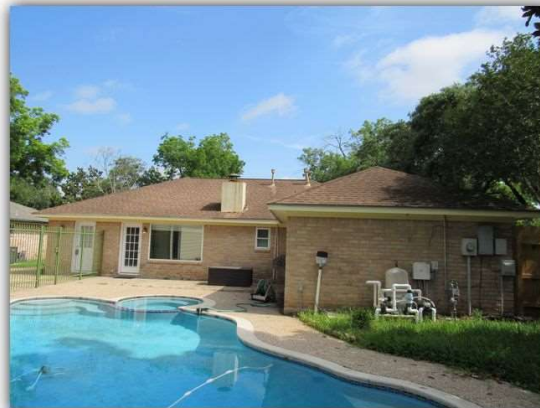
The residence was observed as having a conventional concrete slab on grade foundation. The foundation appears to be functioning as designed and intended at this time. The structure did not exhibit visible indications of excessive shifting or settlement damage typically associated with foundation problems. Minor brick veneer cracks were observed on the west and east sides of the master bedroom area. The structural members and load bearing walls appeared unremarkable at this time. The foundation appears to be reasonably level.

Evidence of minor shifting was observed along the southeast portion of the foundation. While it is this inspector's opinion that the foundation has only experienced minor shifting, if concerned, further evaluation by a Registered Professional Engineer or a qualified foundation repair contractor would be recommended.

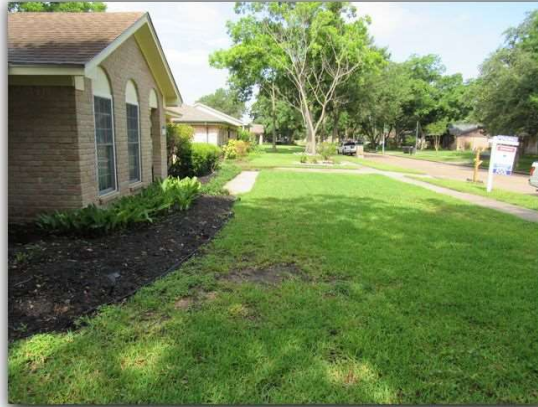
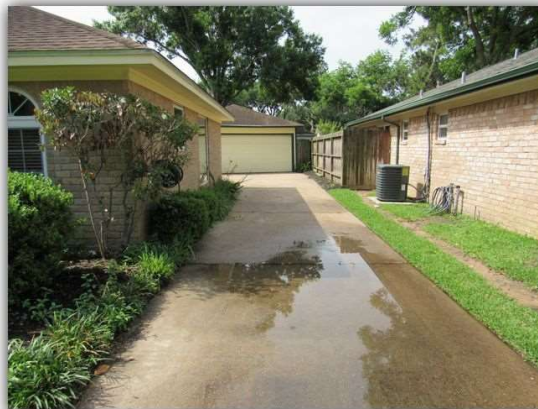
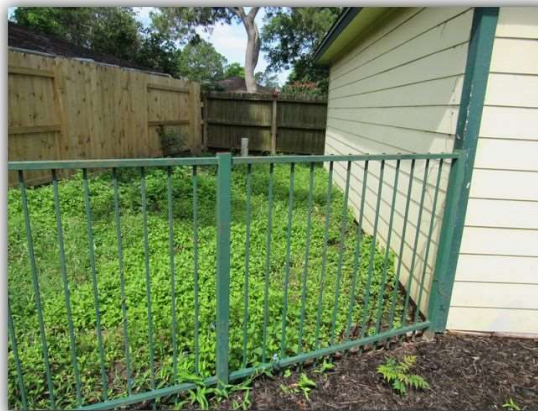
The grading on the property appears satisfactory at this time. The slope and drainage was considered typical and normal. It is recommended that 3-5" of foundation exposure be kept around the perimeter of the foundation and that a consistent moisture content be maintained. Improper grading and moisture control can lead to possible foundation problems.

It is recommended to lower the soil level of the flower beds along the perimeter of the foundation, as needed, to expose 3-5" of the foundation wall and provide proper drainage away from the foundation.

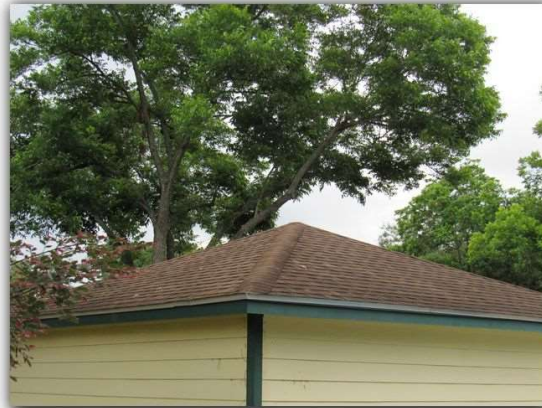
The residence was observed as having a hip and gable framed roof with a composition shingle cover. The roof was observed and inspected from ground level using visual aids. The overall visible shingle cover, associated flashing, and roof venting jacks appeared in satisfactory condition at this time with no physical damage observed. No water penetration was observed from the visible areas of the interior roof or interior ceilings. The typical life expectancy for a similar shingle roof system is approximately 15-20 years.

Recommend pruning the tree limbs near, or in contact with, the roof covering and provide a minimum 3' clearance from the roof surface. Branches contacting the roof can cause excessive wear and decrease the life expectancy of the roof covering.

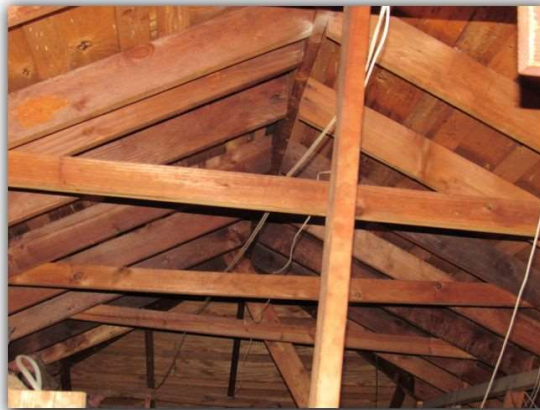
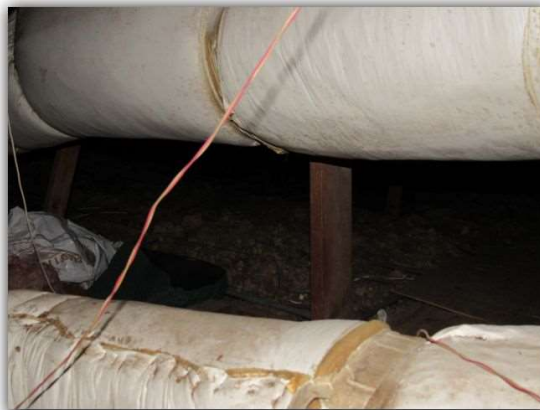
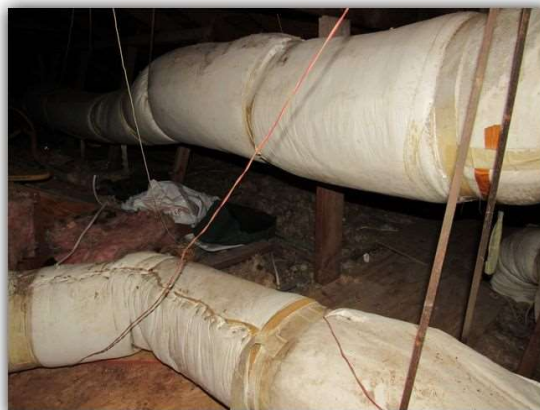
The accessible portions of the attic area of the residence was visually inspected. The overall condition of the visible interior rafters, framing, supports and radiant barrier lined decking appear sound at this time. Insulation in the attic area was observed at a depth of approx. 6-8". Attic ventilation was observed to be continuous soffit vents at the eaves with ridge vents at the ridge. Attic ventilation appears to be adequate at this time.

Recommend securing the vertical insulation in the attic as needed.

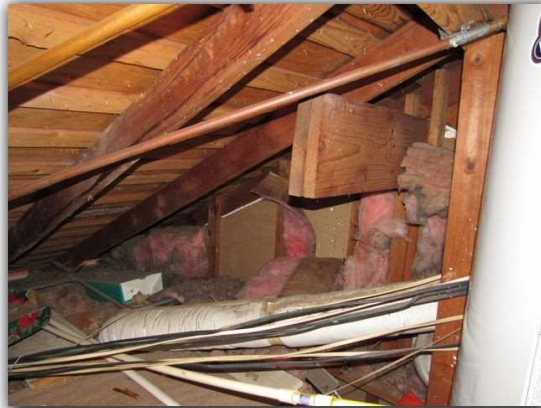
- Purlins in the west and east attic areas were observed to have inadequate strut supports. Recommend adding struts to the purlins at a maximum spacing of 4' on center and at an angle not greater than 45 degrees from vertical (IRC - R802.5.1).
- Recommend installing a cricket at the roof structure and chimney to provide adequate discharge of storm water and eliminate the accumulation of debris from behind the chimney.

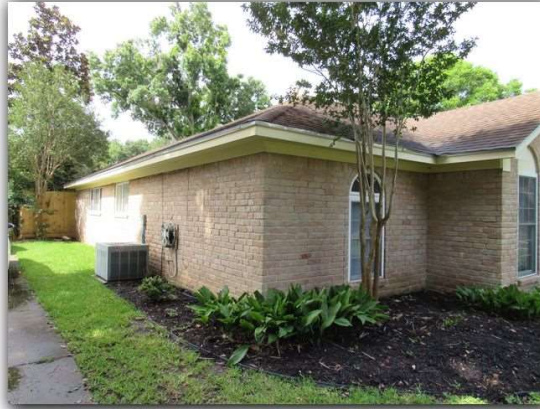
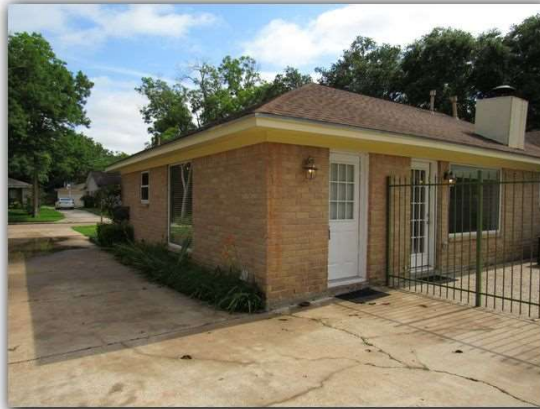
The masonry wall areas and fiber cement sided walls on frame construction were observed to be in overall good condition at this time. Interior and exterior walls showed no indication of excessive shifting at this time.

Minor brick veneer cracks were observed on the west and east sides of the master bedroom area.

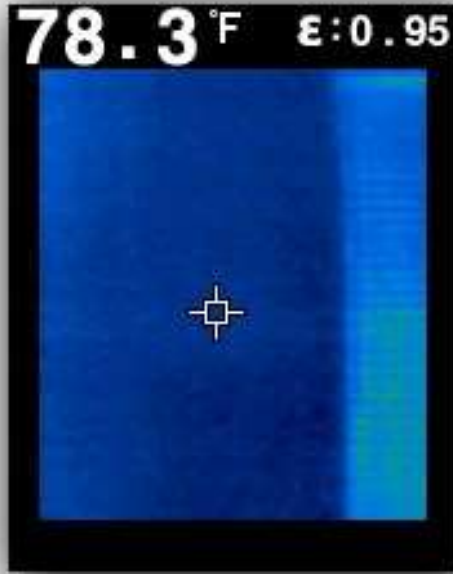
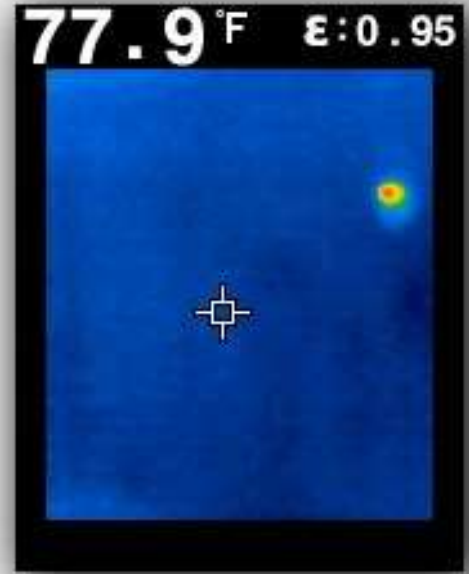
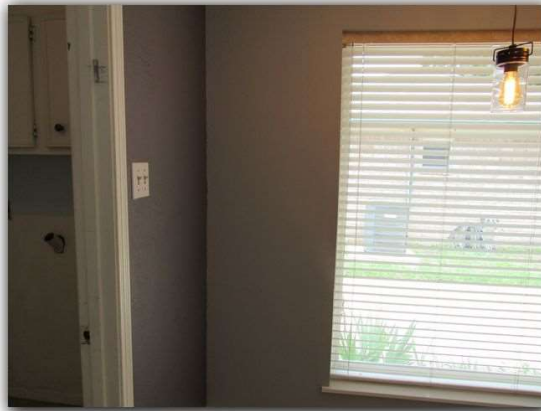
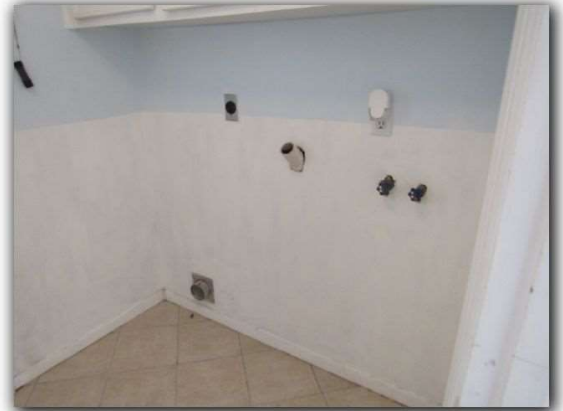
Thermal imaging of the perimeter walls of the living area did not reveal any anomalies at this time. The following thermal images are followed by the digital pictures of the area below the image.

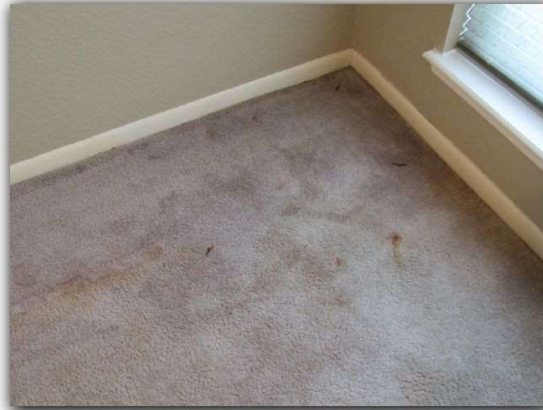
- Stained carpet observed in the study. Recommend cleaning or replacement as deemed necessary.

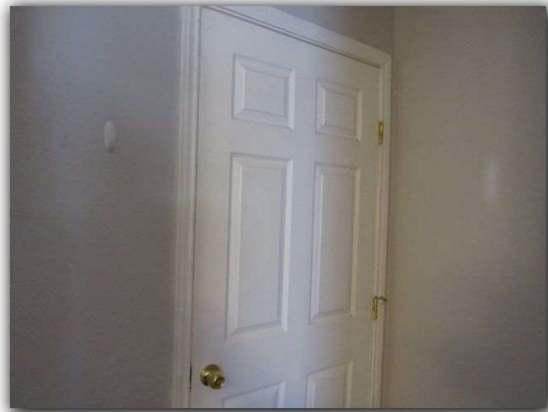
Closure/fit adjustments are needed at the northeast bedroom entry door.

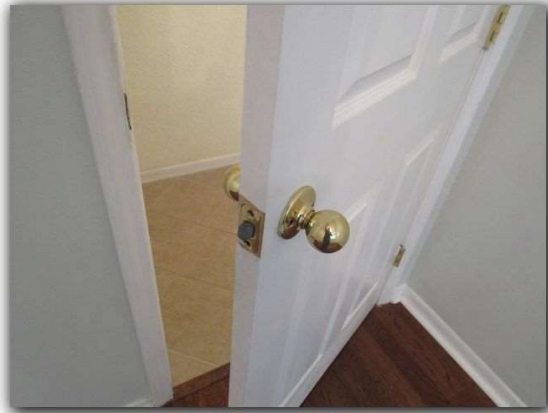
The latch for the east bedroom door improperly installed. Latch observed to be reversed at the time of the inspection.

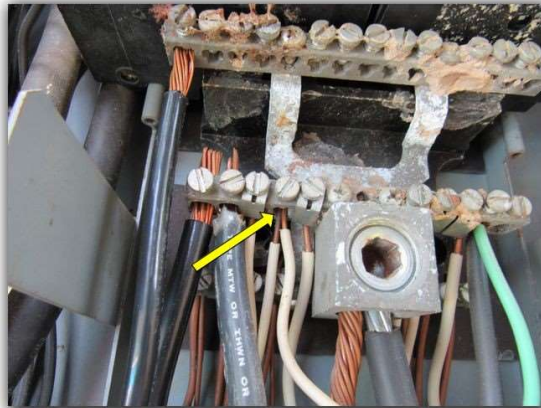
Double lugging was observed at the neutral bus bar. Double lugging is not permitted and the neutral wires should be terminated separately in the bus bar.

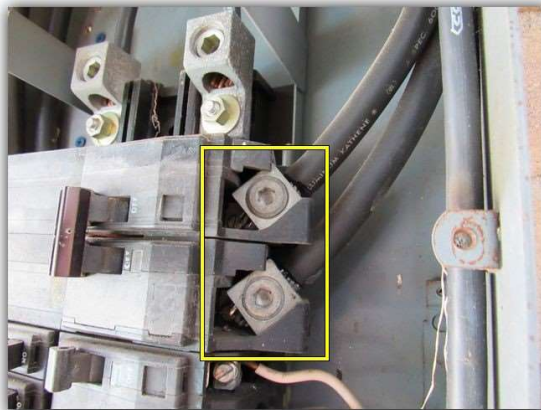
- The service panel cabinet does not appear to be bonded. Recommend necessary repairs be made to bond the service panel cabinet to the neutral bus bar. Metal components that can become energized from a lightning strike should be bonded/grounded.
- The aluminum main leads and ground wire in the service panel are required to be protected with an anti-oxidant inhibitor per the electrical code. The electrical grease is not present and should be installed on the leads connected to the main breaker and bus bar.

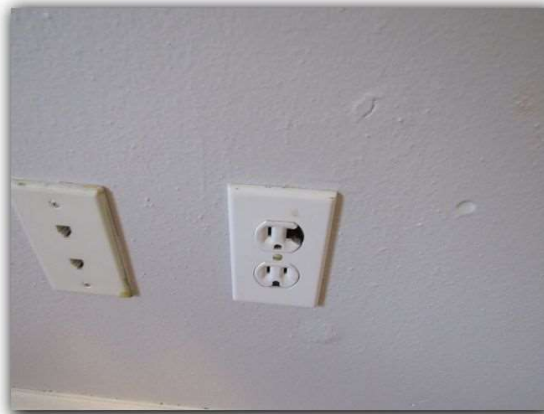
Repairs are needed to replace the damaged outlet in the northeast bedroom.

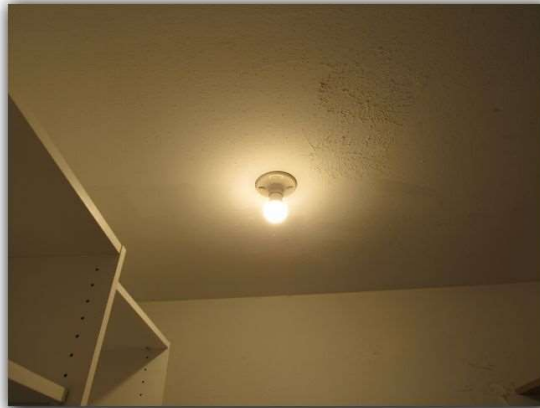
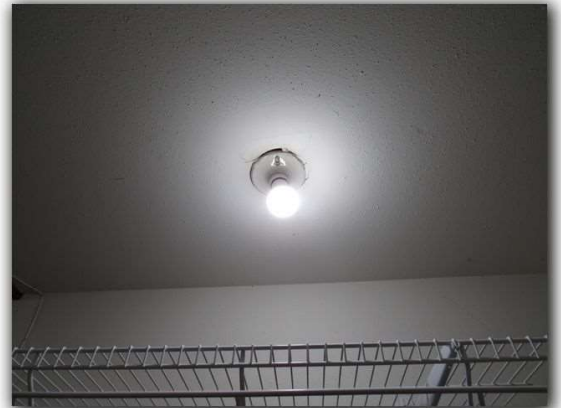
Closet lights are not protected by light globes. Closet lights should be protected by light globes and have at least 12" clearance from shelving. Repairs are needed to provide the required protection and clearance.

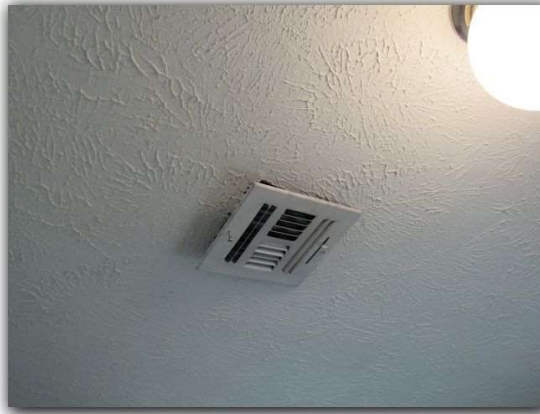
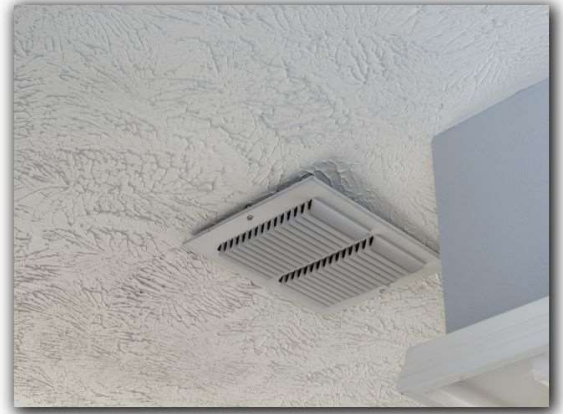
Repairs are called for to secure the loose air duct registers in the utility room and breakfast

room.

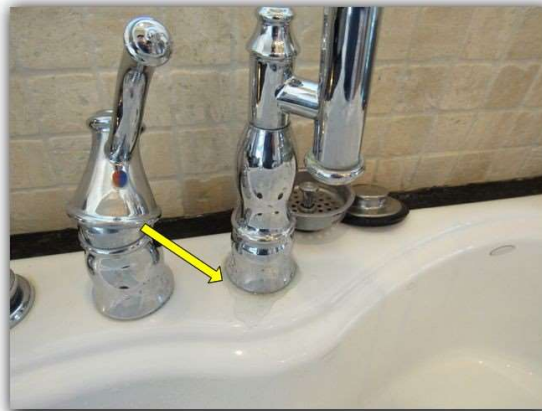
Repairs are called for to repair/replace the leaky kitchen faucet. The swing spout was observed to leak during operation.

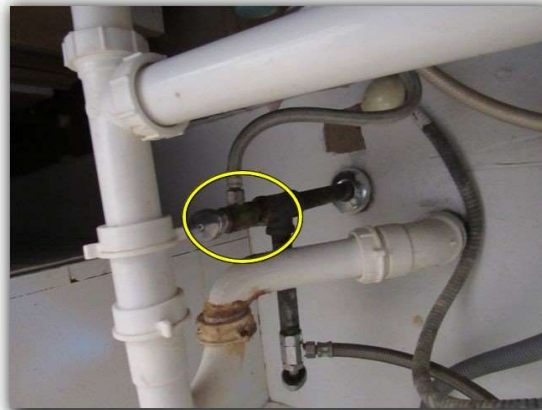
Repairs are needed to remedy the leak in the water supply piping beneath the kitchen sink.

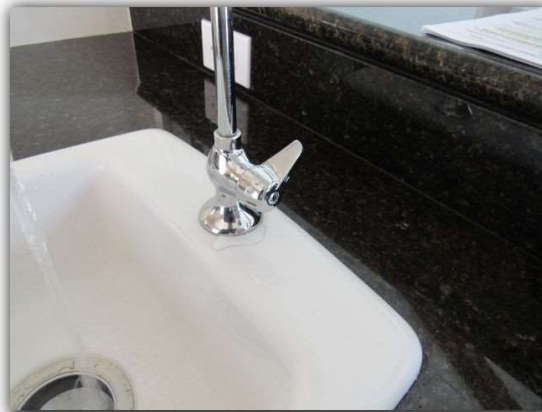
Repairs are needed for the leaking valve at the wet bar faucet.

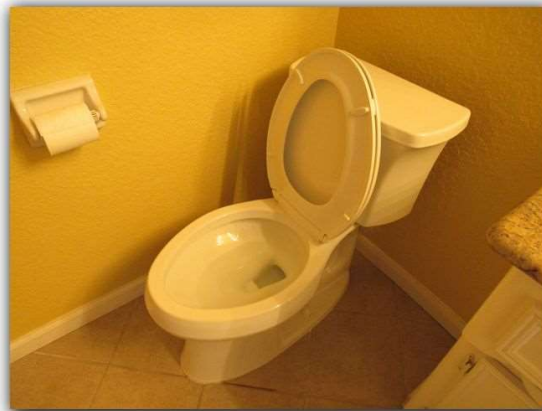
Repairs are needed to remedy the leak at the base of the toilet in the hall bath. The toilet should be removed, the closet flange and toilet base cleaned and a new wax ring and closet bolts installed when mounting the toilet.

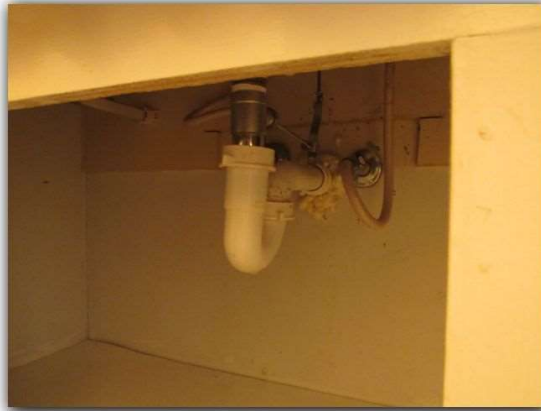
Repairs are needed for the leaking drain assembly under the hall bath lavatory.

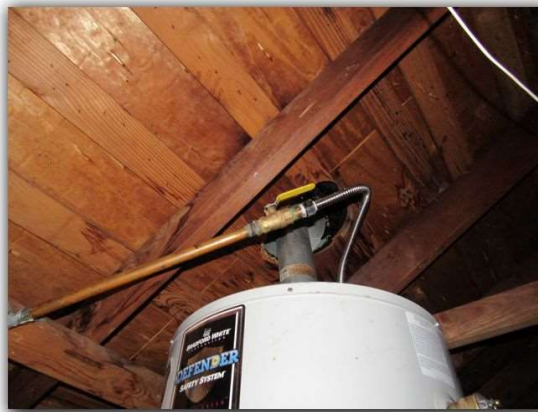
2020 BRADFORD-WHITE 40 gallon gas fired water heater MOD. #RG240S6N, unit was observed to be functional and properly installed at this time. Water temperature was measured at 121 degrees, temperature controls on the water heater can be adjusted for comfort levels.

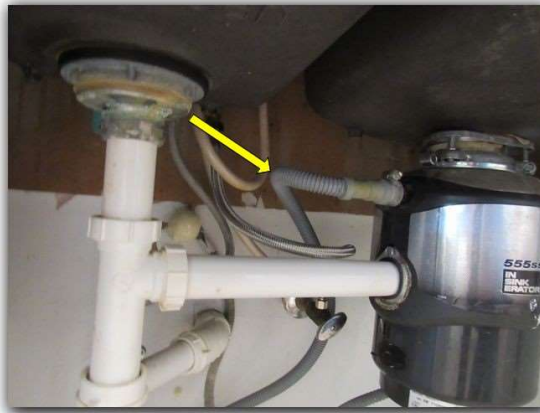
Drain loop in the discharge line not present at the time of the inspection. Recommend the dishwasher discharge line extend higher than the termination point to create a loop and provide anti-siphon protection.

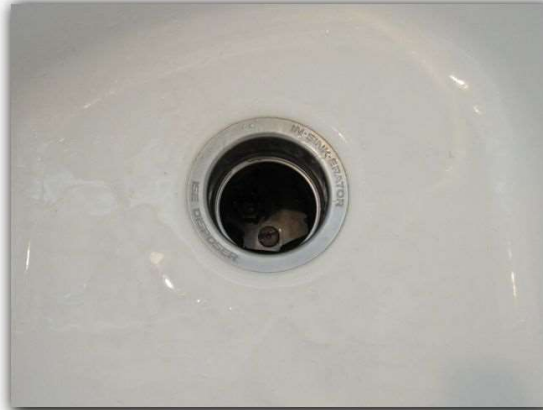
Repairs are needed to replace the damaged splash guard.

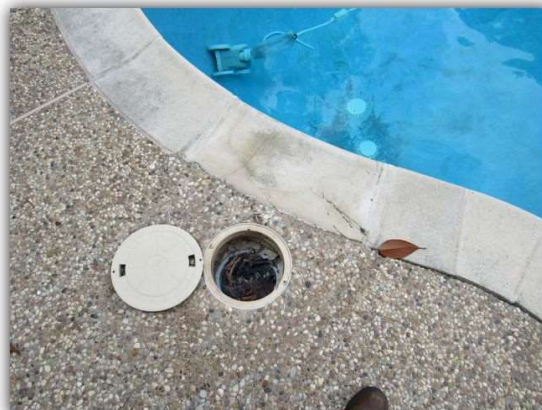
In-ground gunite constructed pool/spa was observed to be structurally sound, no visible cracks in the surfacing or tiling was present at this time. The pool equipment was operated using the timer controller at the equipment area. The 1.5hp-pool pump, 3/4hp booster cleaner pump, cartridge filter system, POLARIS cleaner, returns, skimmers, and spa jets were observed to be operational at the time of the inspection.

Recommend replacing the inoperable pool and spa lights. Light failed to illuminate using the local switches.
