Inspection Report

Property Address: 20607 Providence Point Dr Katy TX 77449

PROPERTY INSPECTION REPORT

| Prepared For: | Judena Pierre | | |
|---|---|---|--|
| By: | Antonio Wilson 9936 / Cliff-Bell Real Estate Inspectors | 7/18/2023 | |

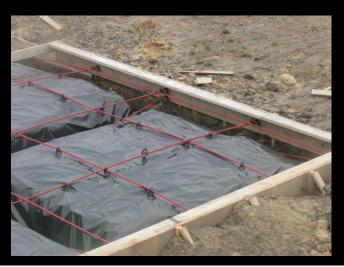
Structure built on a slab-on-grade foundation. A slab-on-grade foundation is a structural engineering practice in which the concrete slab that will serve as the foundation for a building or other structure is formed from a mold that is set into the ground. The concrete is then poured directly into the mold, leaving no space between the ground and the structure. This is informational only

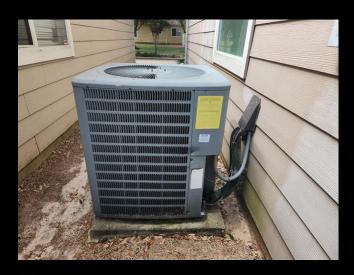
Overview of A/C condenser unit and compressor included in this report. An AC condenser is the outdoor portion of an air conditioner or heat pump that either releases or collects heat, depending on the time of the year. The compressor squeezes the refrigerant while it's in a gaseous state, while the condenser converts the refrigerant gas back into a liquid. see video

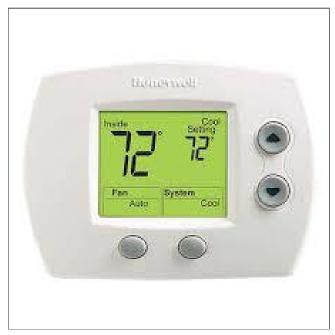
F. Item 1(Picture)

The inspector observed only 1 thermostat (2nd floor only) in a 2-story residence at the time of inspection.

Because heat rises, upstairs rooms are naturally warmer than downstairs rooms. Therefore, if the residence is a two-story house, thermostat placement should always be on the first floor. This way, the thermostat can easily be reached and adjusted as needed. Additionally, placing the thermostat on the first floor will help to ensure that the temperature in the house is evenly distributed. The thermostat should be placed fairly high up onto the wall. Keeping it in the most central part of the whole house helps keep the temperature the most regulated. Recommend consulting with a licensed HVAC professional to determine any corrective action.

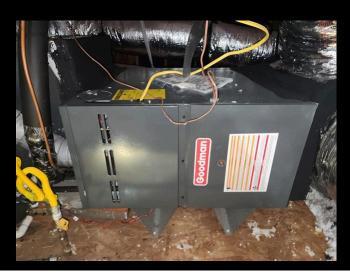
Property equipped with gas heating equipment. A gas furnace is a home heating appliance that runs off of natural gas. The natural gas is ignited in the furnace, warming up the air, which is then delivered throughout the home. This is informational only.

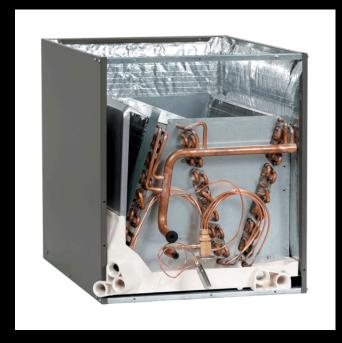
An indoor evaporator coil is the part of an air conditioner or heat pump that absorbs the heat from the air in your house. It is located inside the air handler or attached to the furnace. Due to design, indoor evaporator coils were not able to be viewed and/or inspected. This is informational only.

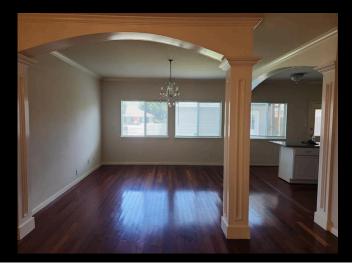
Inspector did not observe any visible structural deficiencies in this Dining Area at the time of inspection.

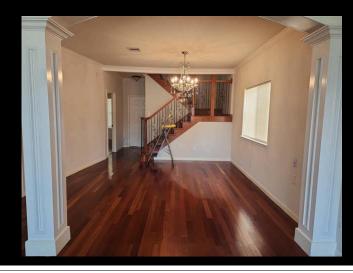
Inspector did not observe any visible structural deficiencies in this Living Room at the time of inspection.
